Client: Town of Addison Date: 1/2/18
 Program: ADA Self-Evaluation and Transition Plan Prepared By: CMP
 KHA No.: 063543021 Checked By: EPE

Corridor : Spring Valley Rd GPS ID: 90029
 Project Name: Intersection of Spring Valley Rd and driveway (Lat. 32.9399; Long. -96.8547)
 Town: Addison

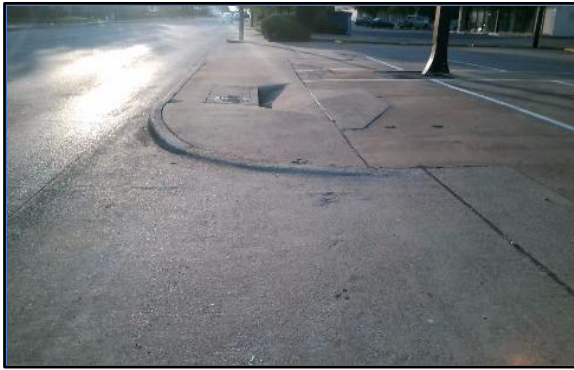
Curb Ramp Issues	Curb Ramp ID ('z' or 'l' in ramp label indicates no existing ramp)		Possible Solutions
	3z	4z	
Curb ramp does not exist and is needed	X	X	Install curb ramp; if median improvement, see shapefile
Curb ramp does not land in crosswalk			
No 4' x 4' clear space at base of curb ramp			
Curbed side is not 90° or has traversable adjacent surface			
Flare cross slope is greater than 10%			
Curb ramp running slope is greater than 8.3%			
Blended transition running slope is greater than 5%			
Cut-thru ramp running slope is greater than 5%			
Curb ramp cross slope is greater than 2%			
Cut-thru ramp cross slope is greater than 2%			
Curb ramp width is less than 48"			
Cut-thru ramp width is less than 60"			
Permanent obstruction (>0.25") in curb ramp/landing/flares			
Temporary obstruction (>0.25") in curb ramp/landing/flares			
No textured surface at base of curb ramp			
No color contrast at base of curb ramp

Corner 3 No Ramp (3z)

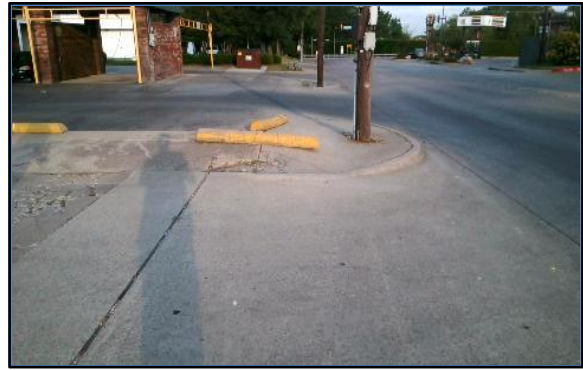
Corner 4 No Ramp (4z)
