Client: Town of Addison Date: 1/2/18
 Program: ADA Self-Evaluation and Transition Plan Prepared By: CMP
 KHA No.: 063543021 Checked By: EPE

Corridor : Spring Valley Rd GPS ID: 90030
 Project Name: Intersection of Spring Valley Rd and driveway (Lat. 32.9399; Long. -96.8537)
 Town: Addison

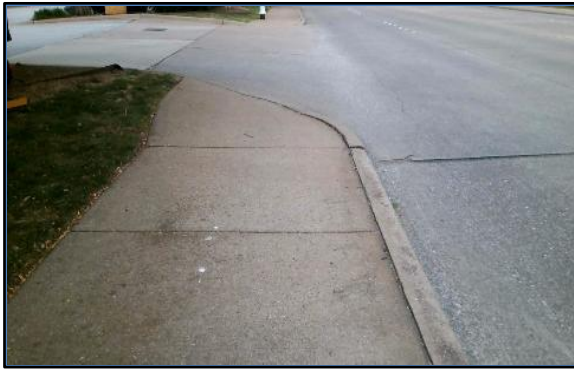
Ramp 3A

Curb Ramp Issues	Curb Ramp ID ('2' or '1' in ramp label indicates no existing ramp)		Possible Solutions
	3A	4A	
Curb ramp does not exist and is needed			Remove and replace curb ramp
Curb ramp does not land in crosswalk			
No 4' x 4' clear space at base of curb ramp			
Curbed side is not 90° or has traversable adjacent surface			
Flare cross slope is greater than 10%	X	X	
Curb ramp running slope is greater than 8.3%	X		
Blended transition running slope is greater than 5%			
Cut-thru ramp running slope is greater than 5%			
Curb ramp cross slope is greater than 2%	X	X	
Cut-thru ramp cross slope is greater than 2%			
Curb ramp width is less than 48"			For intersection, commercial driveway, and park ramps, install color truncated domes
Cut-thru ramp width is less than 60"			
Permanent obstruction (>0.25") in curb ramp/landing/flares		X	
Temporary obstruction (>0.25") in curb ramp/landing/flares			
No textured surface at base of curb ramp	X	X

No color contrast at base of curb ramp	X	X	
Landing area does not exist and is needed			
Landing area is less than 5' x 5' or slopes greater than 2%	X	X	
Curb ramp transition onto roadway is greater than 0.25"	X	X	
Counter slope of the gutter or street at the foot of the curb ramp is greater than 5%			
Ponding occurs at base of curb ramp
