Client: Town of Addison Date: 1/2/18
 Program: ADA Self-Evaluation and Transition Plan Prepared By: CMP
 KHA No.: 063543021 Checked By: EPE

Corridor : Beau Park Ln GPS ID: 90032
 Project Name: Intersection of Beau Park Ln and driveway (Lat. 32.9444; Long. -96.8527)
 Town: Addison

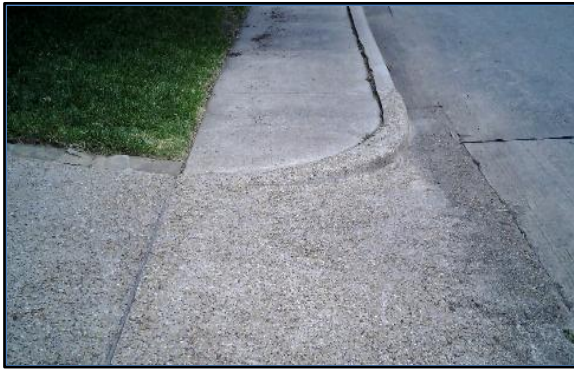
Curb Ramp Issues	Curb Ramp ID ('z' or 'l' in ramp label indicates no existing ramp)		Possible Solutions
	1z	4z	
Curb ramp does not exist and is needed	X	X	Install curb ramp; if median improvement, see shapefile
Curb ramp does not land in crosswalk			
No 4' x 4' clear space at base of curb ramp			
Curbed side is not 90° or has traversable adjacent surface			
Flare cross slope is greater than 10%			
Curb ramp running slope is greater than 8.3%			
Blended transition running slope is greater than 5%			
Cut-thru ramp running slope is greater than 5%			
Curb ramp cross slope is greater than 2%			
Cut-thru ramp cross slope is greater than 2%			
Curb ramp width is less than 48"			
Cut-thru ramp width is less than 60"			
Permanent obstruction (>0.25") in curb ramp/landing/flares			
Temporary obstruction (>0.25") in curb ramp/landing/flares			
No textured surface at base of curb ramp			
No color contrast at base of curb ramp

Corner 1 No Ramp (1z)

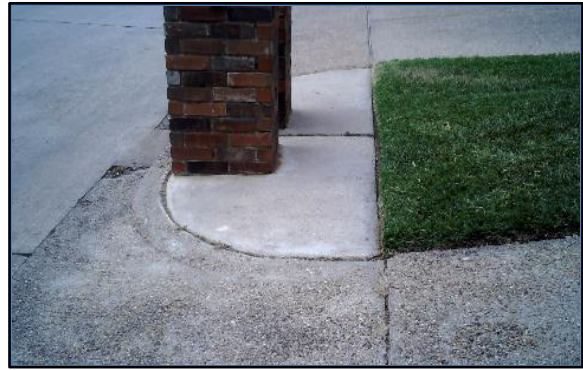
Corner 4 No Ramp (4z)
