Client: Town of Addison Date: 1/2/18
 Program: ADA Self-Evaluation and Transition Plan Prepared By: CMP
 KHA No.: 063543021 Checked By: EPE

Corridor : Beau Park Ln GPS ID: 90033
 Project Name: Intersection of Beau Park Ln and driveway (Lat. 32.9443; Long. -96.8527)
 Town: Addison

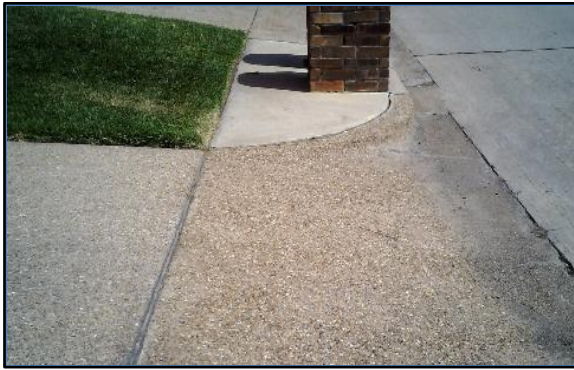
Corner 1 No Ramp (1z)

Curb Ramp Issues	Curb Ramp ID ('z' or 'l' in ramp label indicates no existing ramp)		Possible Solutions
	1z	4z	
Curb ramp does not exist and is needed	X	X	Install curb ramp; if median improvement, see shapefile
Curb ramp does not land in crosswalk			
No 4' x 4' clear space at base of curb ramp			
Curbed side is not 90° or has traversable adjacent surface			
Flare cross slope is greater than 10%			
Curb ramp running slope is greater than 8.3%			
Blended transition running slope is greater than 5%			
Cut-thru ramp running slope is greater than 5%			
Curb ramp cross slope is greater than 2%			
Cut-thru ramp cross slope is greater than 2%			
Curb ramp width is less than 48"			
Cut-thru ramp width is less than 60"			
Permanent obstruction (>0.25") in curb ramp/landing/flares			
Temporary obstruction (>0.25") in curb ramp/landing/flares			
No textured surface at base of curb ramp			
No color contrast at base of curb ramp
