Client: Town of Addison Date: 1/2/18
 Program: ADA Self-Evaluation and Transition Plan Prepared By: CMP
 KHA No.: 063543021 Checked By: EPE

Corridor : Brookwood Ln GPS ID: 90037
 Project Name: Intersection of Brookwood Ln and driveway (Lat. 32.9442; Long. -96.8513)
 Town: Addison

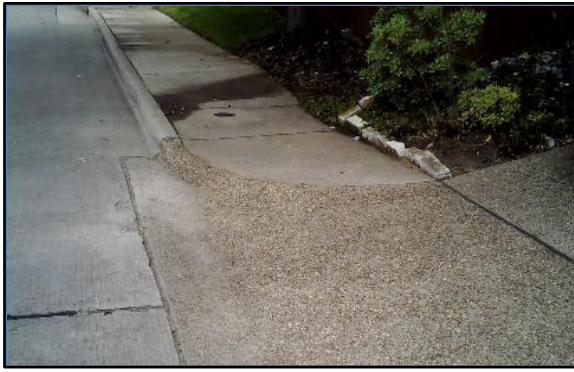
Curb Ramp Issues	Curb Ramp ID ('z' or 'l' in ramp label indicates no existing ramp)		Possible Solutions
	1z	2z	
Curb ramp does not exist and is needed	X	X	Install curb ramp; if median improvement, see shapefile
Curb ramp does not land in crosswalk			
No 4' x 4' clear space at base of curb ramp			
Curbed side is not 90° or has traversable adjacent surface			
Flare cross slope is greater than 10%			
Curb ramp running slope is greater than 8.3%			
Blended transition running slope is greater than 5%			
Cut-thru ramp running slope is greater than 5%			
Curb ramp cross slope is greater than 2%			
Cut-thru ramp cross slope is greater than 2%			
Curb ramp width is less than 48"			
Cut-thru ramp width is less than 60"			
Permanent obstruction (>0.25") in curb ramp/landing/flares			
Temporary obstruction (>0.25") in curb ramp/landing/flares			
No textured surface at base of curb ramp			
No color contrast at base of curb ramp

Corner 1 No Ramp (1z)

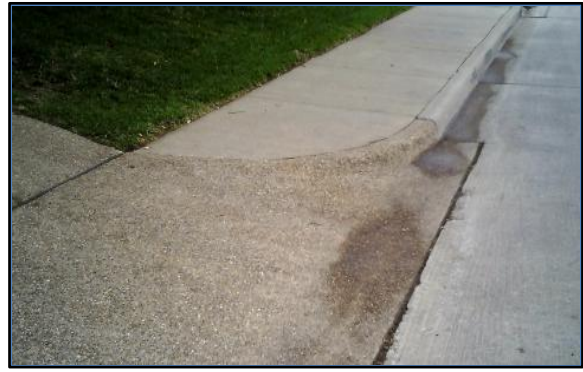
Corner 2 No Ramp (2z)
