Client: Town of Addison Date: 1/2/18
 Program: ADA Self-Evaluation and Transition Plan Prepared By: CMP
 KHA No.: 063543021 Checked By: EPE

Corridor : Brookwood Ln GPS ID: 90038
 Project Name: Intersection of Brookwood Ln and driveway (Lat. 32.9442; Long. -96.8503)
 Town: Addison

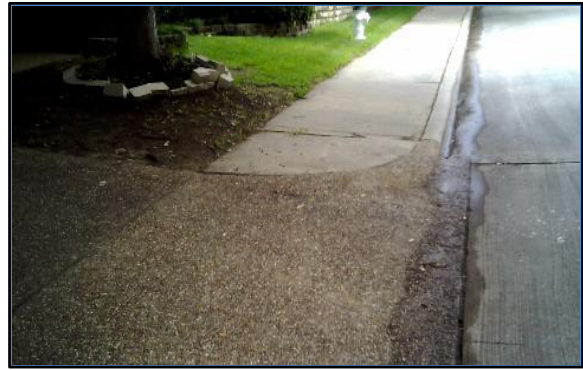
Curb Ramp Issues	Curb Ramp ID ('z' or 'l' in ramp label indicates no existing ramp)		Possible Solutions
	1z	2z	
Curb ramp does not exist and is needed	X	X	Install curb ramp; if median improvement, see shapefile
Curb ramp does not land in crosswalk			
No 4' x 4' clear space at base of curb ramp			
Curbed side is not 90° or has traversable adjacent surface			
Flare cross slope is greater than 10%			
Curb ramp running slope is greater than 8.3%			
Blended transition running slope is greater than 5%			
Cut-thru ramp running slope is greater than 5%			
Curb ramp cross slope is greater than 2%			
Cut-thru ramp cross slope is greater than 2%			
Curb ramp width is less than 48"			
Cut-thru ramp width is less than 60"			
Permanent obstruction (>0.25") in curb ramp/landing/flares			
Temporary obstruction (>0.25") in curb ramp/landing/flares			
No textured surface at base of curb ramp			
No color contrast at base of curb ramp

Corner 2 No Ramp (2z)
