Client: Town of Addison Date: 1/2/18
 Program: ADA Self-Evaluation and Transition Plan Prepared By: CMP
 KHA No.: 063543021 Checked By: EPE

Corridor : Brookwood Ln GPS ID: 90040
 Project Name: Intersection of Brookwood Ln and driveway (Lat. 32.9443; Long. -96.8496)
 Town: Addison

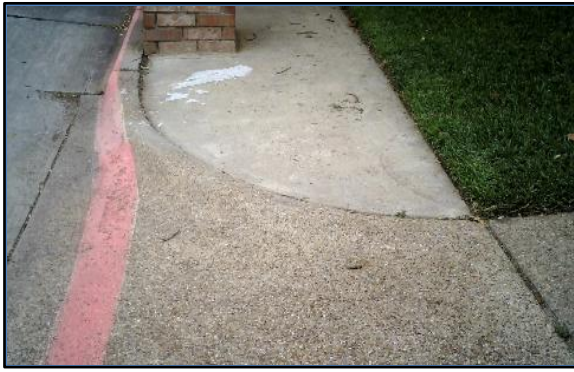
Corner 2 No Ramp (2z)

Curb Ramp Issues	Curb Ramp ID ('z' or 'l' in ramp label indicates no existing ramp)		Possible Solutions
	2z	3z	
Curb ramp does not exist and is needed	X	X	Install curb ramp; if median improvement, see shapefile
Curb ramp does not land in crosswalk			
No 4' x 4' clear space at base of curb ramp			
Curbed side is not 90° or has traversable adjacent surface			
Flare cross slope is greater than 10%			
Curb ramp running slope is greater than 8.3%			
Blended transition running slope is greater than 5%			
Cut-thru ramp running slope is greater than 5%			
Curb ramp cross slope is greater than 2%			
Cut-thru ramp cross slope is greater than 2%			
Curb ramp width is less than 48"			
Cut-thru ramp width is less than 60"			
Permanent obstruction (>0.25") in curb ramp/landing/flares			
Temporary obstruction (>0.25") in curb ramp/landing/flares			
No textured surface at base of curb ramp			
No color contrast at base of curb ramp
