Client: Town of Addison Date: 1/2/18
 Program: ADA Self-Evaluation and Transition Plan Prepared By: CMP
 KHA No.: 063543021 Checked By: EPE

Corridor : Brookwood Ln GPS ID: 90042
 Project Name: Intersection of Brookwood Ln and driveway (Lat. 32.9447; Long. -96.8496)
 Town: Addison

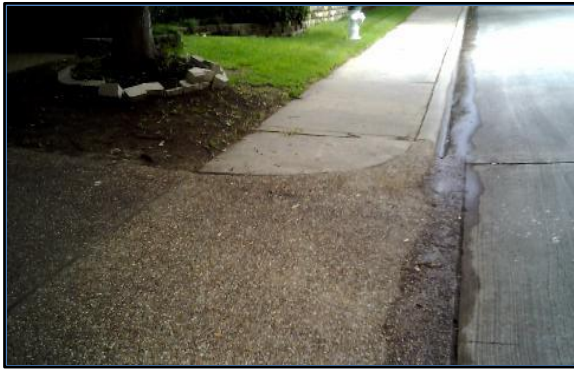
Corner 2 No Ramp (2z)

Curb Ramp Issues	Curb Ramp ID ('z' or 'l' in ramp label indicates no existing ramp)		Possible Solutions
	2z	3z	
Curb ramp does not exist and is needed	X	X	Install curb ramp; if median improvement, see shapefile
Curb ramp does not land in crosswalk			
No 4' x 4' clear space at base of curb ramp			
Curbed side is not 90° or has traversable adjacent surface			
Flare cross slope is greater than 10%			
Curb ramp running slope is greater than 8.3%			
Blended transition running slope is greater than 5%			
Cut-thru ramp running slope is greater than 5%			
Curb ramp cross slope is greater than 2%			
Cut-thru ramp cross slope is greater than 2%			
Curb ramp width is less than 48"			
Cut-thru ramp width is less than 60"			
Permanent obstruction (>0.25") in curb ramp/landing/flares			
Temporary obstruction (>0.25") in curb ramp/landing/flares			
No textured surface at base of curb ramp			
No color contrast at base of curb ramp

Item No.	Item Description	Quantity	Unit	Unit Price	Item Cost
TxDOT 110-6001	EXCAVATION (ROADWAY)	0	CY	\$ 10.00	\$ -
TxDOT 529-6002	CONC CURB (TY II)	0	LF	\$ 15.00	\$ -
TxDOT 531-6001	CONC SIDEWALKS (4")	0	SY	\$ 45.00	\$ -
TxDOT 531	CURB RAMPS	2	EA	\$ 1,500.00	\$ 3,000.00
TxDOT 5003-6002	RETROFIT DET WARN SURF (CAST IN PLACE)	0	SF	\$ 50.00	\$ -
TxDOT 104-6015	REMOVING CONC (SIDEWALKS)	0	SY	\$ 9.00	\$ -
TxDOT 677	ELIM EXT PAVE MRK & MRKS	0	LF	\$ 2.80	\$ -
TxDOT 666/678	REFL PAV MRK PREP TY I & TY II (W) 24" (SLD)	0	LF	\$ 8.50	\$ -
---	REPAVE ROADWAY	0	LS	\$ 5,000.00	\$ -
---	FIX PONDING	0	LS	\$ 2,000.00	\$ -
---	FIX CURB RAMP TRANSITION	0	LS	\$ 2,000.00	\$ -
---	MEDIAN NOSE MODIFICATION	0	LS	\$ 5,000.00	\$ -
---	REMOVE TEMPORARY OBSTRUCTION	0	LS	\$ 500.00	\$ -
---	FIX CURB RAMP COUNTER SLOPE	0	LS	\$ 2,000.00	\$ -
