Client: Town of Addison Date: 1/2/18
 Program: ADA Self-Evaluation and Transition Plan Prepared By: CMP
 KHA No.: 063543021 Checked By: EPE

Corridor: Woodshadow Ln GPS ID: 90046
 Project Name: Intersection of Woodshadow Ln and driveway (Lat. 32.9446; Long. -96.8552)
 Town: Addison

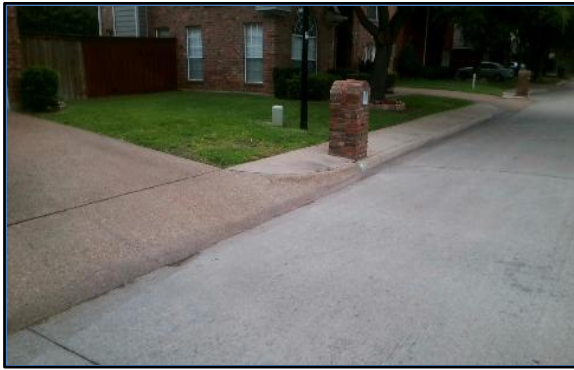
Corner 1 No Ramp (1z)

Curb Ramp Issues	Curb Ramp ID ('z' or 'l' in ramp label indicates no existing ramp)		Possible Solutions
	1z	4z	
Curb ramp does not exist and is needed	X	X	Install curb ramp; if median improvement, see shapefile
Curb ramp does not land in crosswalk			
No 4' x 4' clear space at base of curb ramp			
Curbed side is not 90° or has traversable adjacent surface			
Flare cross slope is greater than 10%			
Curb ramp running slope is greater than 8.3%			
Blended transition running slope is greater than 5%			
Cut-thru ramp running slope is greater than 5%			
Curb ramp cross slope is greater than 2%			
Cut-thru ramp cross slope is greater than 2%			
Curb ramp width is less than 48"			
Cut-thru ramp width is less than 60"			
Permanent obstruction (>0.25") in curb ramp/landing/flares			
Temporary obstruction (>0.25") in curb ramp/landing/flares			
No textured surface at base of curb ramp			
No color contrast at base of curb ramp

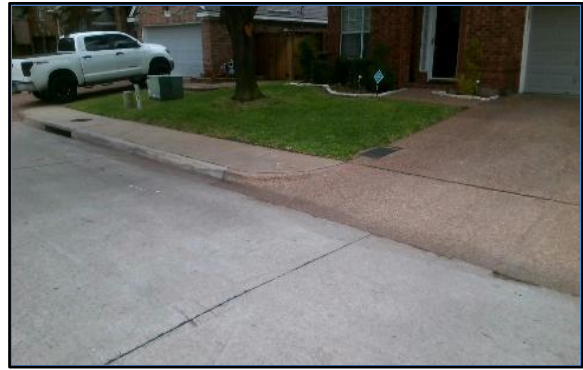
Corner 4 No Ramp (4z)
