Kimley-Horn and Associates, Inc.
Project Description for Unsignalized Intersection Priority: 2

Town of Addison ADA Self-Evaluation and Transition Plan 063543021 Client: Date: 1/2/18 Prepared By: CMP
Checked By: EPE Program: KHA No.:

GPS ID: 90067 Corridor : Addison Cir Project Name Town: Intersection of Addison Cir and Quorum dr Addison

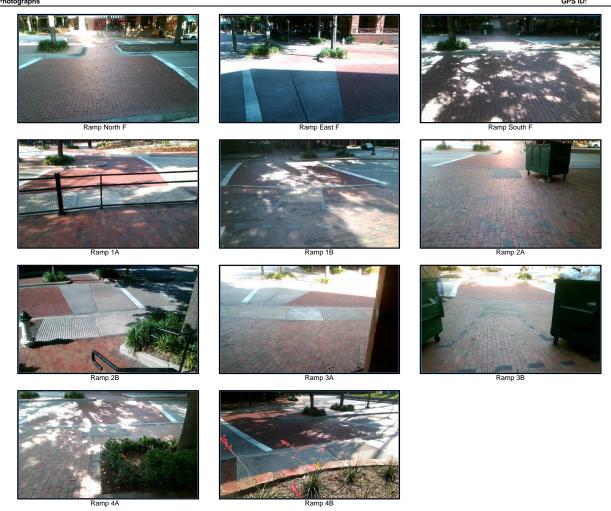
Kimley-Horn and Associates, Inc.
Photographs Intersection of Addison Cir and Quorum dr GPS ID: 90067

Comment: Existing sidewalk, curb ramp, and/or striping configurations permit pedestrians to cross the major street. An Engineering study is needed to confirm crossing should be accommodated at this location and the current crossing treatment is appropriate.
