Client: Town of Addison Date: 1/2/18
 Program: ADA Self-Evaluation and Transition Plan Prepared By: CMP
 KHA No.: 063543021 Checked By: EPE

Corridor : Paladium Dr GPS ID: 90087
 Project Name: Intersection of Paladium Dr and driveway (Lat. 32.9493; Long. -96.8163)
 Town: Addison

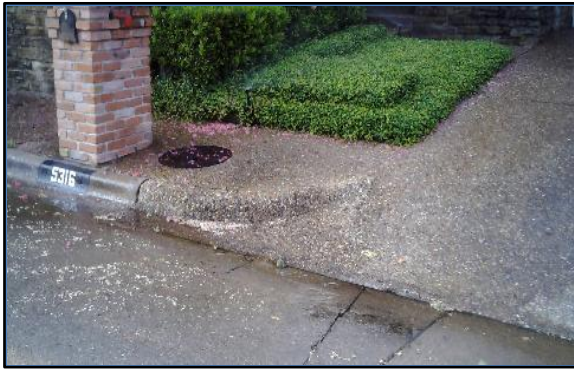
Corner 3 No Ramp (3z)

Curb Ramp Issues	Curb Ramp ID ('z' or 'r' in ramp label indicates no existing ramp)		Possible Solutions
	3z	4z	
Curb ramp does not exist and is needed	X	X	Install curb ramp; if median improvement, see shapefile
Curb ramp does not land in crosswalk			
No 4' x 4' clear space at base of curb ramp			
Curbed side is not 90° or has traversable adjacent surface			
Flare cross slope is greater than 10%			
Curb ramp running slope is greater than 8.3%			
Blended transition running slope is greater than 5%			
Cut-thru ramp running slope is greater than 5%			
Curb ramp cross slope is greater than 2%			
Cut-thru ramp cross slope is greater than 2%			
Curb ramp width is less than 48"			
Cut-thru ramp width is less than 60"			
Permanent obstruction (>0.25") in curb ramp/landing/flares			
Temporary obstruction (>0.25") in curb ramp/landing/flares			
No textured surface at base of curb ramp			
No color contrast at base of curb ramp
