Client: Town of Addison Date: 1/2/18
 Program: ADA Self-Evaluation and Transition Plan Prepared By: CMP
 KHA No.: 063543021 Checked By: EPE

Corridor : Paladium Dr GPS ID: 90088
 Project Name: Intersection of Paladium Dr and driveway (Lat. 32.9494; Long. -96.8161)
 Town: Addison

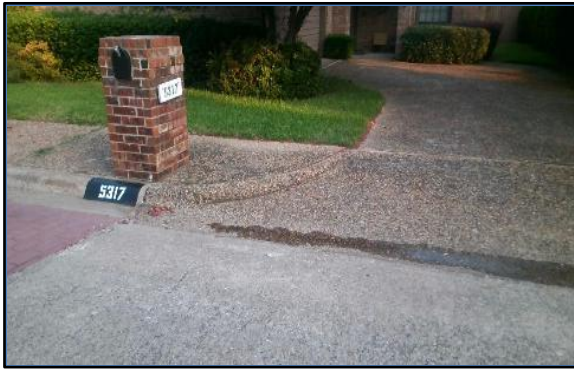
Curb Ramp Issues	Curb Ramp ID ('z' or 'l' in ramp label indicates no existing ramp)		Possible Solutions
	1z	2z	
Curb ramp does not exist and is needed	X	X	Install curb ramp; if median improvement, see shapefile
Curb ramp does not land in crosswalk			
No 4' x 4' clear space at base of curb ramp			
Curbed side is not 90° or has traversable adjacent surface			
Flare cross slope is greater than 10%			
Curb ramp running slope is greater than 8.3%			
Blended transition running slope is greater than 5%			
Cut-thru ramp running slope is greater than 5%			
Curb ramp cross slope is greater than 2%			
Cut-thru ramp cross slope is greater than 2%			
Curb ramp width is less than 48"			
Cut-thru ramp width is less than 60"			
Permanent obstruction (>0.25") in curb ramp/landing/flares			
Temporary obstruction (>0.25") in curb ramp/landing/flares			
No textured surface at base of curb ramp			
No color contrast at base of curb ramp

Corner 1 No Ramp (1z)

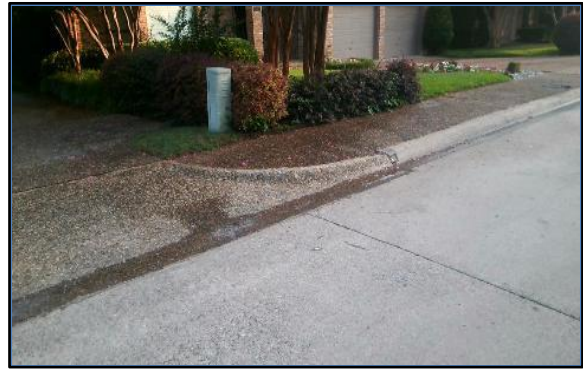
Corner 2 No Ramp (2z)
