Client: Town of Addison Date: 1/2/18
 Program: ADA Self-Evaluation and Transition Plan Prepared By: CMP
 KHA No.: 063543021 Checked By: EPE

Corridor : Paladium Dr GPS ID: 90090
 Project Name: Intersection of Paladium Dr and driveway (Lat. 32.9500; Long. -96.8155)
 Town: Addison

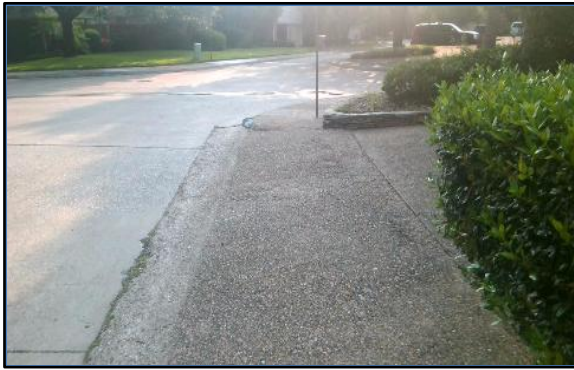
Corner 3 No Ramp (3z)

Curb Ramp Issues	Curb Ramp ID ('z' or 'l' in ramp label indicates no existing ramp)		Possible Solutions
	3z	4z	
Curb ramp does not exist and is needed	X	X	Install curb ramp; if median improvement, see shapefile
Curb ramp does not land in crosswalk			
No 4' x 4' clear space at base of curb ramp			
Curbed side is not 90° or has traversable adjacent surface			
Flare cross slope is greater than 10%			
Curb ramp running slope is greater than 8.3%			
Blended transition running slope is greater than 5%			
Cut-thru ramp running slope is greater than 5%			
Curb ramp cross slope is greater than 2%			
Cut-thru ramp cross slope is greater than 2%			
Curb ramp width is less than 48"			
Cut-thru ramp width is less than 60"			
Permanent obstruction (>0.25") in curb ramp/landing/flares			
Temporary obstruction (>0.25") in curb ramp/landing/flares			
No textured surface at base of curb ramp			
No color contrast at base of curb ramp

Item No.	Item Description	Quantity	Unit	Unit Price	Item Cost
TxDOT 110-6001	EXCAVATION (ROADWAY)	0	CY	\$ 10.00	\$ -
TxDOT 529-6002	CONC CURB (TY II)	0	LF	\$ 15.00	\$ -
TxDOT 531-6001	CONC SIDEWALKS (4")	0	SY	\$ 45.00	\$ -
TxDOT 531	CURB RAMPS	2	EA	\$ 1,500.00	\$ 3,000.00
TxDOT 5003-6002	RETROFIT DET WARN SURF (CAST IN PLACE)	0	SF	\$ 50.00	\$ -
TxDOT 104-6015	REMOVING CONC (SIDEWALKS)	0	SY	\$ 9.00	\$ -
TxDOT 677	ELIM EXT PAVE MRK & MRKS	0	LF	\$ 2.80	\$ -
TxDOT 666/678	REFL PAV MRK PREP TY I & TY II (W) 24" (SLD)	0	LF	\$ 8.50	\$ -
---	REPAVE ROADWAY	0	LS	\$ 5,000.00	\$ -
---	FIX PONDING	0	LS	\$ 2,000.00	\$ -
---	FIX CURB RAMP TRANSITION	0	LS	\$ 2,000.00	\$ -
---	MEDIAN NOSE MODIFICATION	0	LS	\$ 5,000.00	\$ -
---	REMOVE TEMPORARY OBSTRUCTION	0	LS	\$ 500.00	\$ -
---	FIX CURB RAMP COUNTER SLOPE	0	LS	\$ 2,000.00	\$ -
