Client: Town of Addison Date: 1/2/18
 Program: ADA Self-Evaluation and Transition Plan Prepared By: CMP
 KHA No.: 063543021 Checked By: EPE

Corridor : Paladium Dr GPS ID: 90091
 Project Name: Intersection of Paladium Dr and driveway (Lat. 32.9498; Long. -96.8158)
 Town: Addison

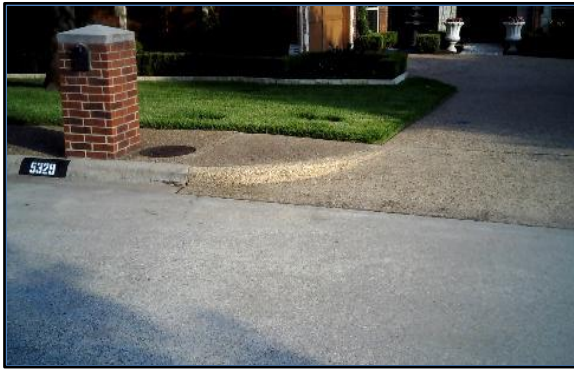
Corner 1 No Ramp (1z)

Curb Ramp Issues	Curb Ramp ID ('z' or 'l' in ramp label indicates no existing ramp)		Possible Solutions
	1z	2z	
Curb ramp does not exist and is needed	X	X	Install curb ramp; if median improvement, see shapefile
Curb ramp does not land in crosswalk			
No 4' x 4' clear space at base of curb ramp			
Curbed side is not 90° or has traversable adjacent surface			
Flare cross slope is greater than 10%			
Curb ramp running slope is greater than 8.3%			
Blended transition running slope is greater than 5%			
Cut-thru ramp running slope is greater than 5%			
Curb ramp cross slope is greater than 2%			
Cut-thru ramp cross slope is greater than 2%			
Curb ramp width is less than 48"			
Cut-thru ramp width is less than 60"			
Permanent obstruction (>0.25") in curb ramp/landing/flares			
Temporary obstruction (>0.25") in curb ramp/landing/flares			
No textured surface at base of curb ramp			
No color contrast at base of curb ramp
