Client: Town of Addison Date: 1/2/18
 Program: ADA Self-Evaluation and Transition Plan Prepared By: CMP
 KHA No.: 063543021 Checked By: EPE

Corridor : Paladium Dr GPS ID: 90092
 Project Name: Intersection of Paladium Dr and driveway (Lat. 32.9499; Long. -96.8157)
 Town: Addison

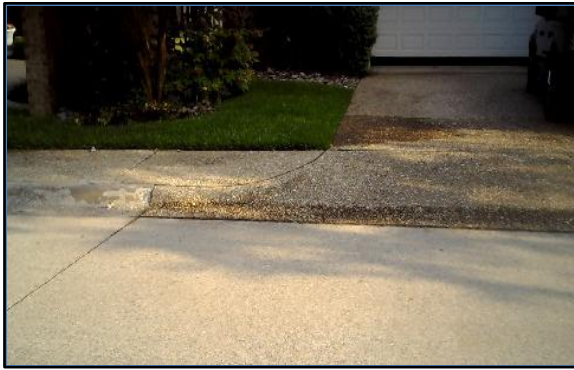
Corner 1 No Ramp (1z)

Curb Ramp Issues	Curb Ramp ID ('z' or 'i' in ramp label indicates no existing ramp)		Possible Solutions
	1z	2z	
Curb ramp does not exist and is needed	X	X	Install curb ramp; if median improvement, see shapefile
Curb ramp does not land in crosswalk			
No 4' x 4' clear space at base of curb ramp			
Curbed side is not 90° or has traversable adjacent surface			
Flare cross slope is greater than 10%			
Curb ramp running slope is greater than 8.3%			
Blended transition running slope is greater than 5%			
Cut-thru ramp running slope is greater than 5%			
Curb ramp cross slope is greater than 2%			
Cut-thru ramp cross slope is greater than 2%			
Curb ramp width is less than 48"			
Cut-thru ramp width is less than 60"			
Permanent obstruction (>0.25") in curb ramp/landing/flares			
Temporary obstruction (>0.25") in curb ramp/landing/flares			
No textured surface at base of curb ramp			
No color contrast at base of curb ramp
