Client: Town of Addison Date: 1/2/18
 Program: ADA Self-Evaluation and Transition Plan Prepared By: CMP
 KHA No.: 063543021 Checked By: EPE

Corridor : Oaks N Dr GPS ID: 90110
 Project Name: Intersection of Oaks N Dr and driveway (Lat. 32.9522; Long. -96.8144)
 Town: Addison

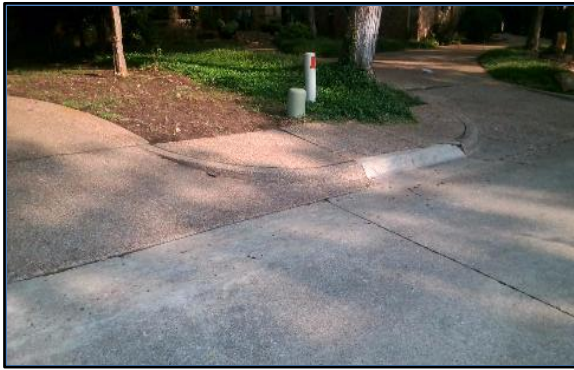
Curb Ramp Issues	Curb Ramp ID ('z' or 'l' in ramp label indicates no existing ramp)		Possible Solutions
	1z	4z	
Curb ramp does not exist and is needed	X	X	Install curb ramp; if median improvement, see shapefile
Curb ramp does not land in crosswalk			
No 4' x 4' clear space at base of curb ramp			
Curbed side is not 90° or has traversable adjacent surface			
Flare cross slope is greater than 10%			
Curb ramp running slope is greater than 8.3%			
Blended transition running slope is greater than 5%			
Cut-thru ramp running slope is greater than 5%			
Curb ramp cross slope is greater than 2%			
Cut-thru ramp cross slope is greater than 2%			
Curb ramp width is less than 48"			
Cut-thru ramp width is less than 60"			
Permanent obstruction (>0.25") in curb ramp/landing/flares			
Temporary obstruction (>0.25") in curb ramp/landing/flares			
No textured surface at base of curb ramp			
No color contrast at base of curb ramp

Corner 1 No Ramp (1z)

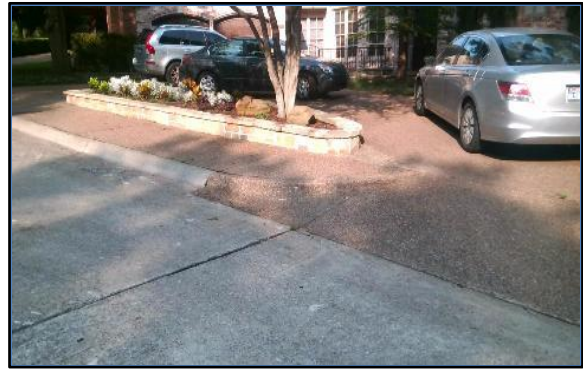
Corner 4 No Ramp (4z)
