**TOPOGRAPHIC SURVEY EXHIBIT OF
REPLAT OF LOT 1 MILLIKEN ADDITION
14905 LAKE FOREST DRIVE**

TOWN OF ADDISON

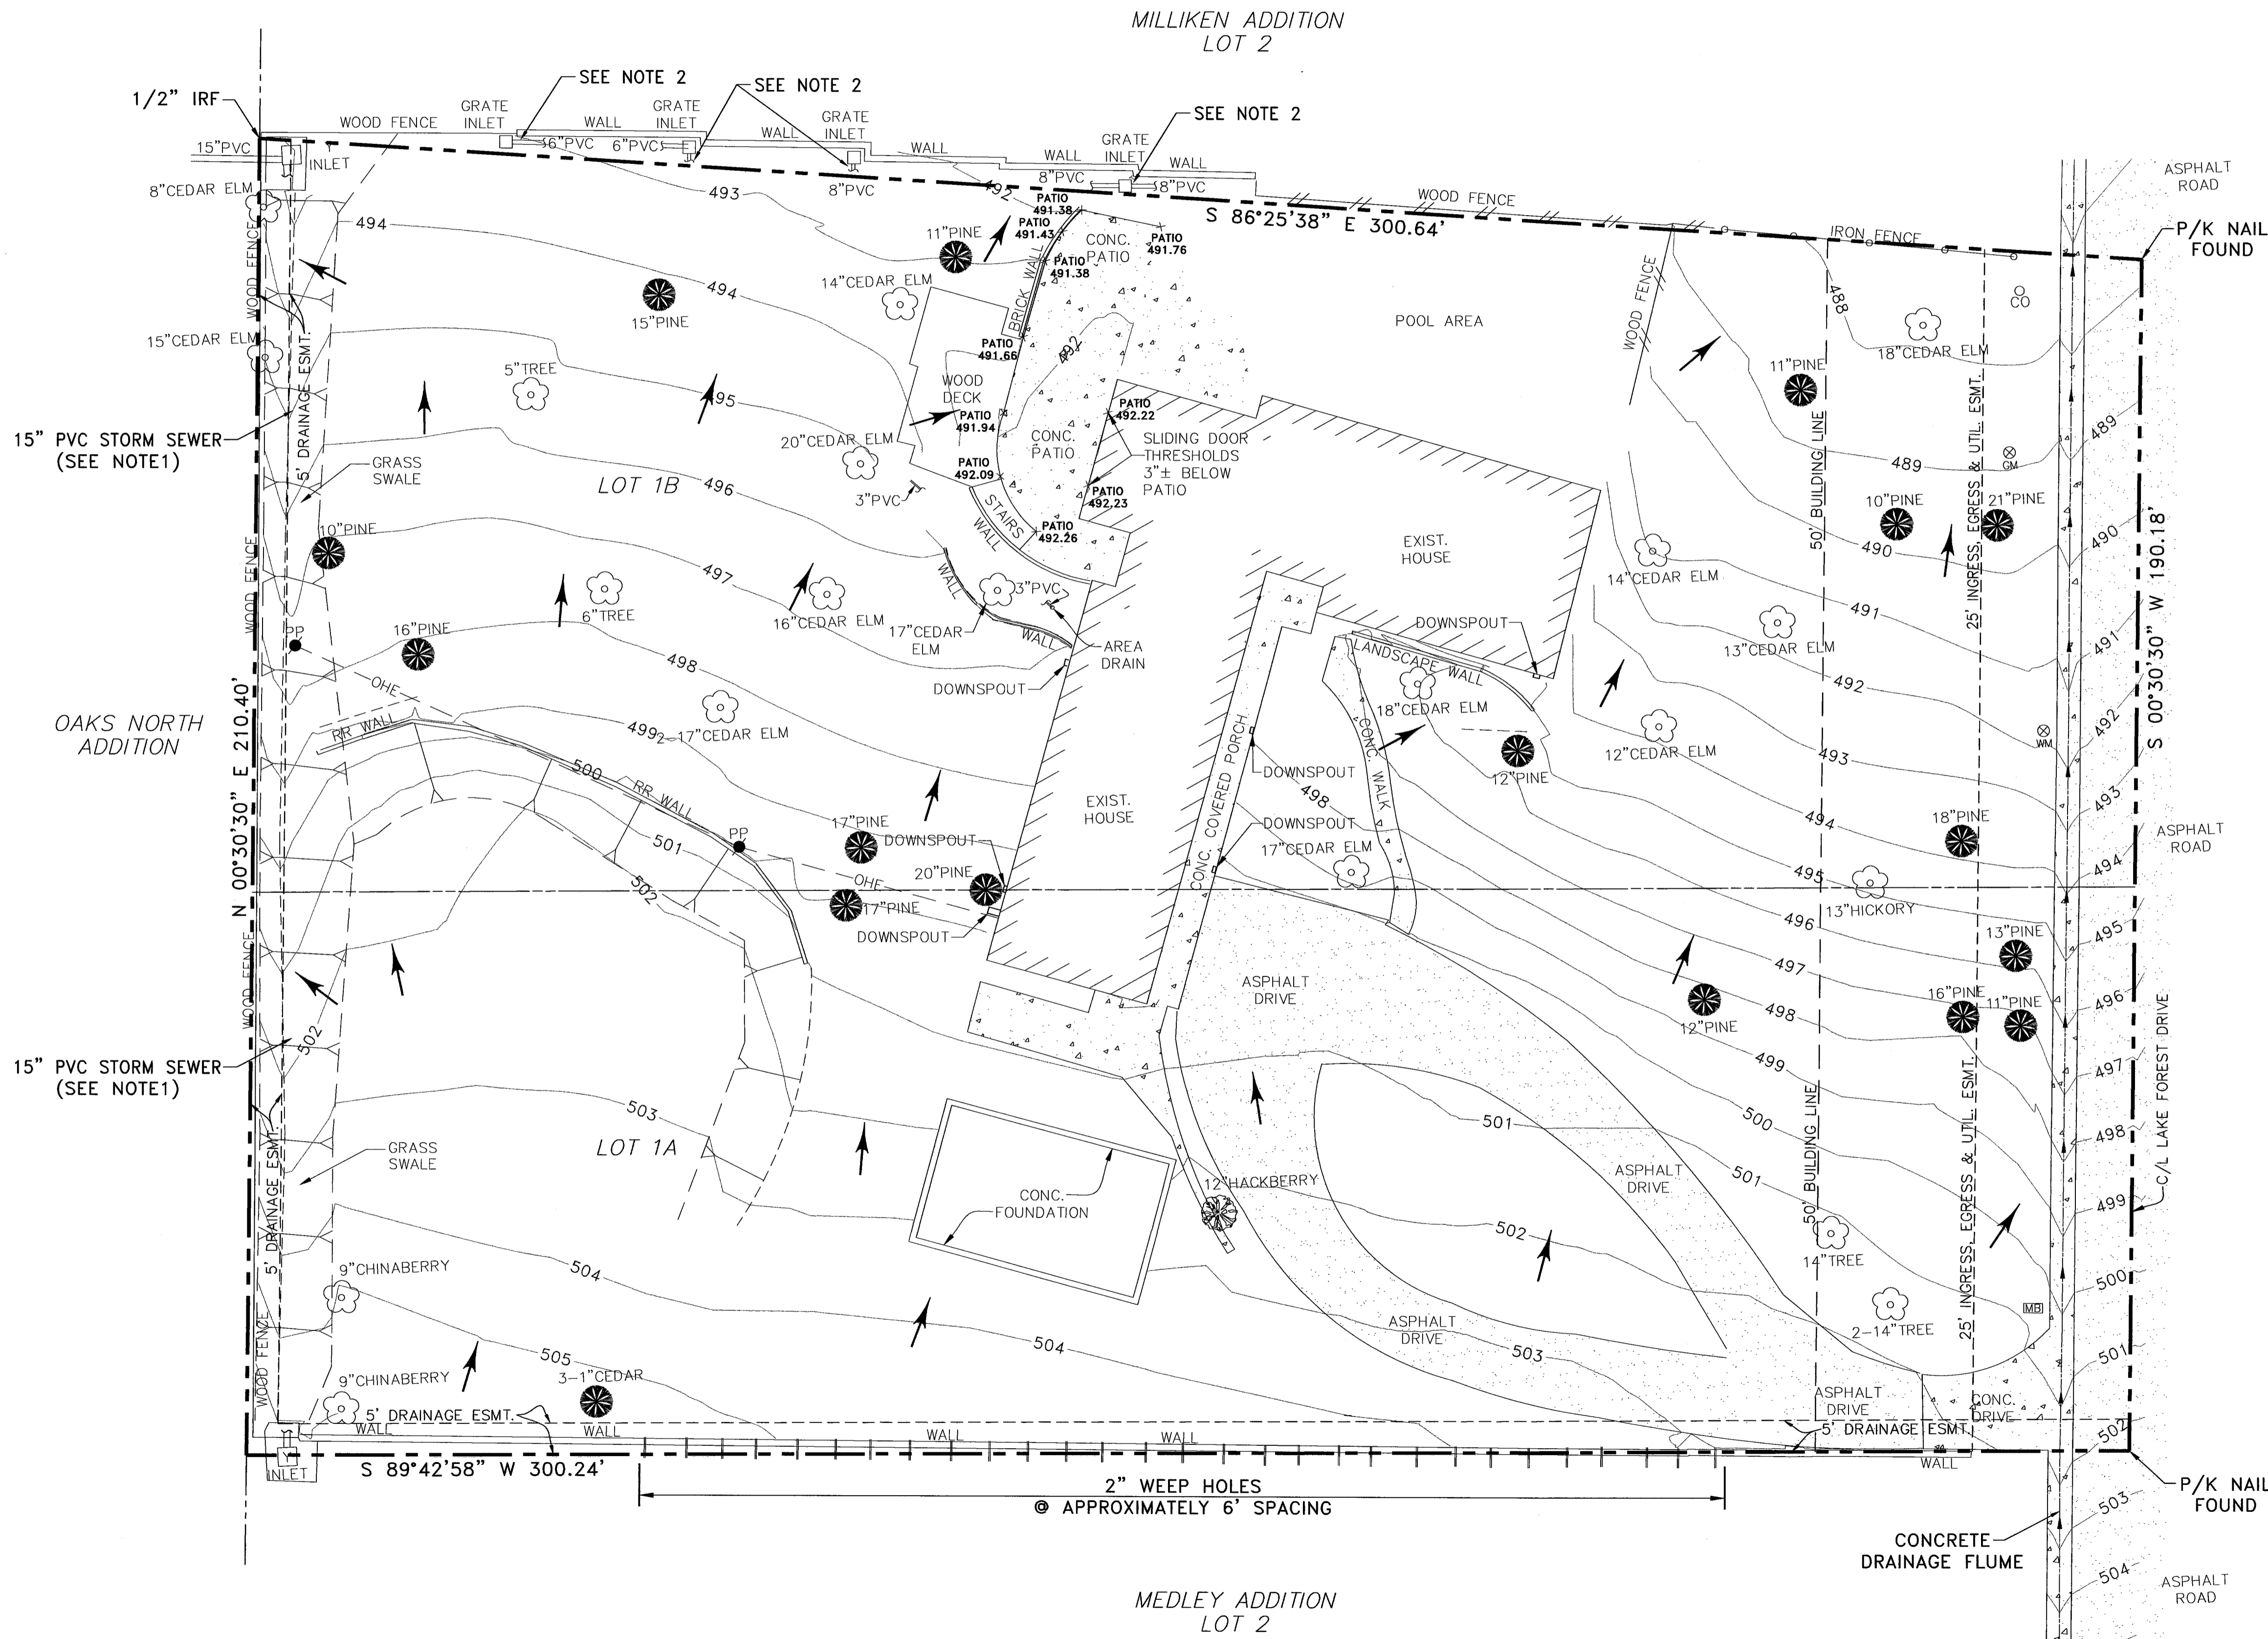
- Notes on Underground Drainage Systems:**
- The 15" PVC storm sewer along the west property line was buried, as a result, no exact location could be determined with the field survey. Locations for the inlets at either end of the 15" pvc storm sewer are shown on this survey exhibit. The location shown of the 15" PVC at the inlets is based on visual inspection of the pipes entering and exiting the "Y" inlets.
 - The PVC storm sewer system along the north property line was not exposed to determine an exact location. Construction plans do not exist for the private drainage system; therefore, the pipes and directions shown on this plan are based on visual inspection of each grate inlet.

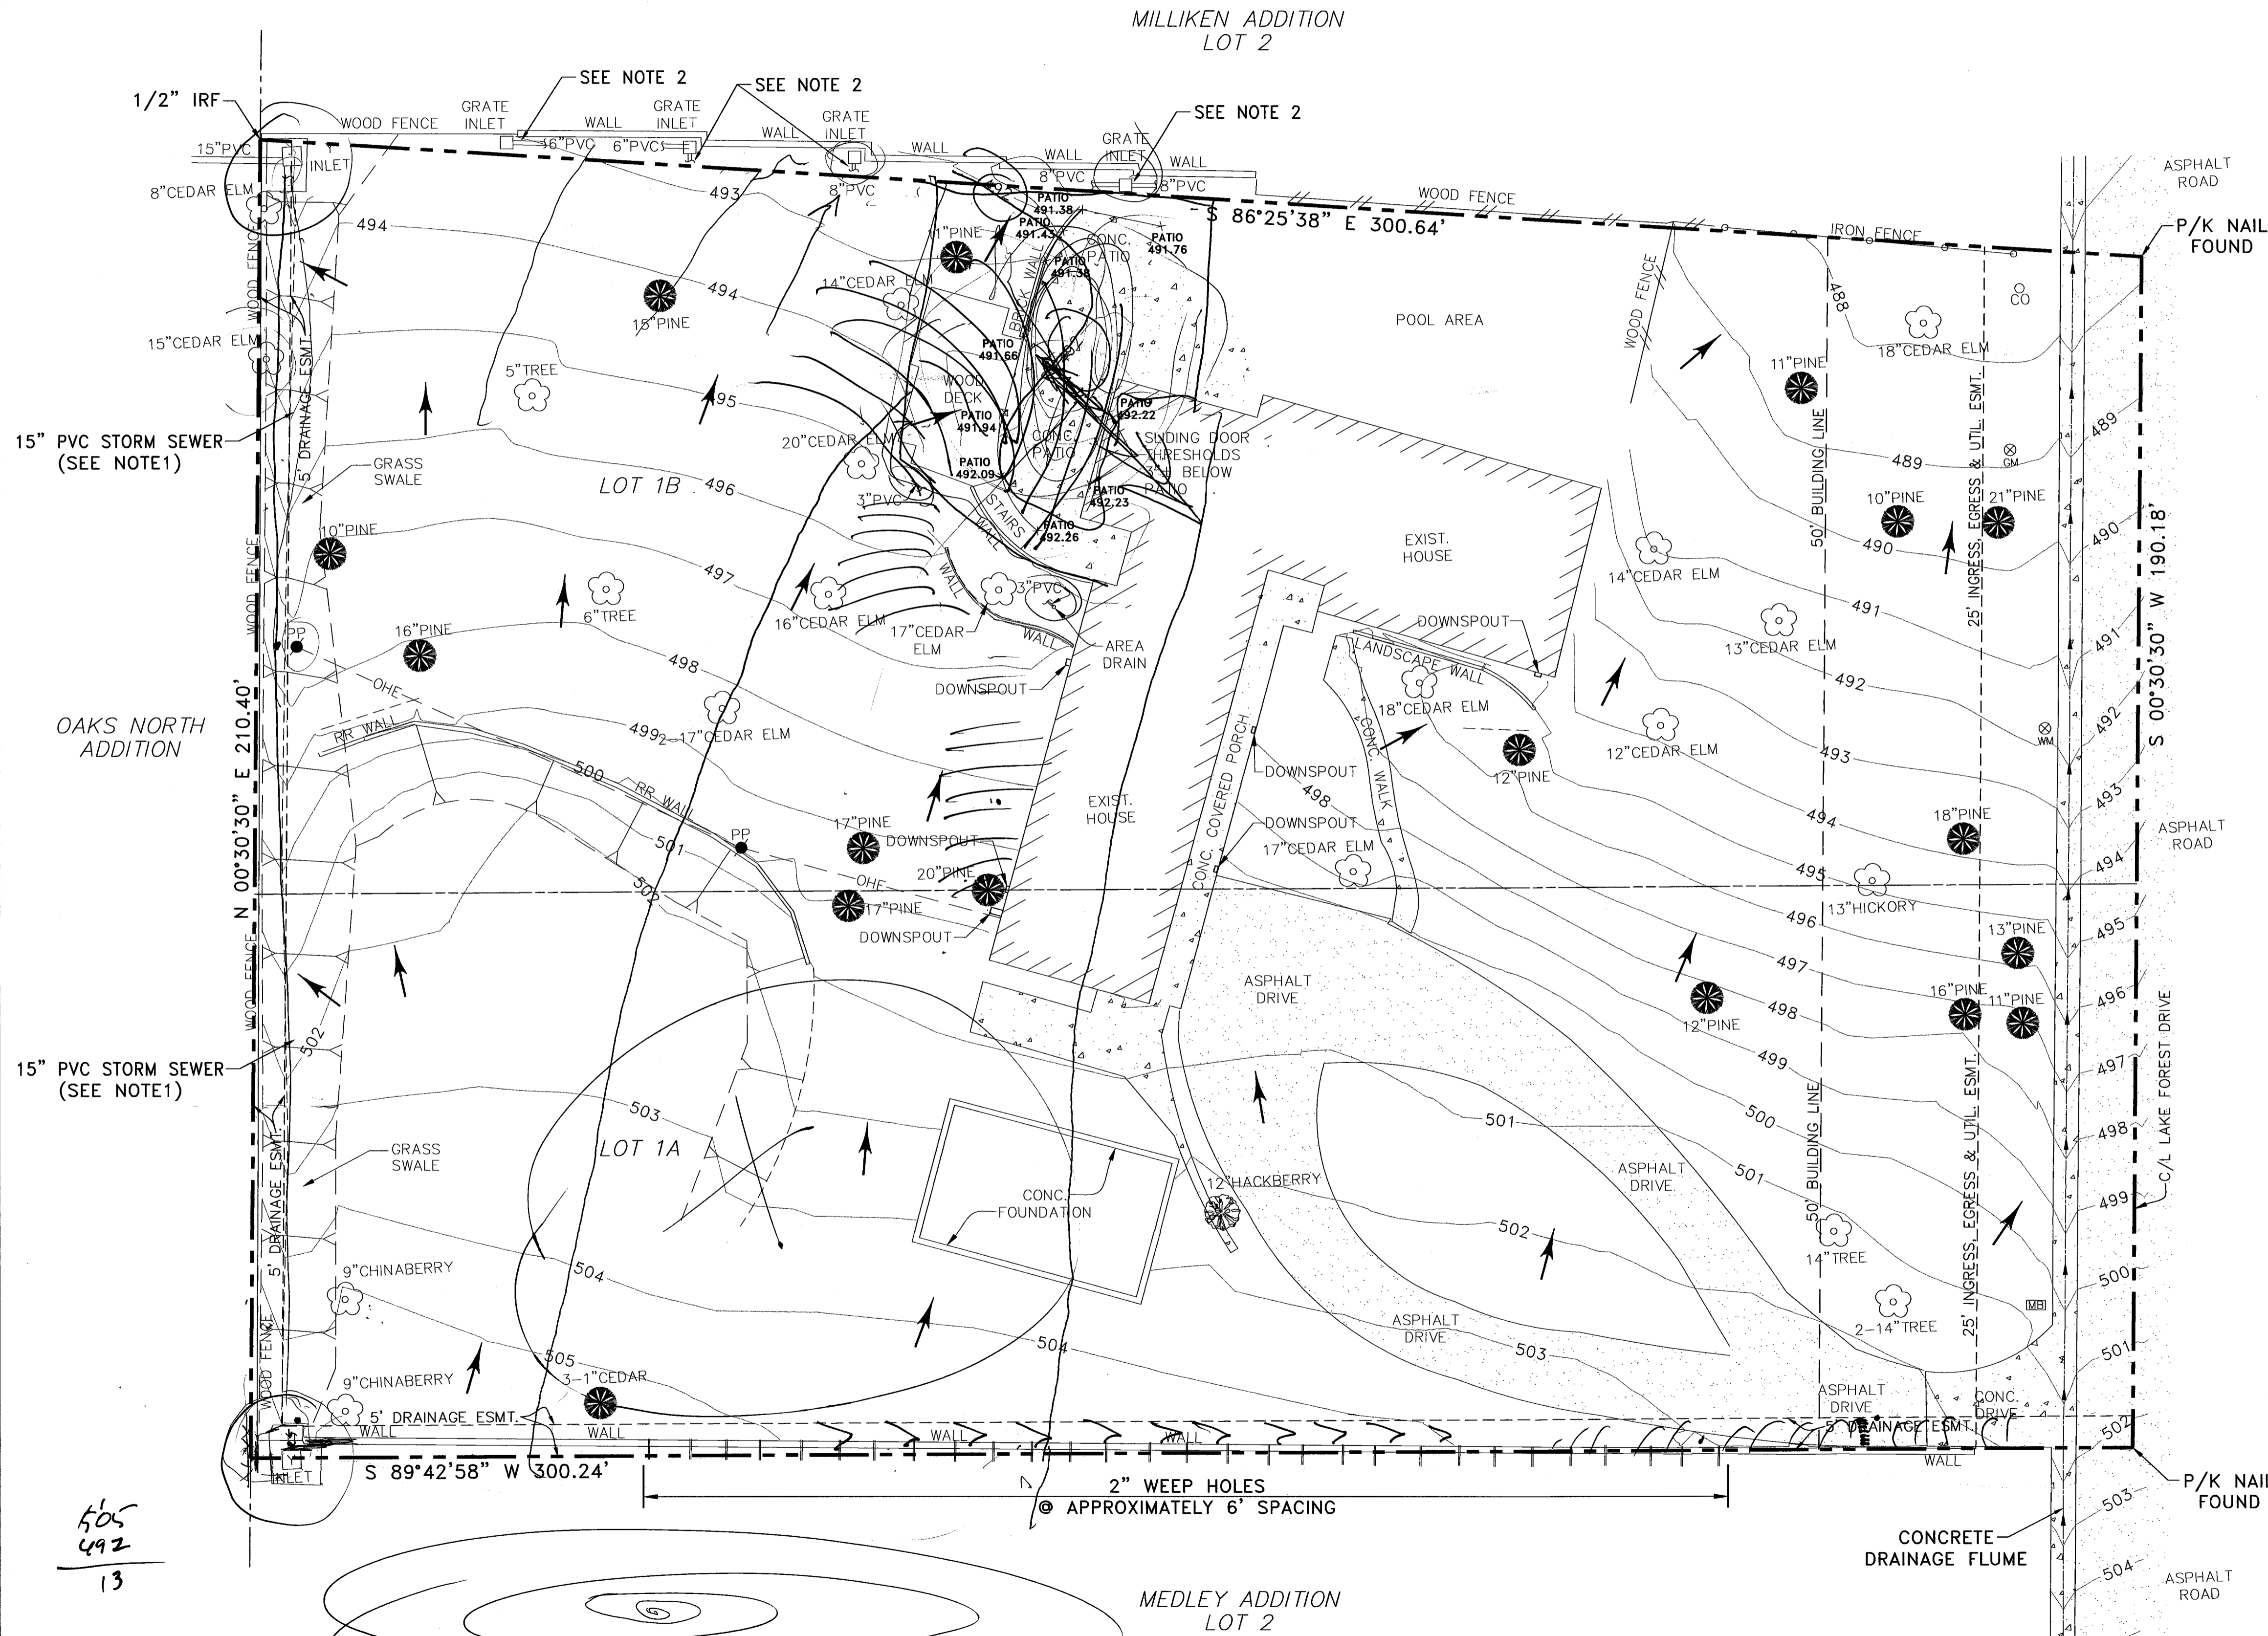
- Notes on Underground Drainage Systems:**
- The 15" PVC storm sewer along the west property line was buried, as a result, no exact location could be determined with the field survey. Locations for the inlets at either end of the 15" pvc storm sewer are shown on this survey exhibit. The location shown of the 15" PVC at the inlets is based on visual inspection of the pipes entering and exiting the "Y" inlets.
 - The PVC storm sewer system along the north property line was not exposed to determine an exact location. Construction plans do not exist for the private drainage system; therefore, the pipes and directions shown on this plan are based on visual inspection of each grate inlet.

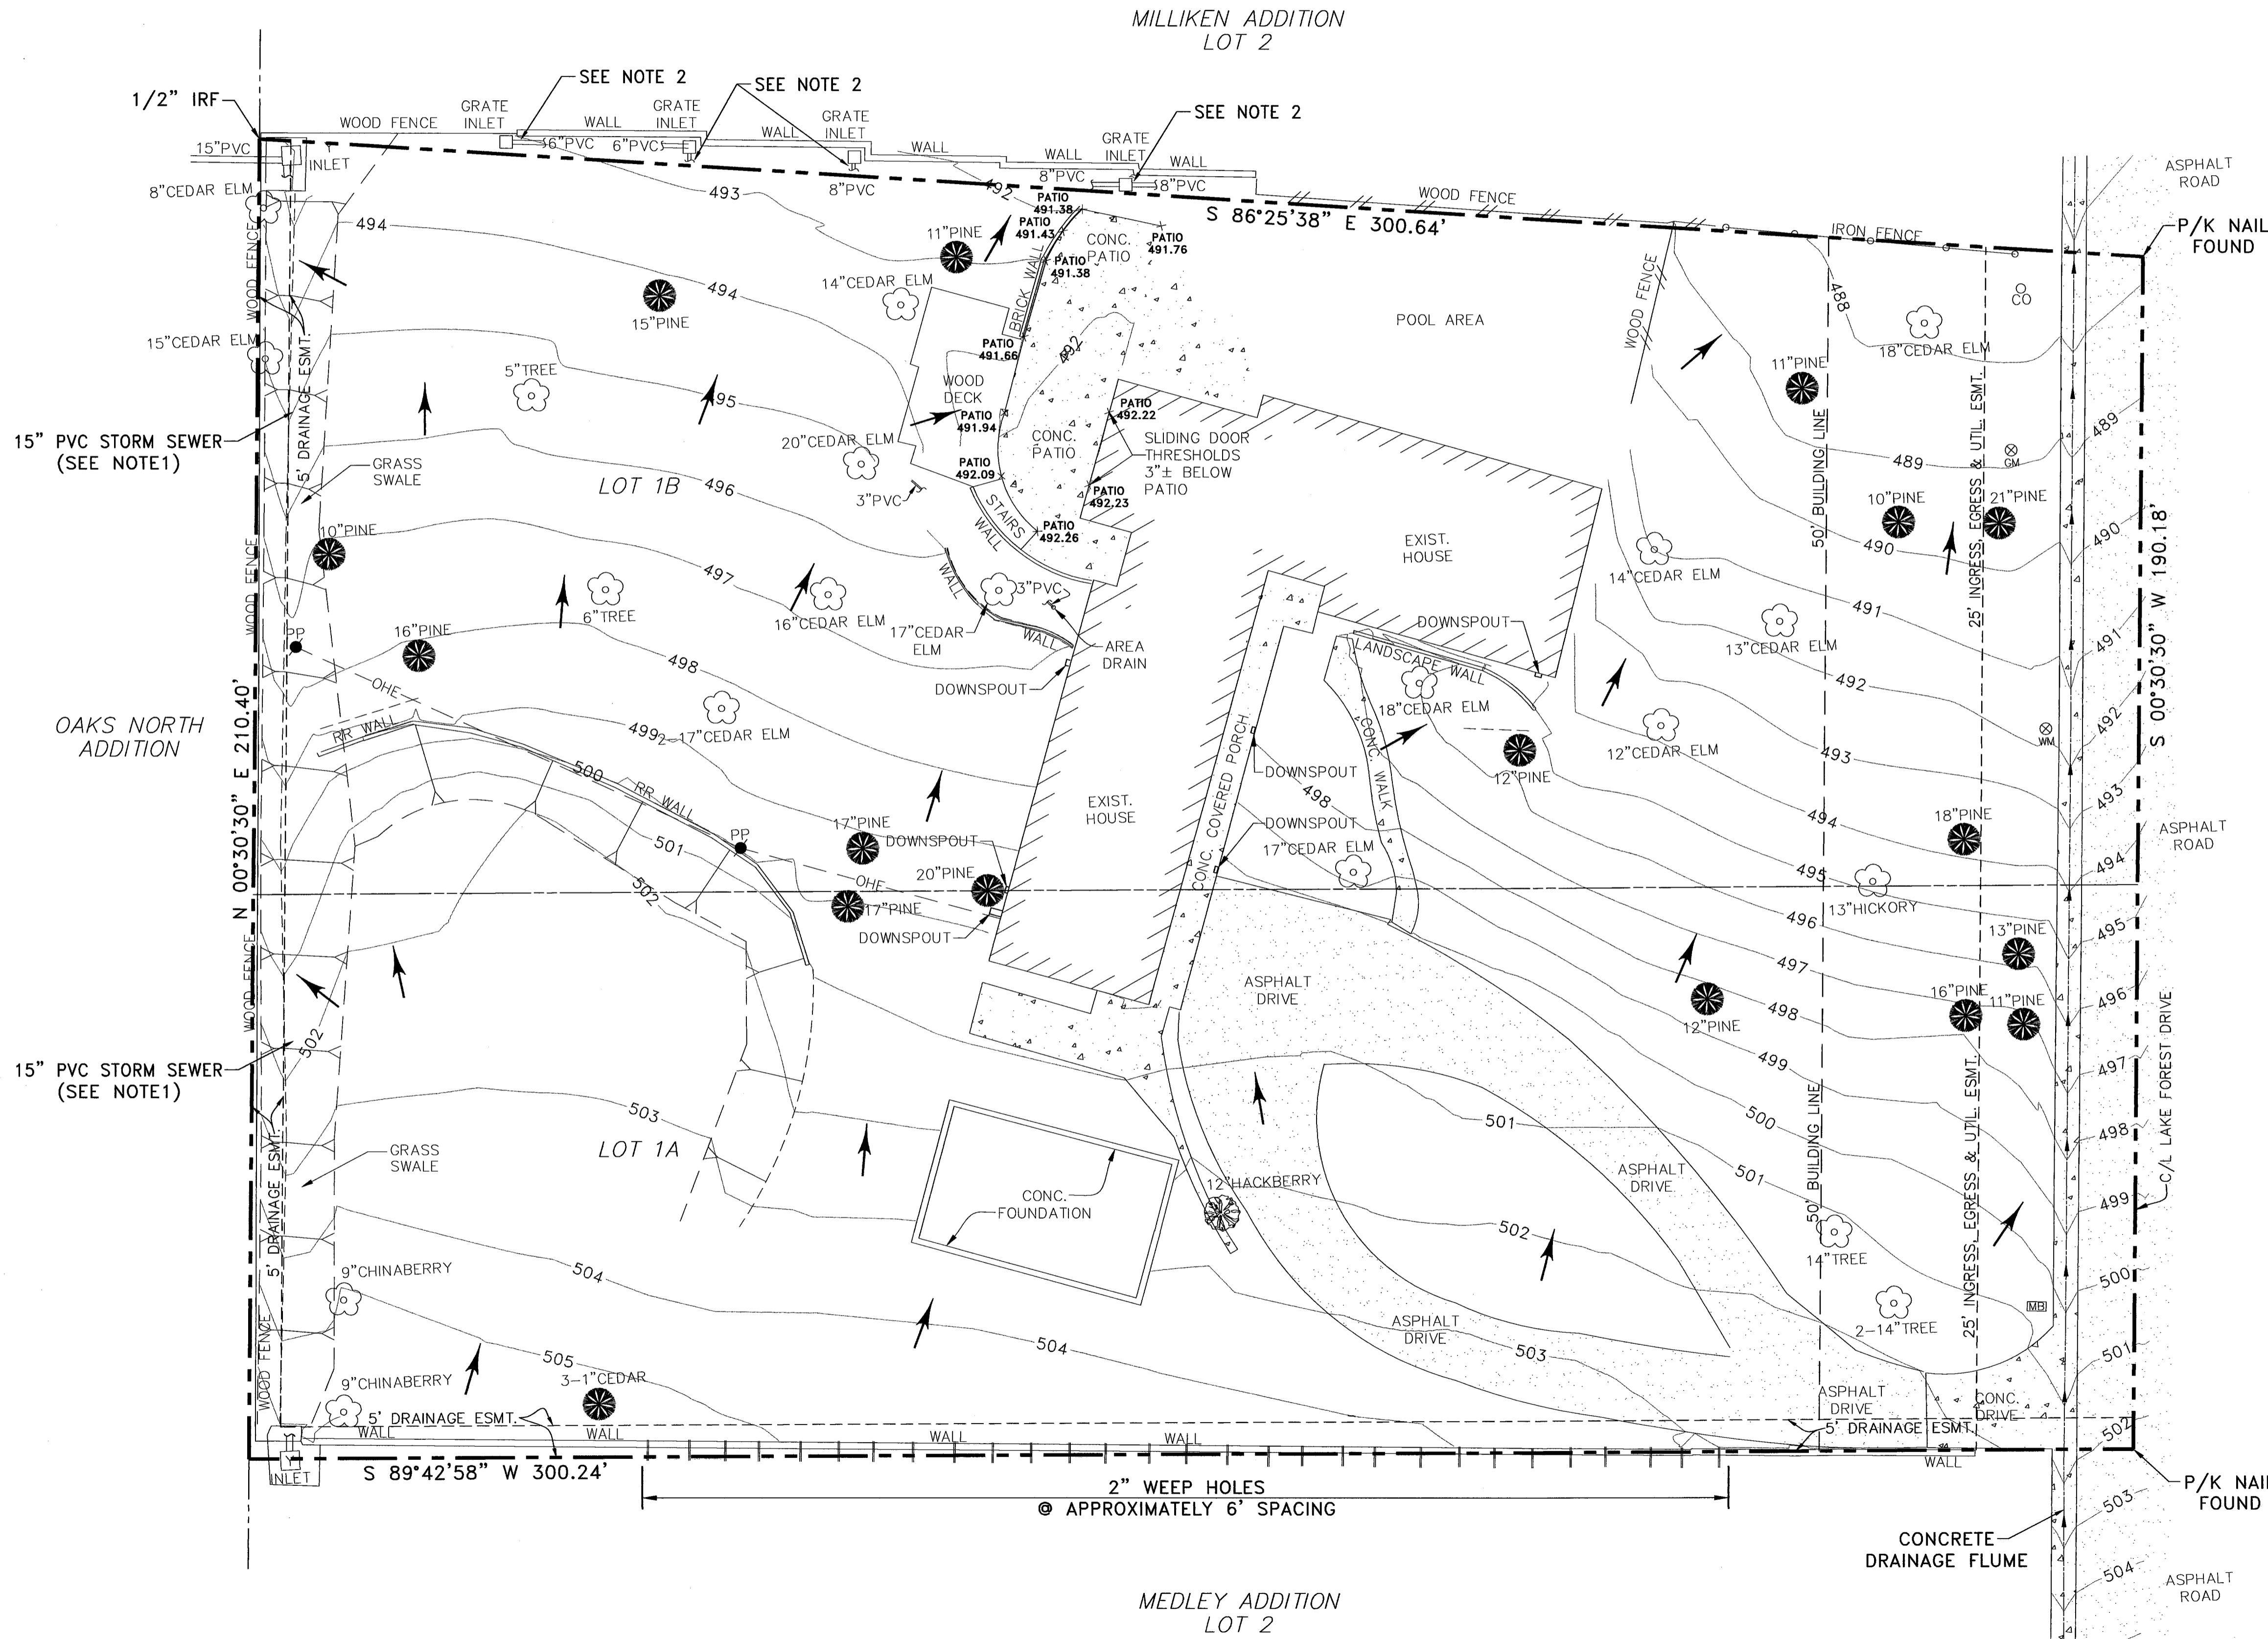
- Notes on Underground Drainage Systems:**
1. The 15" PVC storm sewer along the west property line was buried, as a result, no exact location could be determined with the field survey. Locations for the inlets at either end of the 15" pvc storm sewer are shown on this survey exhibit. The location shown of the 15" PVC at the inlets is based on visual inspection of the pipes entering and exiting the "Y" inlets.
 2. The PVC storm sewer system along the north property line was not exposed to determine an exact location. Construction plans do not exist for the private drainage system; therefore, the pipes and directions shown on this plan are based on visual inspection of each grate inlet.

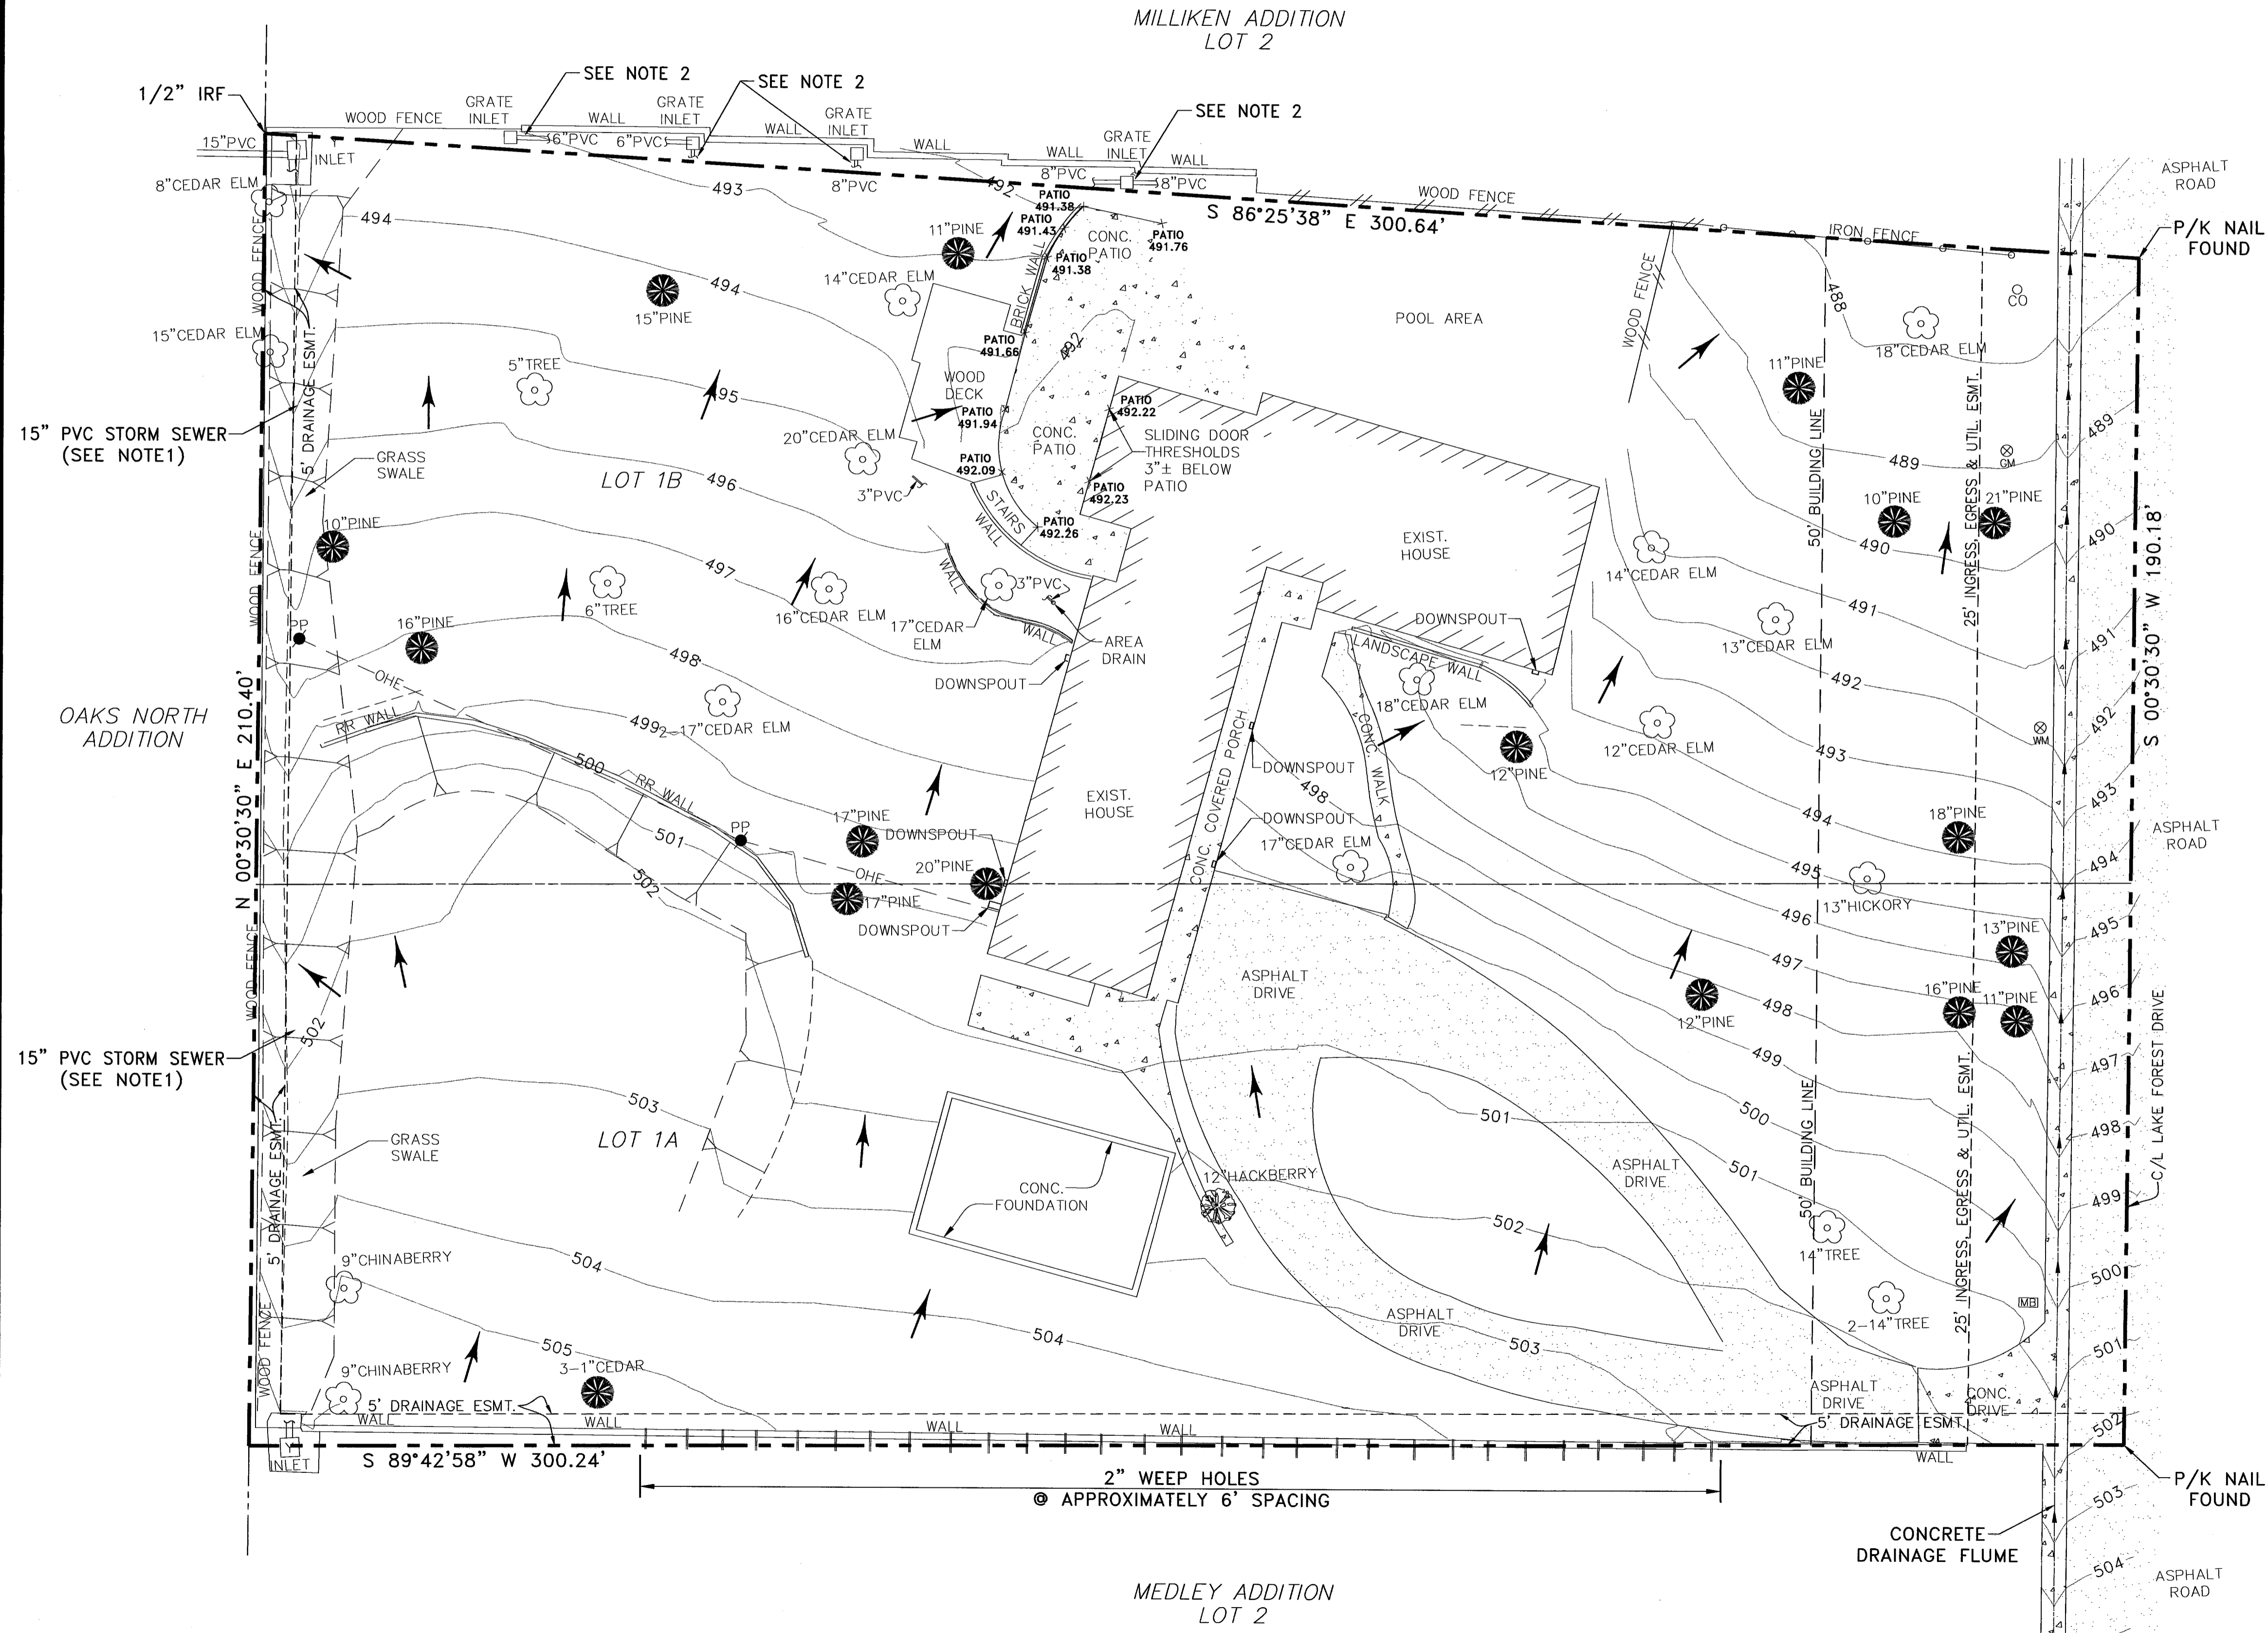
Notes on Underground Drainage Systems:

1. The 15" PVC storm sewer along the west property line was buried, as a result, no exact location could be determined with the field survey. Locations for the inlets at either end of the 15" pvc storm sewer are shown on this survey exhibit. The location shown of the 15" PVC at the inlets is based on visual inspection of the pipes entering and exiting the "Y" inlets.
2. The PVC storm sewer system along the north property line was not exposed to determine an exact location. Construction plans do not exist for the private drainage system; therefore, the pipes and directions shown on this plan are based on visual inspection of each grate inlet.
