DEMOLITION - NILES PROPERTY

**TOWN OF ADDISON
PAYMENT AUTHORIZATION MEMO**

**TOWN OF ADDISON**  
**CONSTRUCTION SPECIFICATIONS  
AND CONTRACT DOCUMENTS**  
**NILE PROPERTIES DEMOLITION**

PROPOSED ARAPAHO ROAD AT SURVEYOR BOULEVARD

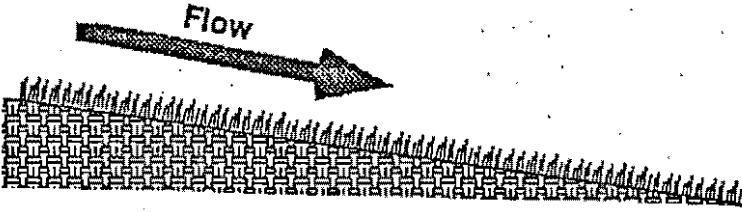
| <p><b>DESCRIPTION</b><br/>Vegetation, as a Best Management Practice, is the sowing of annual grasses, small grains or legumes to provide interim and permanent vegetative stabilization for disturbed areas.</p> <p><b>PRIMARY USE</b><br/>Vegetation is used as a temporary or permanent stabilization technique for areas disturbed by construction but not protected by pavement, building or other structures. As a temporary control, vegetation is used to stabilize stockpiles and barren areas which are inactive for long periods of time. As a permanent control, grasses and other vegetation provide good protection for the soil along with some filtering for overland runoff. Subjected to acceptable runoff velocities, vegetation can provide a good method of permanent storm water management as well as a visual amenity to the site.</p> <p>Other BMPs may be required to assist in the establishment of vegetation. These other techniques include erosion control matting, swales and dikes to direct flow around newly seeded areas and proper grading to limit runoff velocities during construction.</p> <p><b>APPLICATIONS</b><br/>Vegetative techniques can and should apply to every construction project with few exceptions. Vegetation effectively reduces erosion in swales, stock piles, berms, mild to medium slopes and along roadways. Vegetative strips can provide some protection when used as a perimeter control for utility and site development construction.</p> <p>In many cases, the initial cost of temporary seeding may be high compared to tarps or covers for stockpiles or other barren areas subject to erosion yet inactive. This initial cost should be weighed with the amount of time the area is to remain inactive, since maintenance cost for vegetated areas is much less than most structural controls.</p> | <p><b>Targeted Constituents</b></p> <ul style="list-style-type: none"> <li><input checked="" type="checkbox"/> Sediment</li> <li><input checked="" type="checkbox"/> Nutrients<br/>Toxic Materials</li> <li><input type="checkbox"/> Oil &amp; Grease</li> <li><input type="checkbox"/> Floatable Materials</li> <li><input type="checkbox"/> Other Construction Wastes</li> </ul> <p><b>Implementation Requirements</b></p> <ul style="list-style-type: none"> <li><input checked="" type="checkbox"/> Capital Costs</li> <li><input checked="" type="checkbox"/> Maintenance</li> <li><input type="checkbox"/> Training</li> <li><input checked="" type="checkbox"/> Suitability for Slopes &gt;5%</li> </ul> <p><b>Legend</b></p> <ul style="list-style-type: none"> <li><input checked="" type="checkbox"/> Significant Impact</li> <li><input checked="" type="checkbox"/> Medium Impact</li> <li><input type="checkbox"/> Low Impact</li> <li>? Unknown or Questionable Impact</li> </ul> |

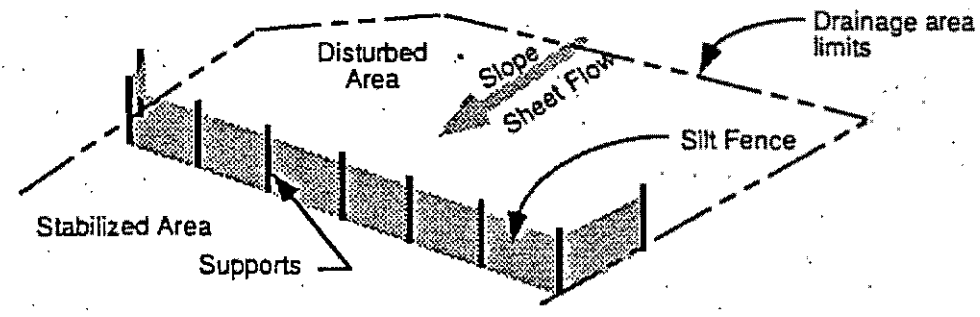
| <p><b>DESCRIPTION</b></p> <p>A silt fence consists of geotextile fabric supported by poultry netting or other backing stretched between either wooden or metal posts with the lower edge of the fabric securely embedded in the soil. The fence is typically located downstream of disturbed areas to intercept runoff in the form of sheet flow. Silt fence provides both filtration and time for sedimentation to reduce sediment and it reduces the velocity of the runoff. Properly designed silt fence is economical since it can be re-located during construction and re-used on other projects.</p> <p><b>PRIMARY USE</b></p> <p>Silt fence is normally used as perimeter control located downstream of disturbed areas. It is only feasible for non-concentrated, sheet flow conditions.</p> <p><b>APPLICATIONS</b></p> <p>Silt fence is an economical means to treat overland, non-concentrated flows for all types of projects. Silt fences are used as perimeter control devices for both site developments and linear (roadway) type projects. They are most effective with coarse to silty soil types. Due to the potential of clogging, silt fence should not be used with clay soil types.</p> <p>In order to reduce the length of silt fence, it should be placed adjacent to the down slope side of the construction activities.</p> <p><b>DESIGN CRITERIA</b></p> <ul style="list-style-type: none"> <li><input type="checkbox"/> Fences are to be constructed along a line of constant elevation (along a contour line) where possible.</li> <li><input type="checkbox"/> Maximum slope adjacent to the fence is 1:1.</li> <li><input type="checkbox"/> Maximum distance of flow to silt fence should be 200 feet or less.</li> <li><input type="checkbox"/> Maximum concentrated flow to silt fence shall be 1 CFS per 20 feet of fence.</li> <li><input type="checkbox"/> If 50% or less of soil, by weight, passes the U.S. Standard sieve No. 200, select the equivalent opening size (E.O.S.) to retain 85% of the soil.</li> <li><input type="checkbox"/> Maximum equivalent opening size shall be 70 (#70 sieve).</li> <li><input type="checkbox"/> Minimum equivalent opening size shall be 100 (#100 sieve).</li> <li><input type="checkbox"/> If 85% or more of soil, by weight, passes the U.S. Standard sieve No. 200, silt fences shall not be used due to potential clogging.</li> </ul> | <p><b>Targeted Constituents</b></p> <ul style="list-style-type: none"> <li><input checked="" type="radio"/> Sediment</li> <li><input type="radio"/> Nutrients</li> <li><input type="radio"/> Toxic Materials</li> <li><input type="radio"/> Oil &amp; Grease</li> <li><input type="radio"/> Floatable Materials</li> <li><input type="radio"/> Other Construction Wastes</li> </ul> <p><b>Implementation Requirements</b></p> <ul style="list-style-type: none"> <li><input checked="" type="radio"/> Capital Costs</li> <li><input checked="" type="radio"/> Maintenance</li> <li><input type="radio"/> Training</li> <li><input checked="" type="radio"/> Suitability for Slopes &gt;5%</li> </ul> <p><b>Legend</b></p> <ul style="list-style-type: none"> <li><input checked="" type="radio"/> Significant Impact</li> <li><input type="radio"/> Medium Impact</li> <li><input type="radio"/> Low Impact</li> <li>? Unknown or Questionable Impact</li> </ul> <p style="text-align: center; border: 1px solid black; padding: 5px;"><b>Fe = 0.75</b></p> <p style="text-align: center; border: 1px solid black; padding: 5px;"><b>S-1</b></p> <div style="text-align: center;"> </div> <p style="text-align: center;">North Central Texas<br/>Council of Governments</p> |

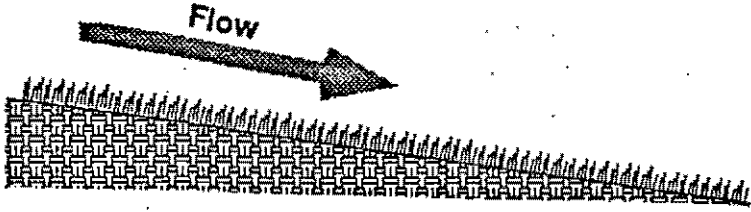
| <p><b>DESCRIPTION</b><br/>Vegetation, as a Best Management Practice, is the sowing of annual grasses, small grains or legumes to provide interim and permanent vegetative stabilization for disturbed areas.</p> <p><b>PRIMARY USE</b><br/>Vegetation is used as a temporary or permanent stabilization technique for areas disturbed by construction but not protected by pavement, building or other structures. As a temporary control, vegetation is used to stabilize stockpiles and barren areas which are inactive for long periods of time. As a permanent control, grasses and other vegetation provide good protection for the soil along with some filtering for overland runoff. Subjected to acceptable runoff velocities, vegetation can provide a good method of permanent storm water management as well as a visual amenity to the site.</p> <p>Other BMPs may be required to assist in the establishment of vegetation. These other techniques include erosion control matting, swales and dikes to direct flow around newly seeded areas and proper grading to limit runoff velocities during construction.</p> <p><b>APPLICATIONS</b><br/>Vegetative techniques can and should apply to every construction project with few exceptions. Vegetation effectively reduces erosion in swales, stock piles, berms, mild to medium slopes and along roadways. Vegetative strips can provide some protection when used as a perimeter control for utility and site development construction.</p> <p>In many cases, the initial cost of temporary seeding may be high compared to tarps or covers for stockpiles or other barren areas subject to erosion yet inactive. This initial cost should be weighed with the amount of time the area is to remain inactive, since maintenance cost for vegetated areas is much less than most structural controls.</p> <p><b>DESIGN CRITERIA</b><br/><i>Surface Preparation</i></p> <ul style="list-style-type: none"> <li><input type="checkbox"/> Interim or final grading must be completed prior to seeding, minimizing all steep slopes.</li> <li><input type="checkbox"/> Install all necessary erosion structures such as dikes, swales, diversions, etc., prior to seeding.</li> </ul> | <p><b>Targeted Constituents</b></p> <ul style="list-style-type: none"> <li>● Sediment</li> <li>○ Nutrients<br/>Toxic Materials</li> <li>○ Oil &amp; Grease</li> <li>○ Floatable Materials</li> <li>○ Other Construction Wastes</li> </ul> <p><b>Implementation Requirements</b></p> <ul style="list-style-type: none"> <li>● Capital Costs</li> <li>● Maintenance</li> <li>○ Training</li> <li>● Suitability for Slopes &gt;5%</li> </ul> <p><b>Legend</b></p> <ul style="list-style-type: none"> <li>● Significant Impact</li> <li>● Medium Impact</li> <li>○ Low Impact</li> <li>? Unknown or Questionable Impact</li> </ul> <p style="text-align: center; font-size: 1.2em;"><b>Fe = 0.90</b></p> <p style="text-align: center; font-size: 1.2em;"><b>E-4</b></p> <p style="text-align: center;">North Central Texas<br/>Council of Governments</p> |

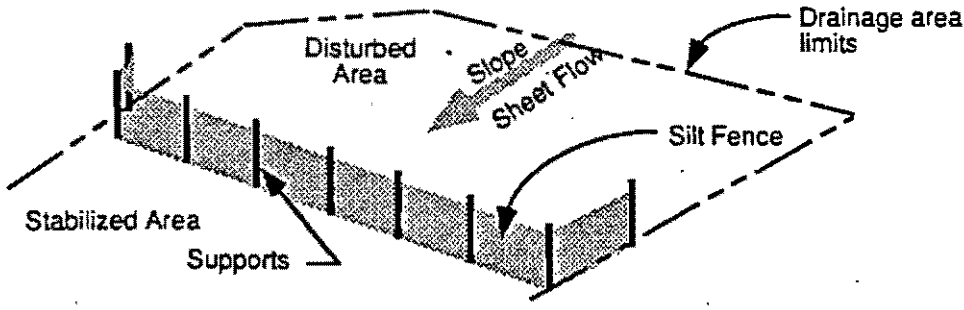
| <h1>Silt Fence</h1> | <h2>Applications</h2> |
|---|---|
| <p><b>DESCRIPTION</b><br/> A silt fence consists of geotextile fabric supported by poultry netting or other backing stretched between either wooden or metal posts with the lower edge of the fabric securely embedded in the soil. The fence is typically located downstream of disturbed areas to intercept runoff in the form of sheet flow. Silt fence provides both filtration and time for sedimentation to reduce sediment and it reduces the velocity of the runoff. Properly designed silt fence is economical since it can be re-located during construction and re-used on other projects.</p> <p><b>PRIMARY USE</b><br/> Silt fence is normally used as perimeter control located downstream of disturbed areas. It is only feasible for non-concentrated, sheet flow conditions.</p> <p><b>APPLICATIONS</b><br/> Silt fence is an economical means to treat overland, non-concentrated flows for all types of projects. Silt fences are used as perimeter control devices for both site developments and linear (roadway) type projects. They are most effective with coarse to silty soil types. Due to the potential of clogging, silt fence should not be used with clay soil types.</p> <p>In order to reduce the length of silt fence, it should be placed adjacent to the down slope side of the construction activities.</p> <p><b>DESIGN CRITERIA</b></p> <ul style="list-style-type: none"> <li><input type="checkbox"/> Fences are to be constructed along a line of constant elevation (along a contour line) where possible.</li> <li><input type="checkbox"/> Maximum slope adjacent to the fence is 1:1.</li> <li><input type="checkbox"/> Maximum distance of flow to silt fence should be 200 feet or less.</li> <li><input type="checkbox"/> Maximum concentrated flow to silt fence shall be 1 CFS per 20 feet of fence.</li> <li><input type="checkbox"/> If 50% or less of soil, by weight, passes the U.S. Standard sieve No. 200, select the equivalent opening size (E.O.S.) to retain 85% of the soil.</li> <li><input type="checkbox"/> Maximum equivalent opening size shall be 70 (#70 sieve).</li> <li><input type="checkbox"/> Minimum equivalent opening size shall be 100 (#100 sieve).</li> <li><input type="checkbox"/> If 85% or more of soil, by weight, passes the U.S. Standard sieve No. 200, silt fences shall not be used due to potential clogging.</li> </ul> | <p><b>Targeted Constituents</b></p> <ul style="list-style-type: none"> <li><input checked="" type="radio"/> Sediment</li> <li><input type="radio"/> Nutrients</li> <li><input type="radio"/> Toxic Materials</li> <li><input type="radio"/> Oil &amp; Grease</li> <li><input type="radio"/> Floatable Materials</li> <li><input type="radio"/> Other Construction Wastes</li> </ul> <p><b>Implementation Requirements</b></p> <ul style="list-style-type: none"> <li><input checked="" type="radio"/> Capital Costs</li> <li><input checked="" type="radio"/> Maintenance</li> <li><input type="radio"/> Training</li> <li><input checked="" type="radio"/> Suitability for Slopes &gt;5%</li> </ul> <p><b>Legend</b></p> <ul style="list-style-type: none"> <li><input checked="" type="radio"/> Significant Impact</li> <li><input checked="" type="radio"/> Medium Impact</li> <li><input type="radio"/> Low Impact</li> <li>? Unknown or Questionable Impact</li> </ul> <p><b>Fe = 0.75</b></p> <p><b>S-1</b></p> <p>North Central Texas Council of Governments</p> |
