**PHASE ONE
ENVIRONMENTAL SITE ASSESSMENT**

**the proposed Keller Springs Toll Tunnel
Addison, Texas**

TEXAS TURNPIKE AUTHORITY

HDR ENGINEERING, INC.

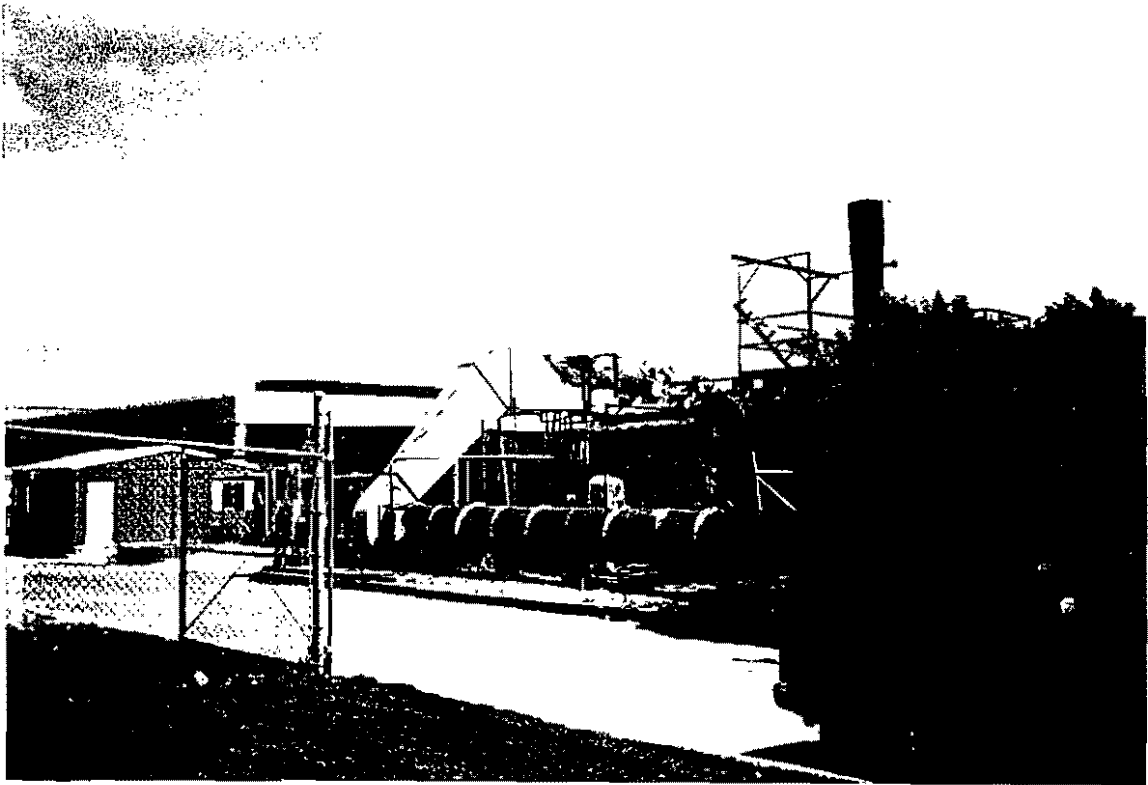
A facility that appeared as an equipment yard in historical aerial photos at the southeast corner of Midcourt and Chennault in Carrollton is now a grassy mound. No historical information could be ascertained to evaluate the site. Forney Corporation, at 3405 Wiley Post, was observed to have many drums of un-identified waste behind its manufacturing facility, near its igniter testing facility, see Photos 10 & 11.

Photo 11 - View southeast of Forney Engineering diesel igniter testing facility for coal fired power plants.
