Kimley-Horn and Associates, Inc. **Priority: 6**
Project Description for Unsignalized Intersection

Client:	**Town of Addison**	**Date: 1/2/18**
Program:	**ADA Self-Evaluation and Transition Plan**	**Prepared By: CMP**
KHA No.:	**063543021**	**Checked By: EPE**

Corridor :	**Brookwood Ln**	**GPS ID: 90036**
Project Name:	**Intersection of Brookwood Ln and driveway (Lat. 32.9442; Long. -96.8525)**	
Town:	**Addison**

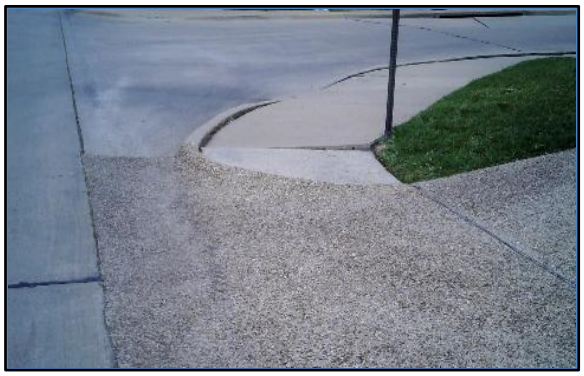
Corner 1 No Ramp (1*z*)

Curb Ramp Issues	Curb Ramp ID ('z' or 'i' in ramp label indicates no existing ramp) 1z	2z		Possible Solutions
Curb ramp does not exist and is needed	X	X		Install curb ramp; if median improvement, see shapefile
Curb ramp does not land in crosswalk				
No 4' x 4' clear space at base of curb ramp				
Curbed side is not 90° or has traversable adjacent surface				
Flare cross slope is greater than 10%				
Curb ramp running slope is greater than 8.3%				
Blended transition running slope is greater than 5%				
Cut-thru ramp running slope is greater than 5%				
Curb ramp cross slope is greater than 2%				
Cut-thru ramp cross slope is greater than 2%				
Curb ramp width is less than 48"				
Cut-thru ramp width is less than 60"				
Permanent obstruction (>0.25") in curb ramp/landing/flares				
Temporary obstruction (>0.25") in curb ramp/landing/flares				
No textured surface at base of curb ramp				
No color contrast at base of curb ramp

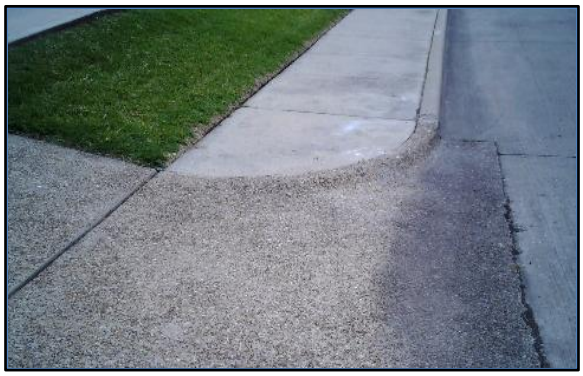
Corner 2 No Ramp (2*z*)
