**ADDION AIRPORT
BUILDING REPORT**

Facility Information: **Facility Name:** Pilot Lounge West

Inspector: Karen Jackson **Date:** April 17, 2017

Address: 4550 Richard Byrd **City:** Addison **County:** Dallas

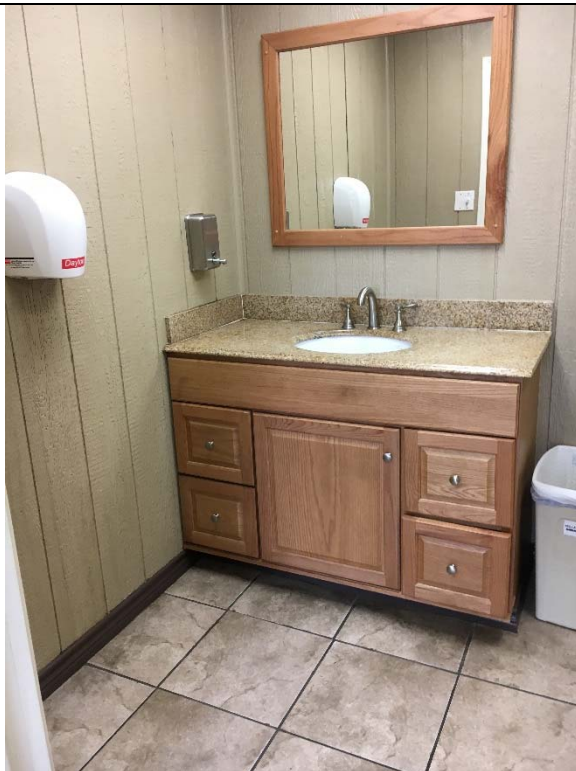
Violation 3 - The lavatory is mounted at 35-1/2" to the counter and toe and knee clearance is not provided.

Replace lavatory with a compliant lavatory.
