**TOWN OF ADDISON
BUILDING REPORT**

Facility Name: Wiley Post Office Building

Date: April 10, 2017

Address: 4308 & 4310 Wiley Post Road

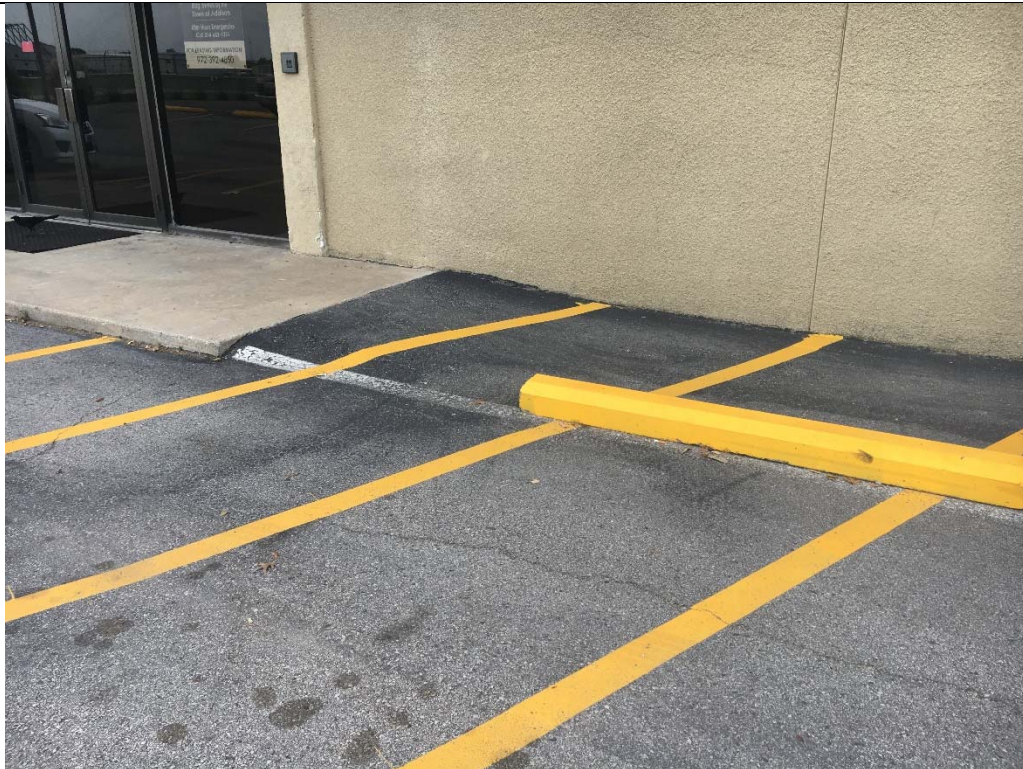
Violation 2 -There are 5 covered parking spaces at the west portion of the building (4308) with no accessible parking spaces provided.
