**TOWN OF ADDISON  
BUILDING REPORT**

**Facility Information:** **Facility Name:** Athletic Club  
**Facility Contact:** Lisa Pyles **Contact Phone:** 972-450-2878

**Accessology Inspector Information:**  
**Inspector:** Karen Jackson **Date:** April 25, 2017  
**Email:** Kjackson@accessology.com

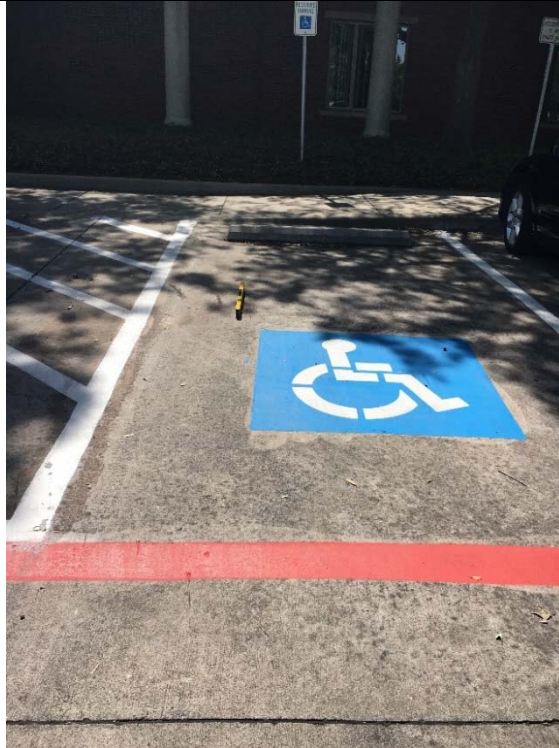
**Violation 1** - The far right accessible parking space in the front lot (closest to the main door) has a running slope of 3.2%.

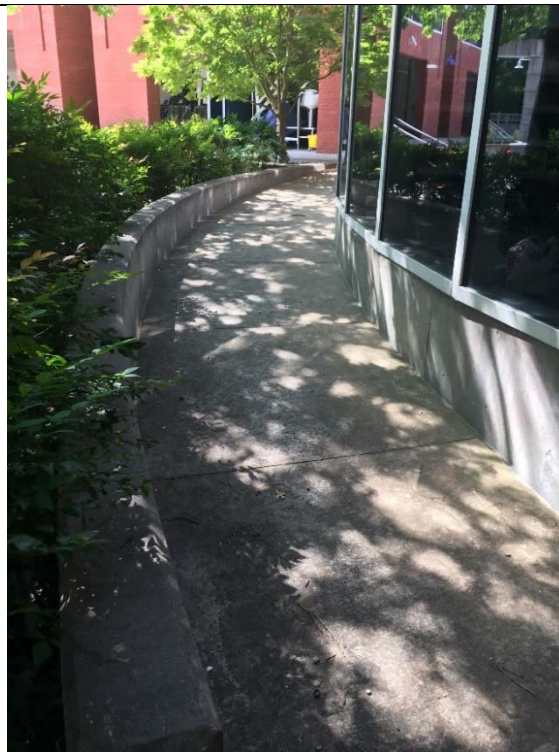
**Violation 2** - The ramp leading to the exterior upper pool area and the exterior restrooms has a 5.4% running slope with no handrails.

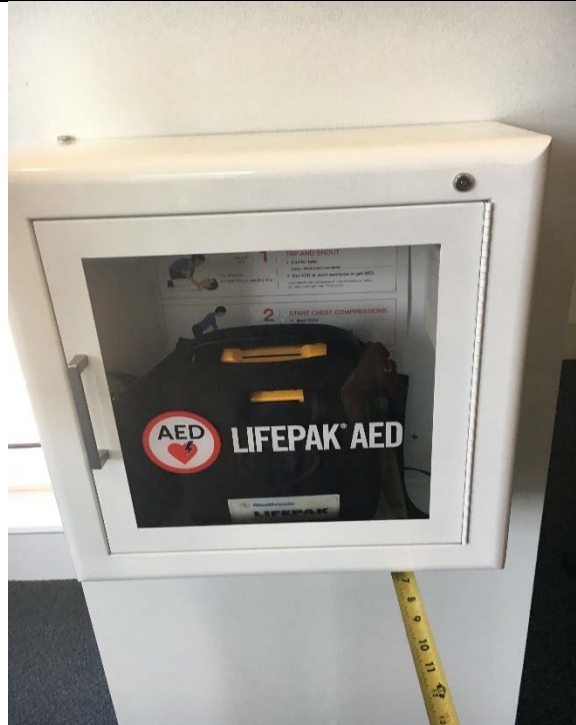
**Violation 15** - The Lifepak AED case located in the 2nd floor exercise room protrudes into the path of travel 7" at 27".

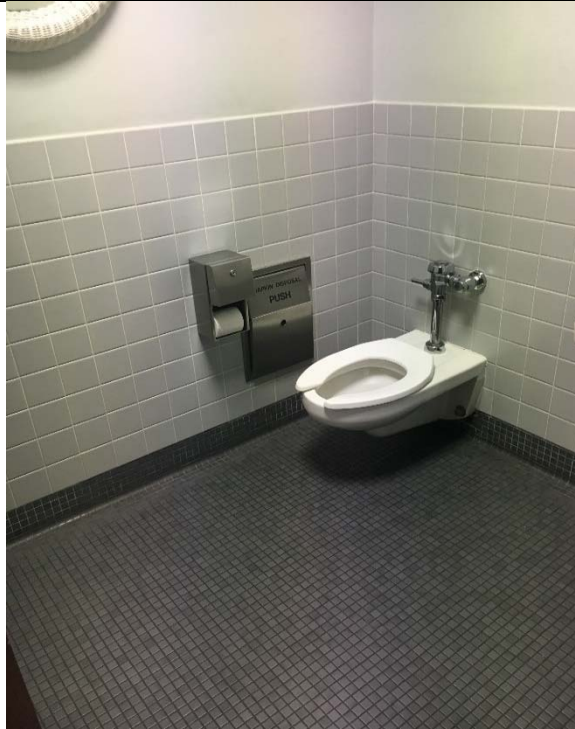
**Violation 21** - Single user restroom on 2nd floor - The flush control on the water closet is located on the wrong side of the toilet tank. Flush controls must be installed on the open side of the water closet.

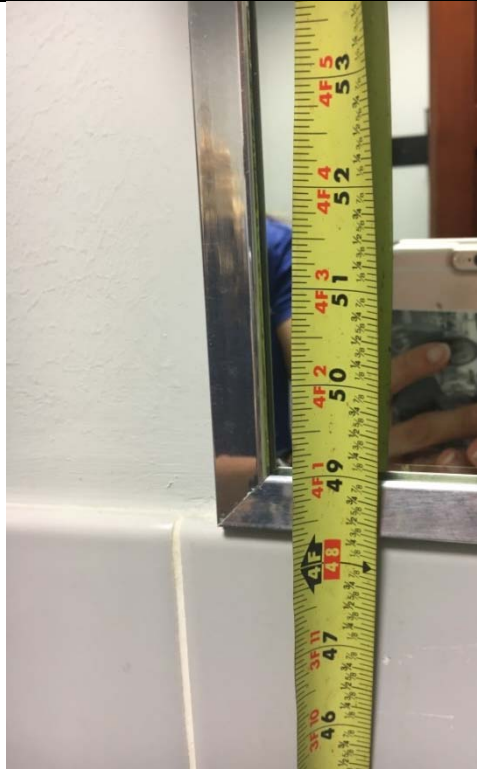
**Violation 24** - Single user restroom on the 2nd floor - The mirror is mounted with the bottom of the reflective surface at 49" where a maximum of 40" is required.

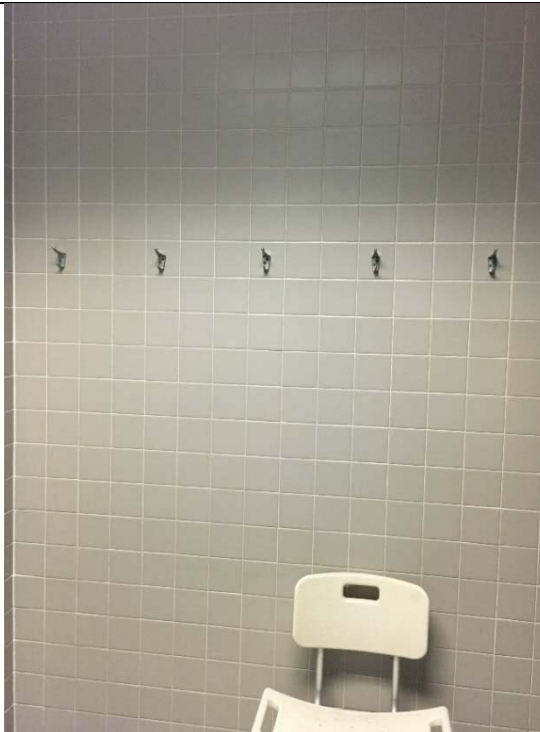
**Violation 31** - Women's Locker Room - Hooks by the shower are mounted at 68" to the highest operable part, 48" maximum is required.

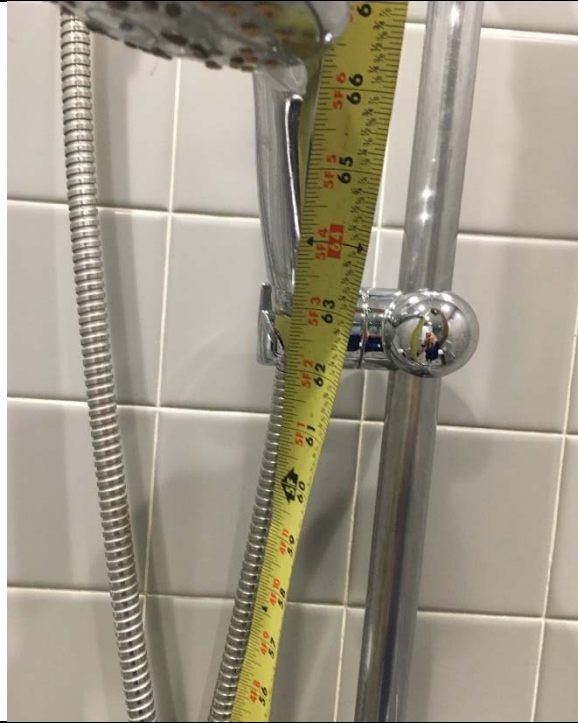
**Violation 32** - Women's Locker Room - The shower head is mounted at 63" where a maximum of 48" is required.

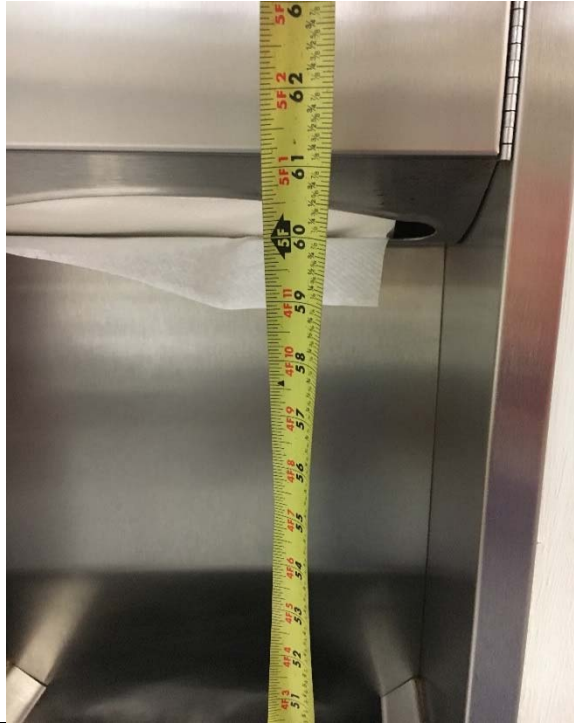
**Violation 34** - Women's Locker Room - Paper towel dispenser's operable part is at 60" where a maximum of 48" is required.

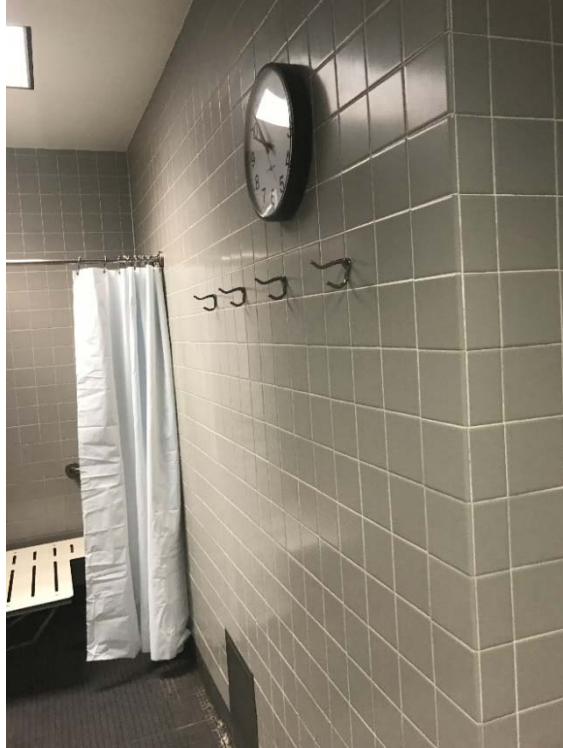
**Violation 40** - Men's Locker Room - Coat hooks are mounted at 68" to the highest operable part, 48" maximum is required.

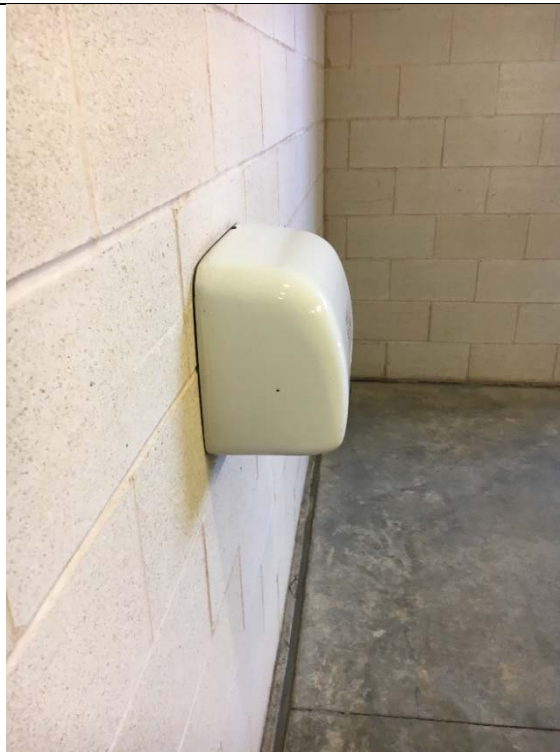
**Violation 44** - Men's and Women's restrooms in pool area - Hand dryers protrude into the path of travel 7".

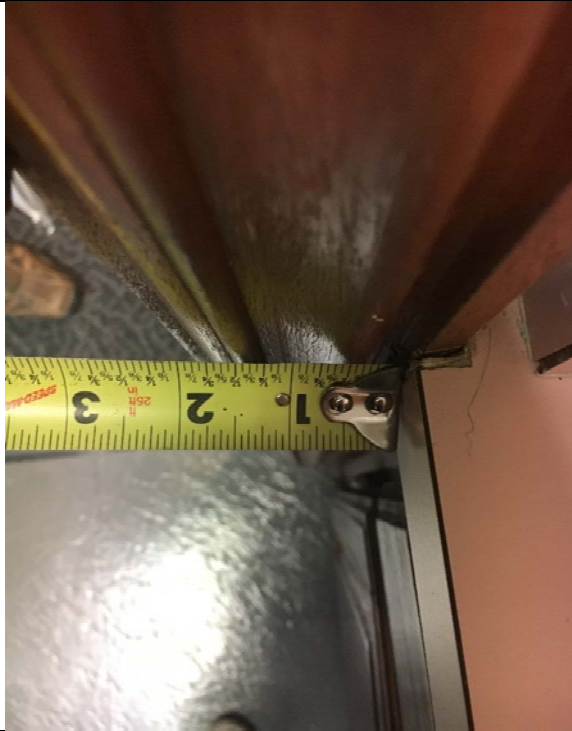
**Violation 45** - There is only a 2" maneuvering clearance on the pull side of the door leading into the breakroom on the 2nd floor, a minimum of 18" is required.

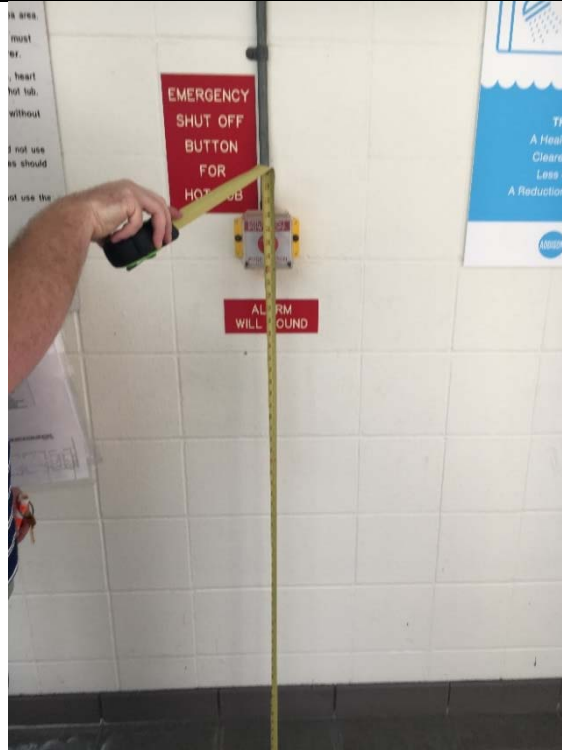
**Violation 61** - The emergency shut off bottom at the indoor pool is mounted at 50", where a maximum of 48" is required.

51	Modify counter to provide 36" length at 36" high maximum.	Level 4	\$2,100.00
52	Modify door to provide a minimum clear opening of 32".	Level 7	\$2,625.00
53	Add a drinking fountain for standing persons.	Level 6	\$2,100.00
54	Relocate drinking fountains further to the right to provide a 60" clear deep maneuvering clearance.	Level 6	\$2,625.00
55	Relocate equipment to allow for the required clear floor space at each type of exercise equipment.	Level 7	\$158.00
56	Provide a clear and level 30" x 48" area at the drinking fountain.	Level 8	\$525.00
57	Provide access into the pool in compliance with section 1009.	Level 4	\$6,300.00
58	Provide an additional hooks at 48" high maximum.	Level 6	\$525.00
59	Modify ramp so the slope is no greater than 1:12 (8.33%).	Level 12	\$1,050.00
60	Relocate controls to an area with a level clear floor space.	Level 6	\$525.00
61	Relocate the emergency shut off to 48" high maximum.	Level 6	\$525.00

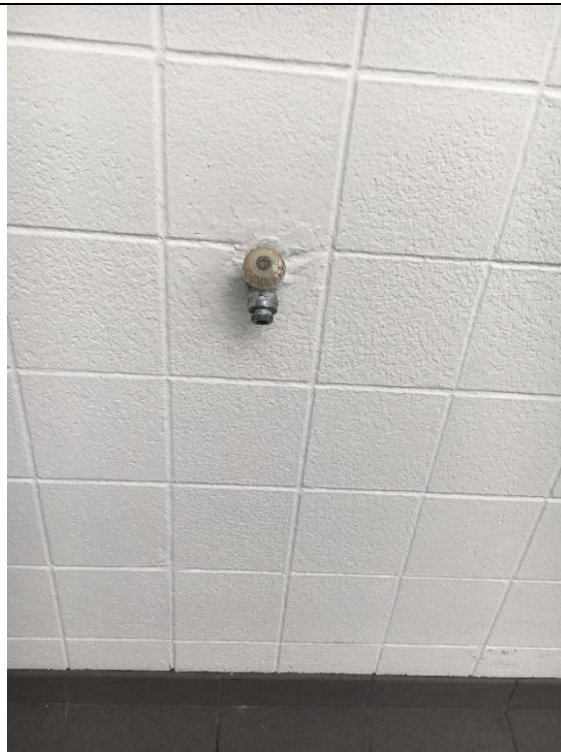
**Violation 62** - The control for the hose in the indoor pool area requires tight grasping and twisting to operate.

62	Replace with controls that do not require grasping and twisting to operate.	Level 12	\$525.00
63	Relocate the phone to 48" high maximum.	Level 6	\$525.00
		Grand Total	\$107,627.00
