| MAST ARM DETAILS | | | | | | |
| BELTLINE RD. EAST OF MARSH LN. | | | | | | |
| TOWN OF ADDISON, TEXAS | | | | | | |
| LAWRENCE A. CATES & ASSOC. | | | | | | CONSULTING ENGINEERS |

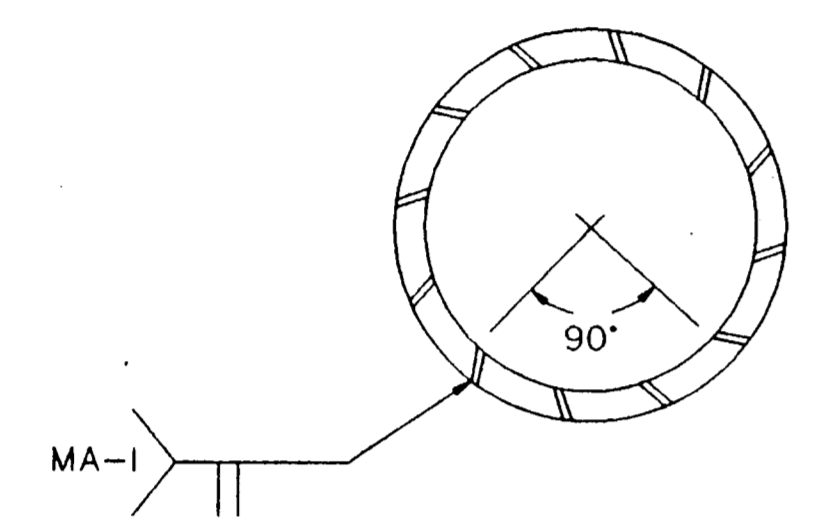
ARM WELD DETAIL

LONGITUDINAL SEAM WELD MUST BE ORIENTED WITHIN THE LOWER 90° OF THE SIGNAL ARM.

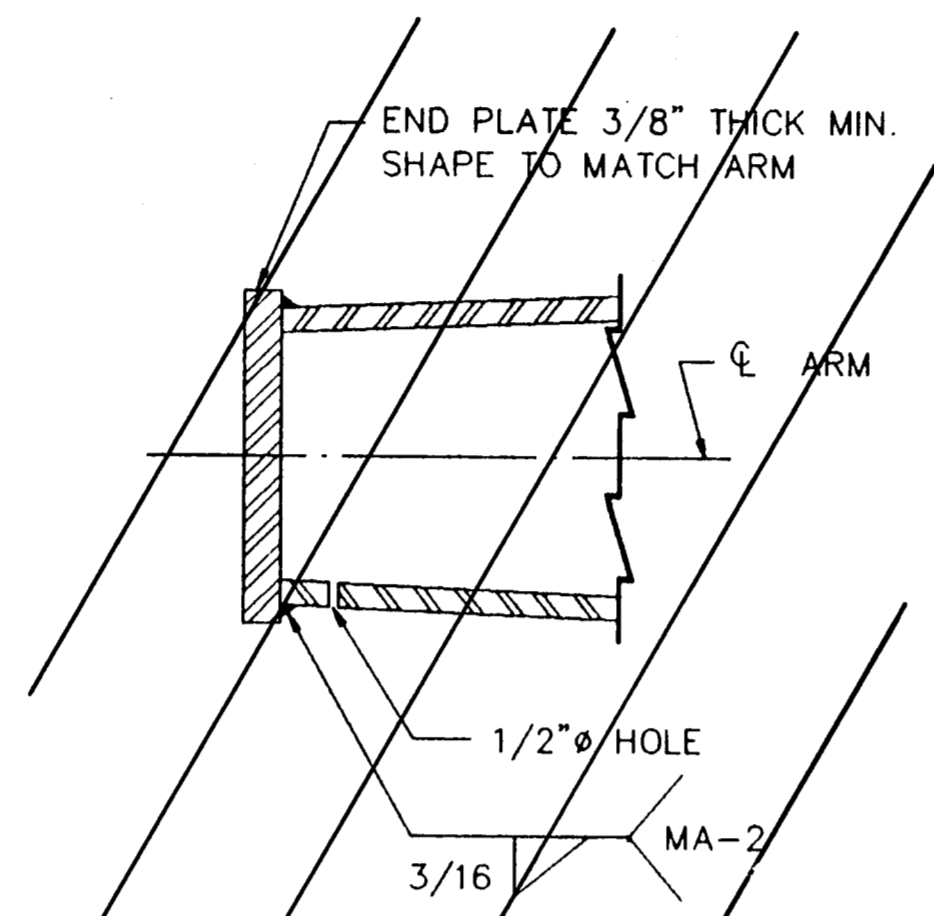
PLATE WELD DETAIL

NOTE :
POLE MANUFACTURER SHALL DRILL 1/2" HOLE IN BOTTOM OF MAST ARM AT END PLATE (FOR HOT-DIP GALVANIZING)

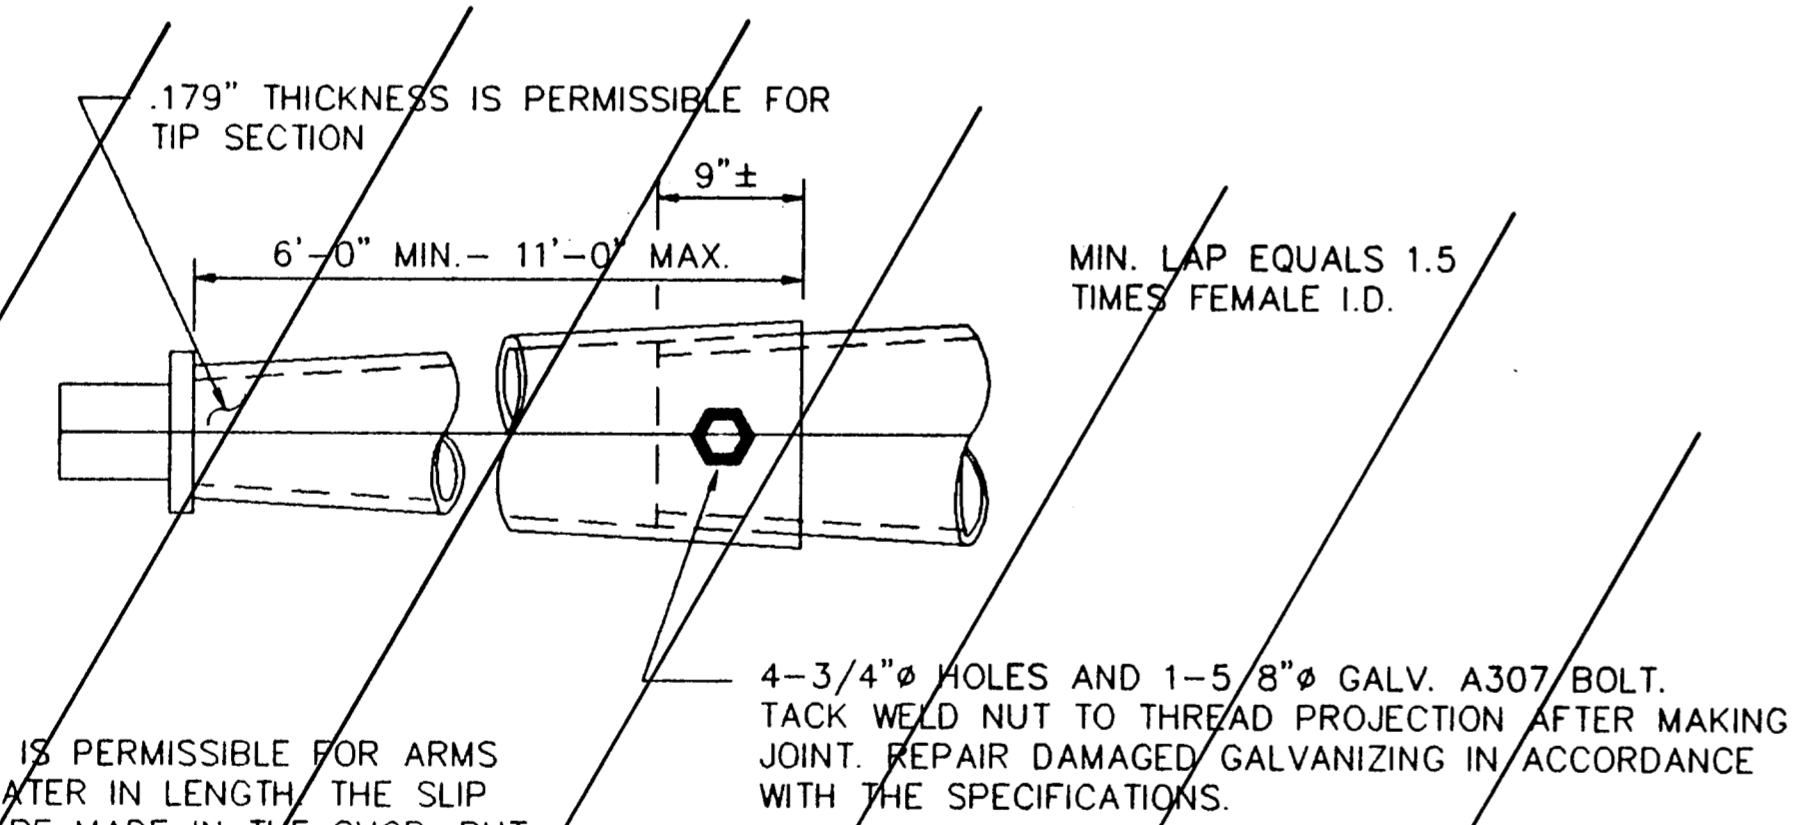
SLIP JOINT DETAILS

A SLIP JOINT IS PERMISSIBLE FOR ARMS 40' AND GREATER IN LENGTH. THE SLIP JOINT SHALL BE MADE IN THE SHOP, BUT MAY BE MATCH MARKED AND SHIPPED DISASSEMBLED.

4-3/4" HOLES AND 1-5/8" GALV. A307 BOLT. TACK WELD NUT TO THREAD PROJECTION AFTER MAKING JOINT. REPAIR DAMAGED GALVANIZING IN ACCORDANCE WITH THE SPECIFICATIONS.

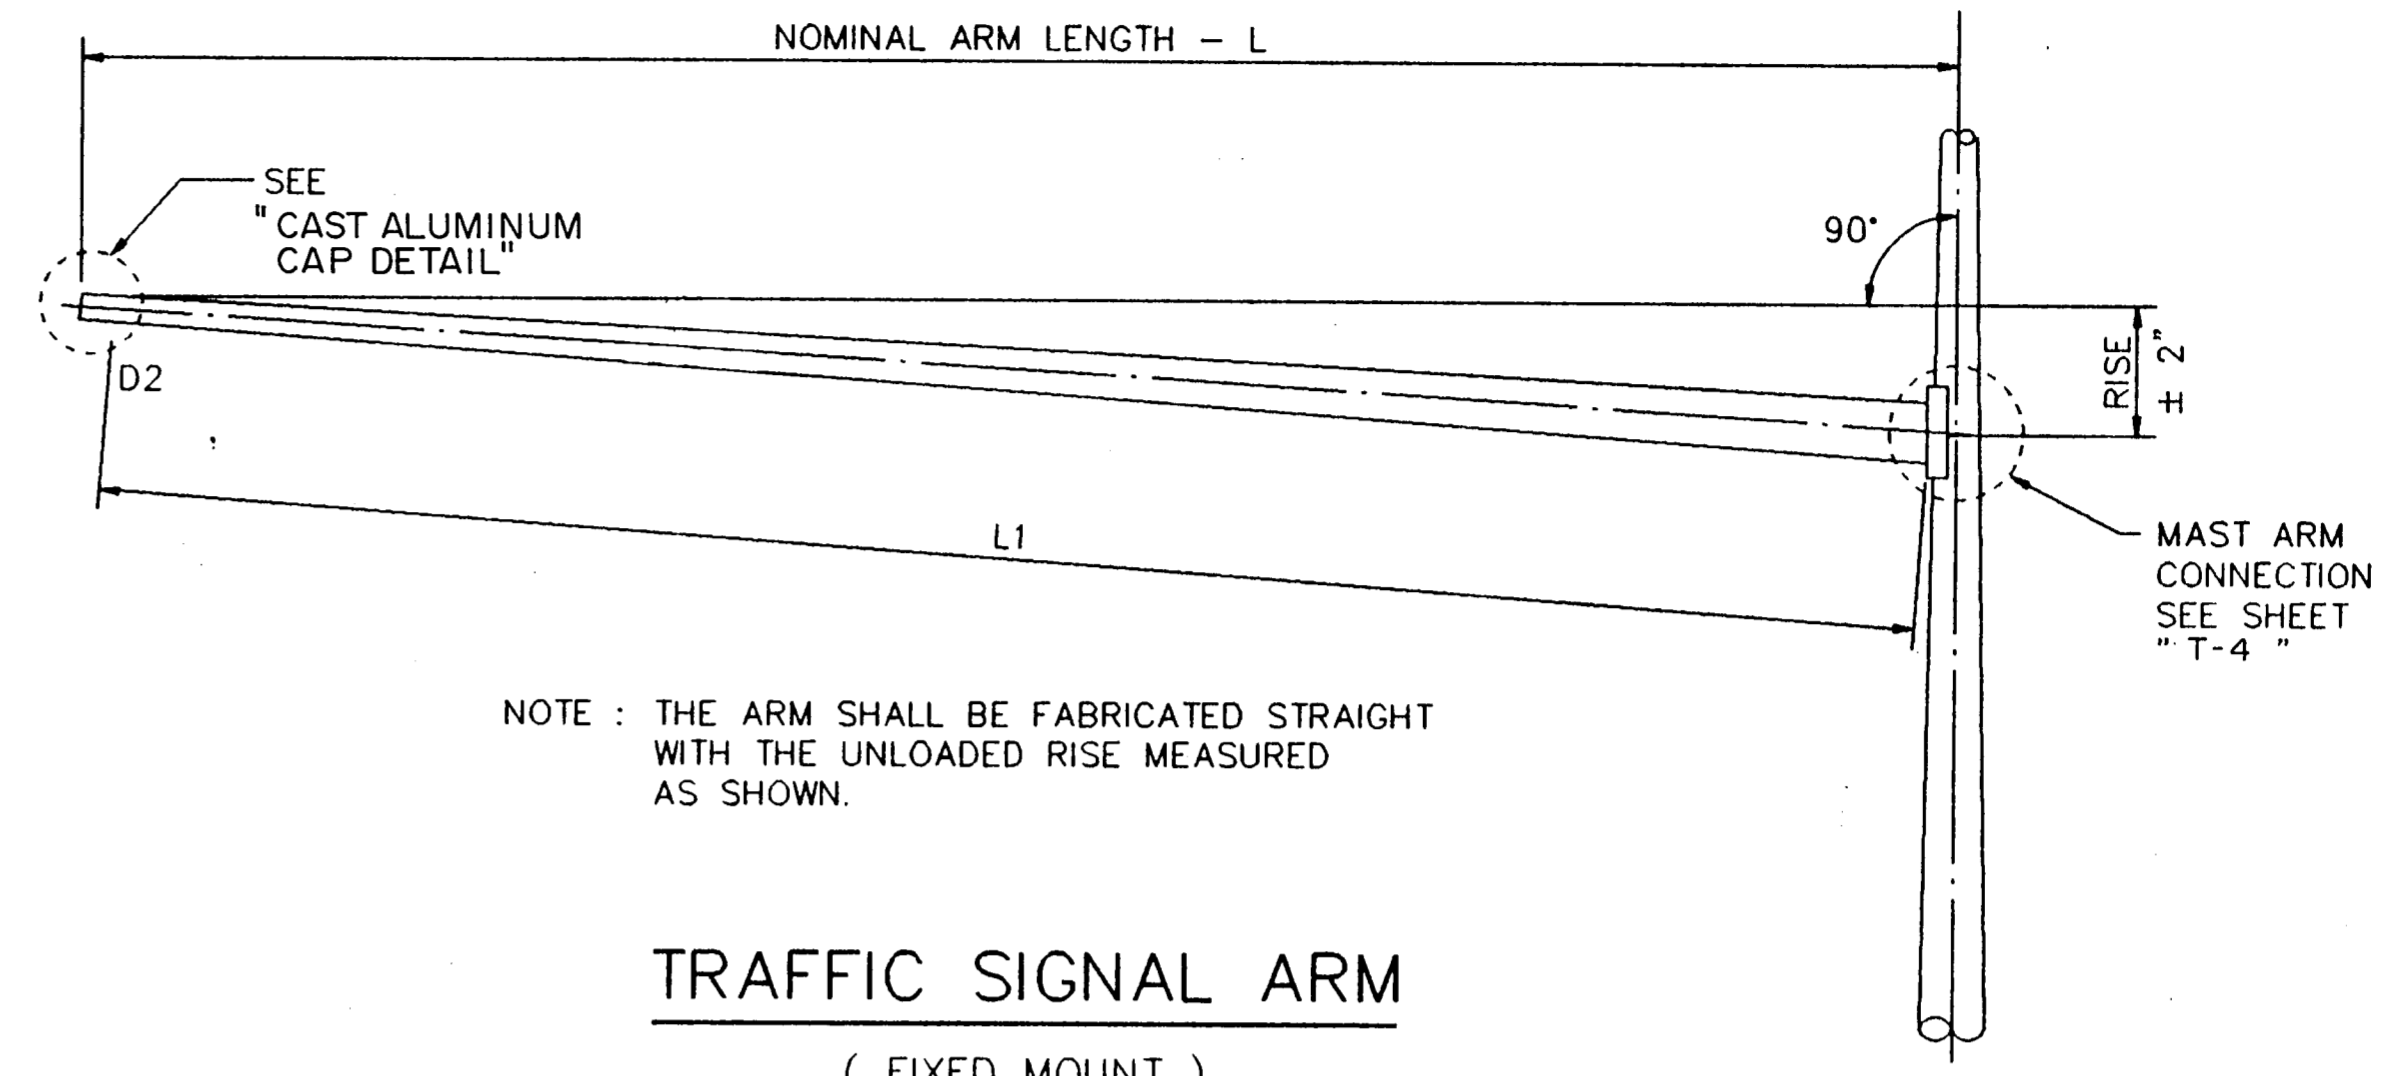
TRAFFIC SIGNAL ARM
(FIXED MOUNT)

NOTE : THE ARM SHALL BE FABRICATED STRAIGHT WITH THE UNLOADED RISE MEASURED AS SHOWN.

TRAFFIC SIGNAL ARM SEE ABOVE DETAIL

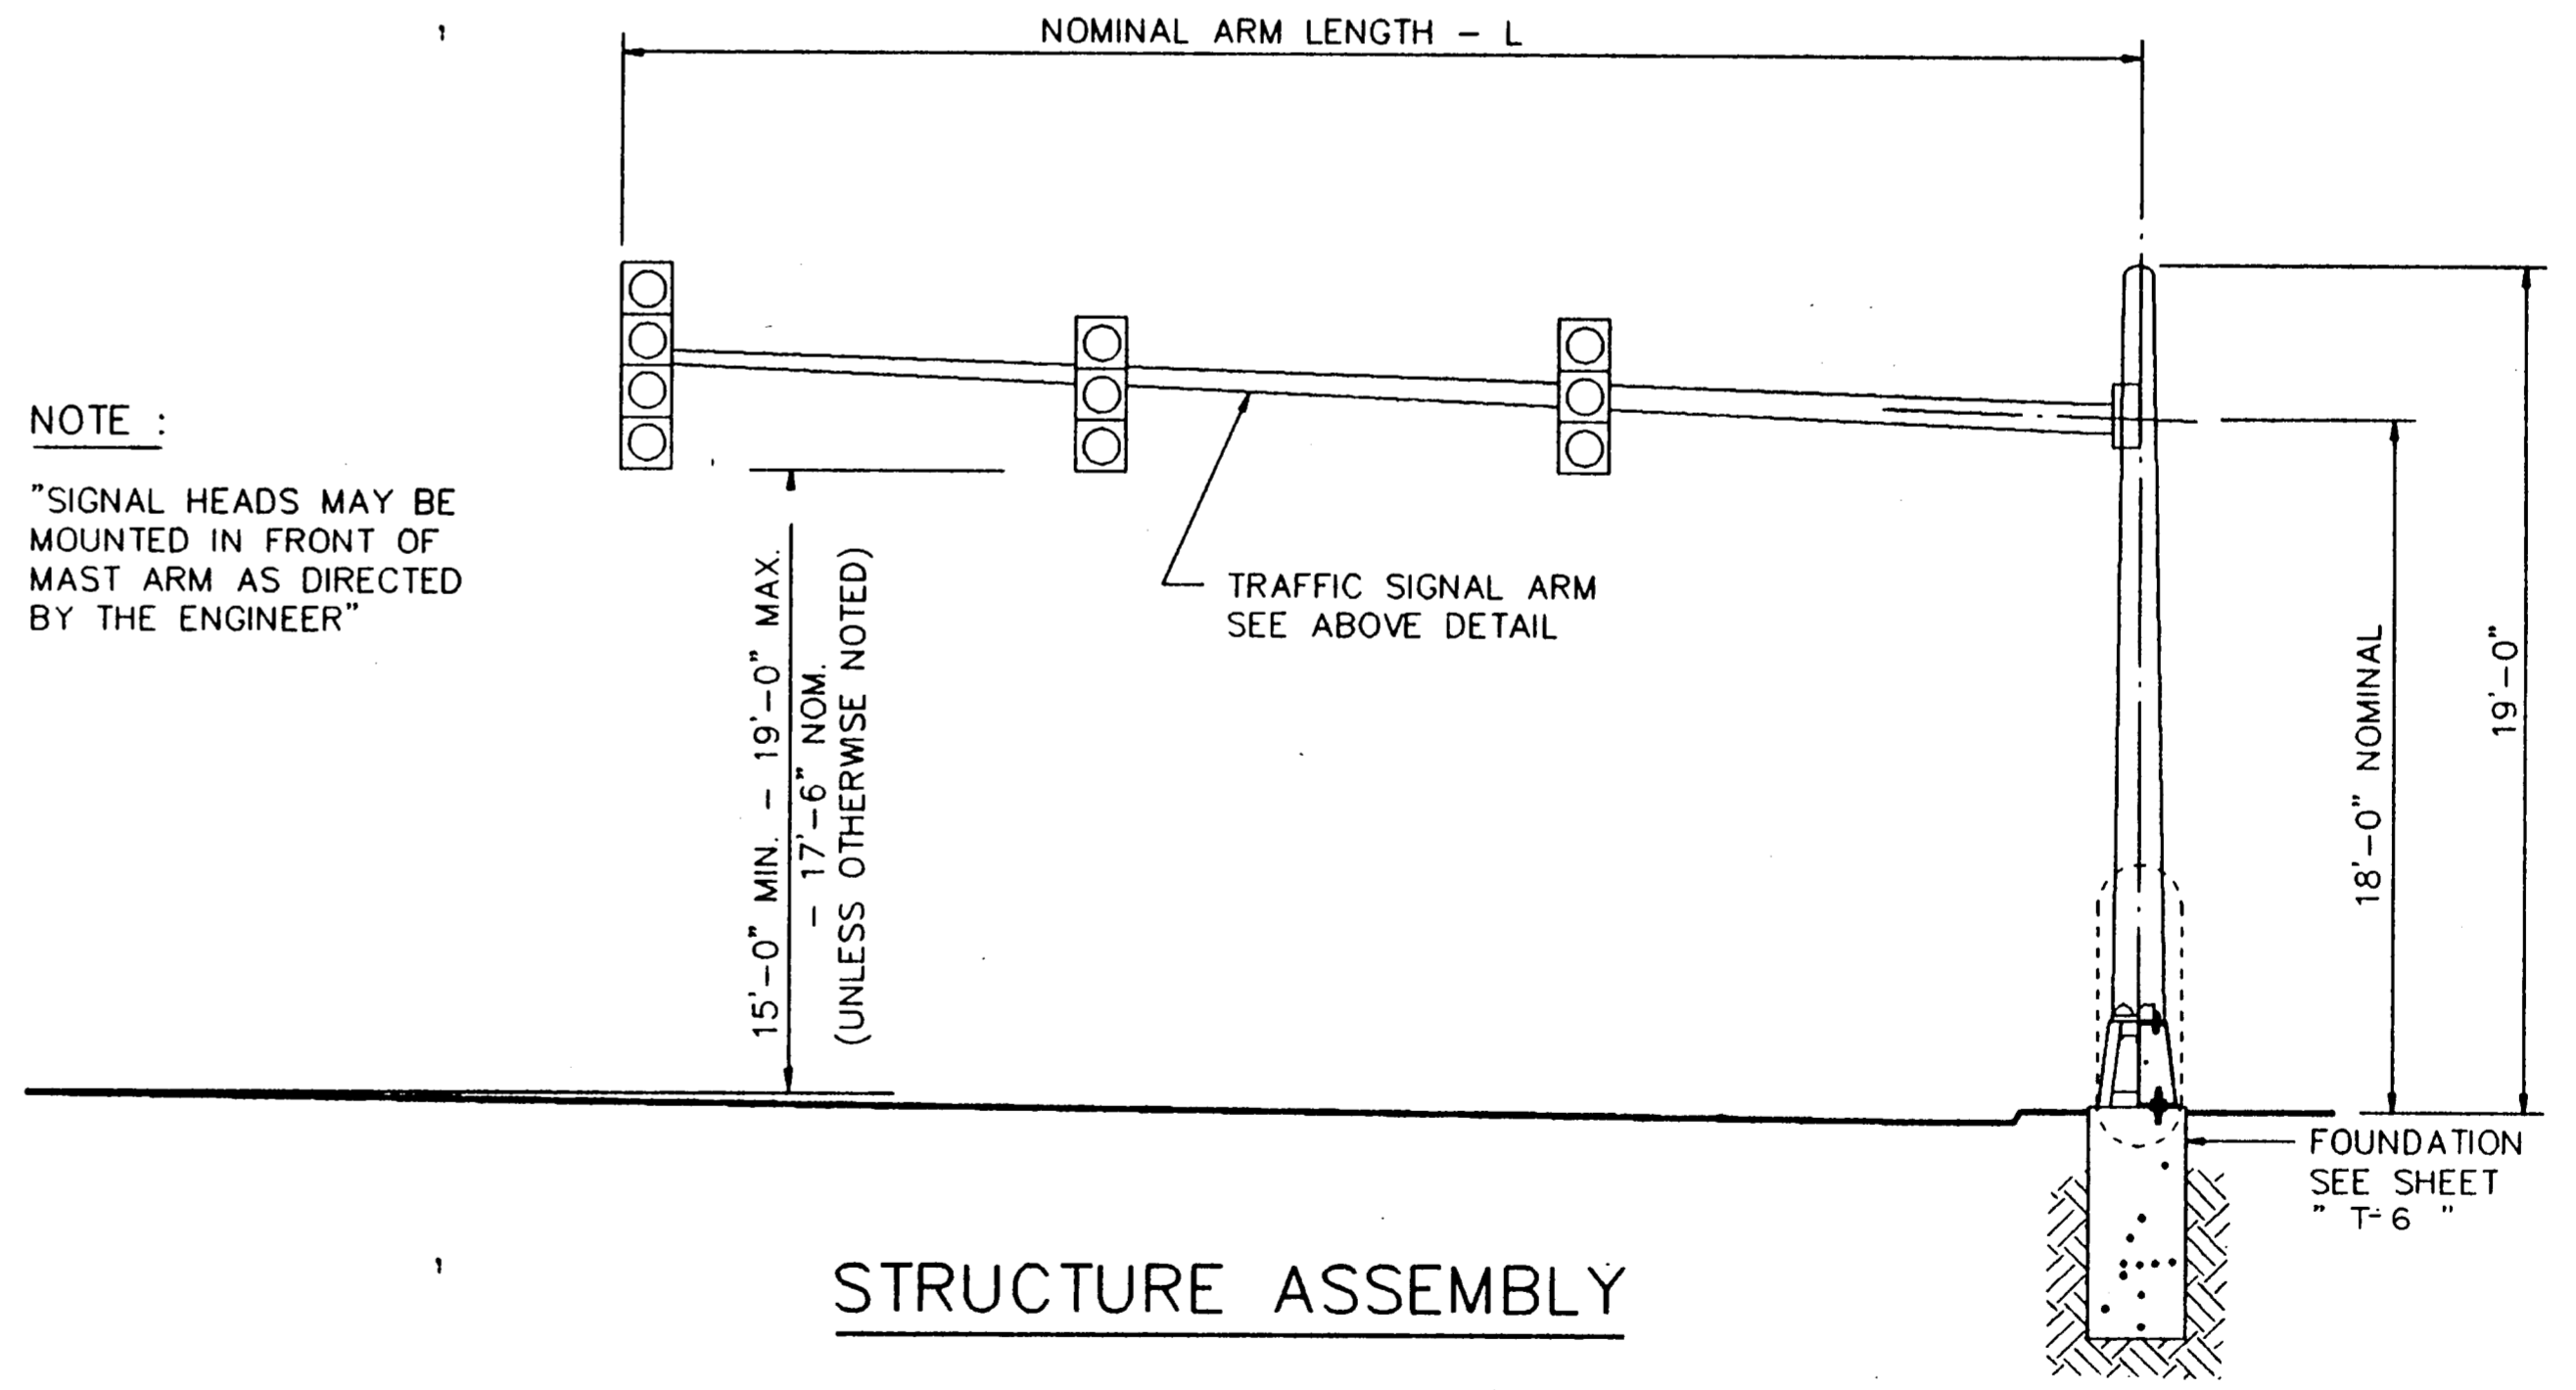
STRUCTURE ASSEMBLY

"SIGNAL HEADS MAY BE MOUNTED IN FRONT OF MAST ARM AS DIRECTED BY THE ENGINEER"
