RFI

RFI #: 87 Date: 3/27/2012 Job: EB-02 Keller Springs Lofts Phone: 877-777-5115

Subject: Brick Ledge at 10" Drop in Slab

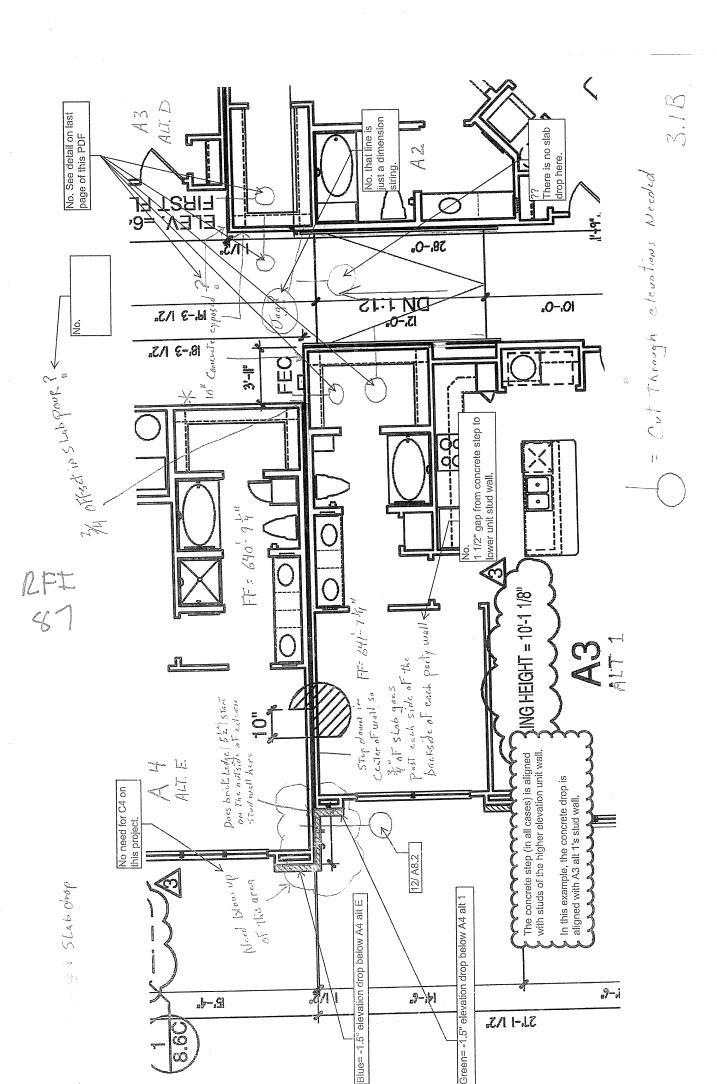
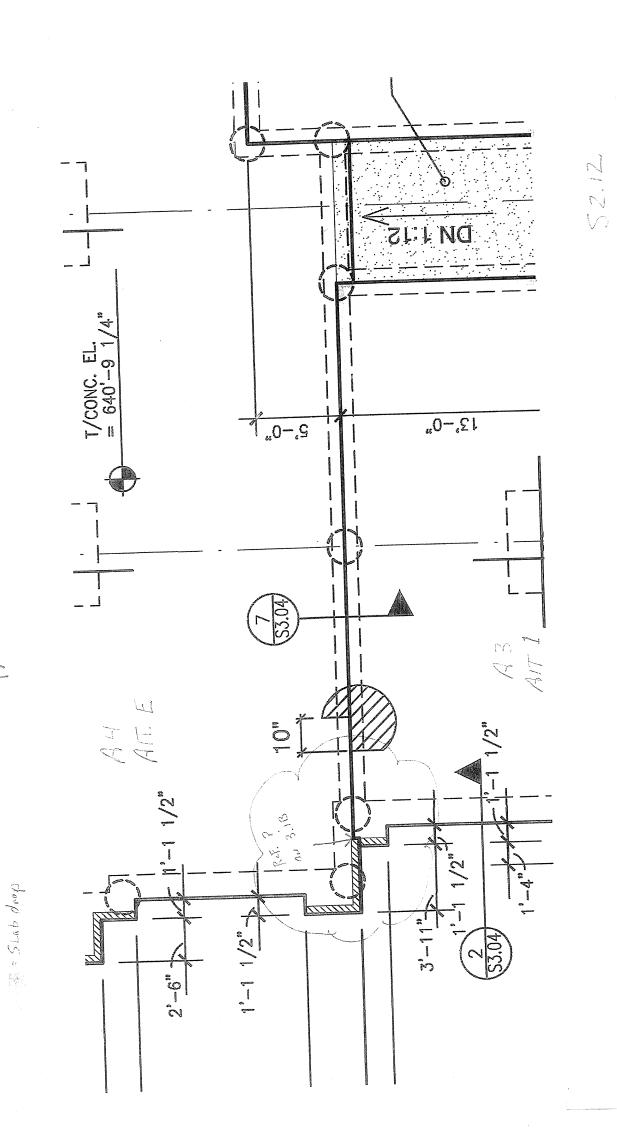
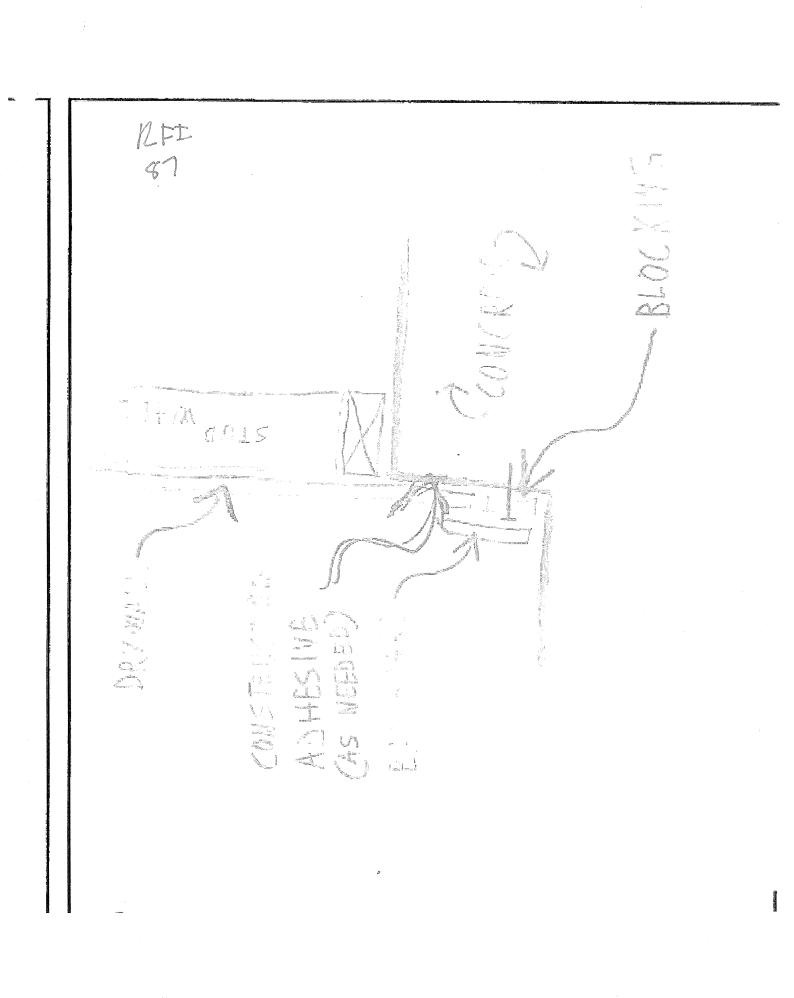
Date Required: 4/3/2012 Request: On the left hand side of the attached drawings, please provide a blow up of the area that the brick ledge is located and the two slabs are at different elevations. How does the 3/4" gap on the back side of each wall tie into the brick ledges at different levels? See Detail 7/S3.04 that shows the air gaps behind the walls. Requested by: David Miller Embrey Builders LLC

Response: I've talked with Trent Perkins about detail 7/ S3.04 and it will be revised to match my comments on the next pages of this PDF. Ryan Faulds Answered by BGO architects April 04, 2012

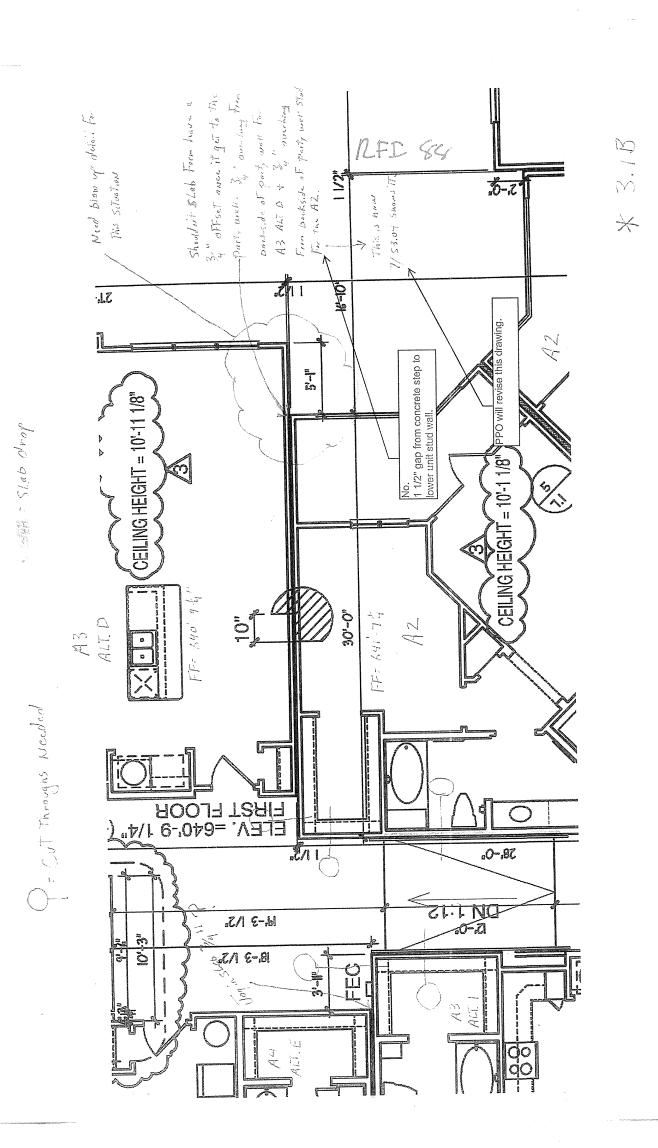
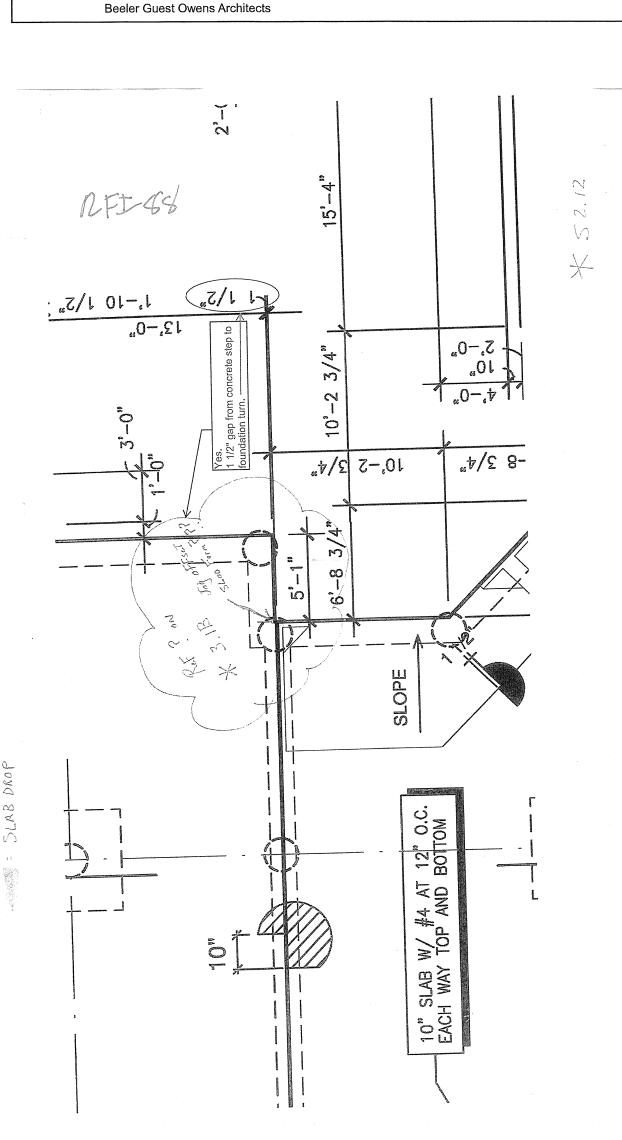
1. Please confirm that the ceiling height of the A1 unit (#1118) is 10'-11 1/8". Sheet A3.1A shows it to be that measurement, but

A3.1B shows it to be something else.

2. Please confirm ceiling heights of the A4 units on A3.1D. Shouldn't they be 10'-1 1/8"?

3. Please confirm the ceiling height of the A2 units on A3.1D. One has 10'-1 1/8" and I think it should be 10'-7 1/8".

1. drawing A3.1A is correct, and A3.1B is incorrect.

2&3 on sheet A3.1D, starting with the ceiling height of unit A3 on the far right facing the pool courtyard= 10' - 1 1/8". going clockwise around the courtyard from there we get

A3= 10'- 1 1/8" (no change, but when you see *** that means change)
A2= 10'- 7 1/8" due to drop in foundation

A4= 10'- 1 1/8*** because we step back up in the foundation A4= 10'- 1 1/8" ***
