RFI #: 135
 Date: 5/31/2012
 Job: EB-02 Keller Springs Lofts
 Phone: 877-777-5115

Subject: Slab at Club Poured Short

RFI #: 148
 Date: 6/8/2012
 Job: EB-02 Keller Springs Lofts
 Phone: 877-777-5115

Subject: Great Room TV / Proper Rating for Wall

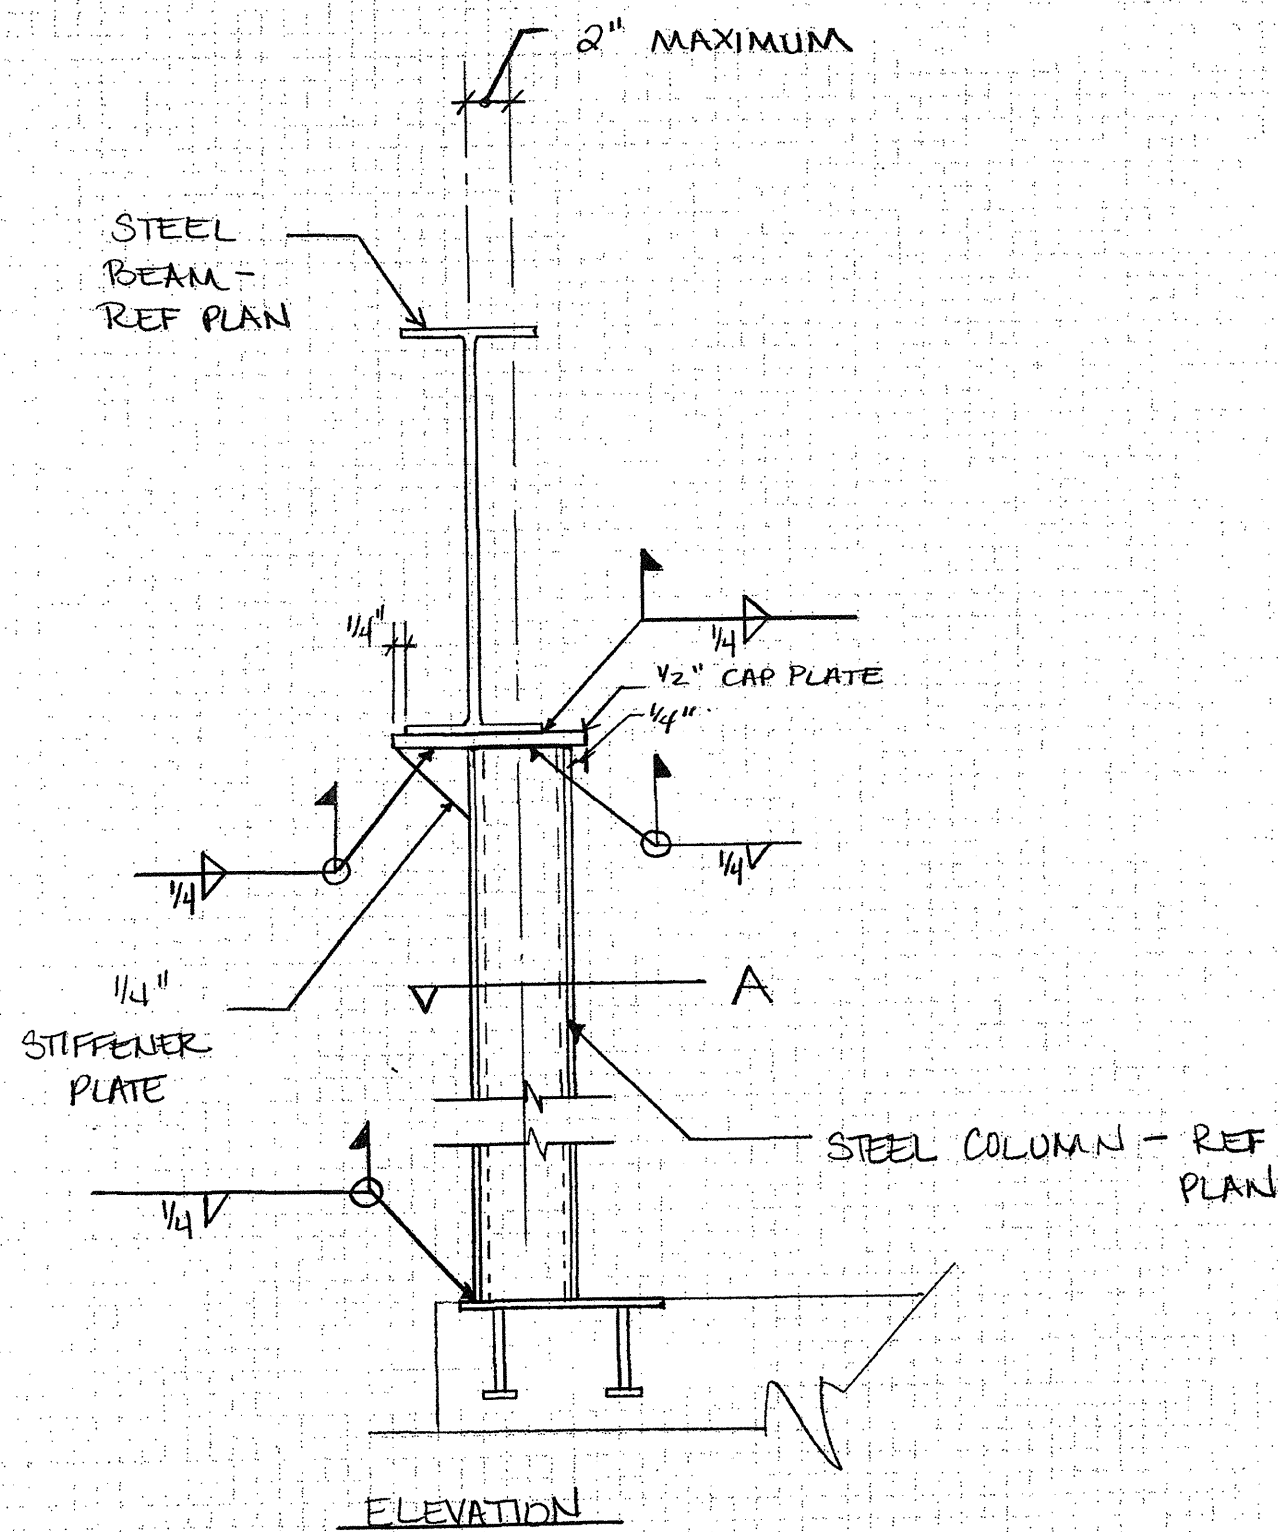
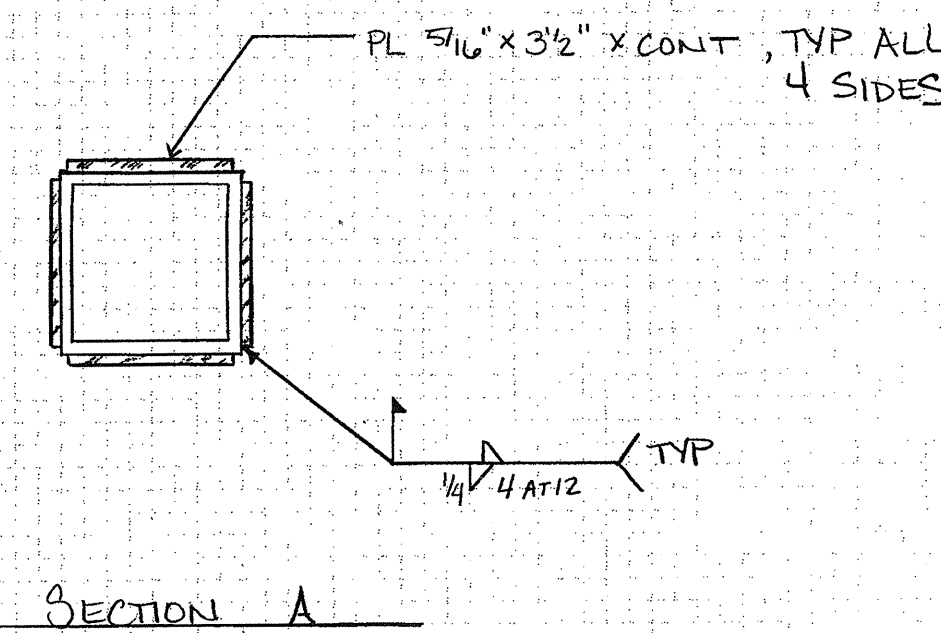
Response:
 Per the conference call on May 30, 2012, the beams will remain in the current locations indicated on the drawings and modifications made per the attached sketches. The columns will be attached to the embed plates at their current locations. The maximum offset of the column from its intended location on the structural drawings is two (2) inches. If this limit cannot be maintained with the current locations of the embeds, contact PPO for additional remedial recommendations.

Request:
 On the courtyard side of the Club, where the 45 degree angle is, the concrete slab form board was about 2 inches short right in the angle. Please provide a fix for the following:
 1. How can the steel beam be positioned to carry the exterior wall of the floors above?
 2. How can the slab be repaired so that we have the correct dimensions for the exterior wall of the clubhouse?
