RFI

To: Jordan & Skala Engineers, Inc. RFI #: 66  
 14240 Midway Road, Suite 350 Date: 2/24/2012  
 Dallas, TX 75244 Job: EB-02 Keller Springs Lofts  
 Ph: 469/985-1616 Fax: 469/985-1615 Phone: 877-777-5115

Subject: HVAC requirements for elevator shaft

Subject: Corridor duct issues

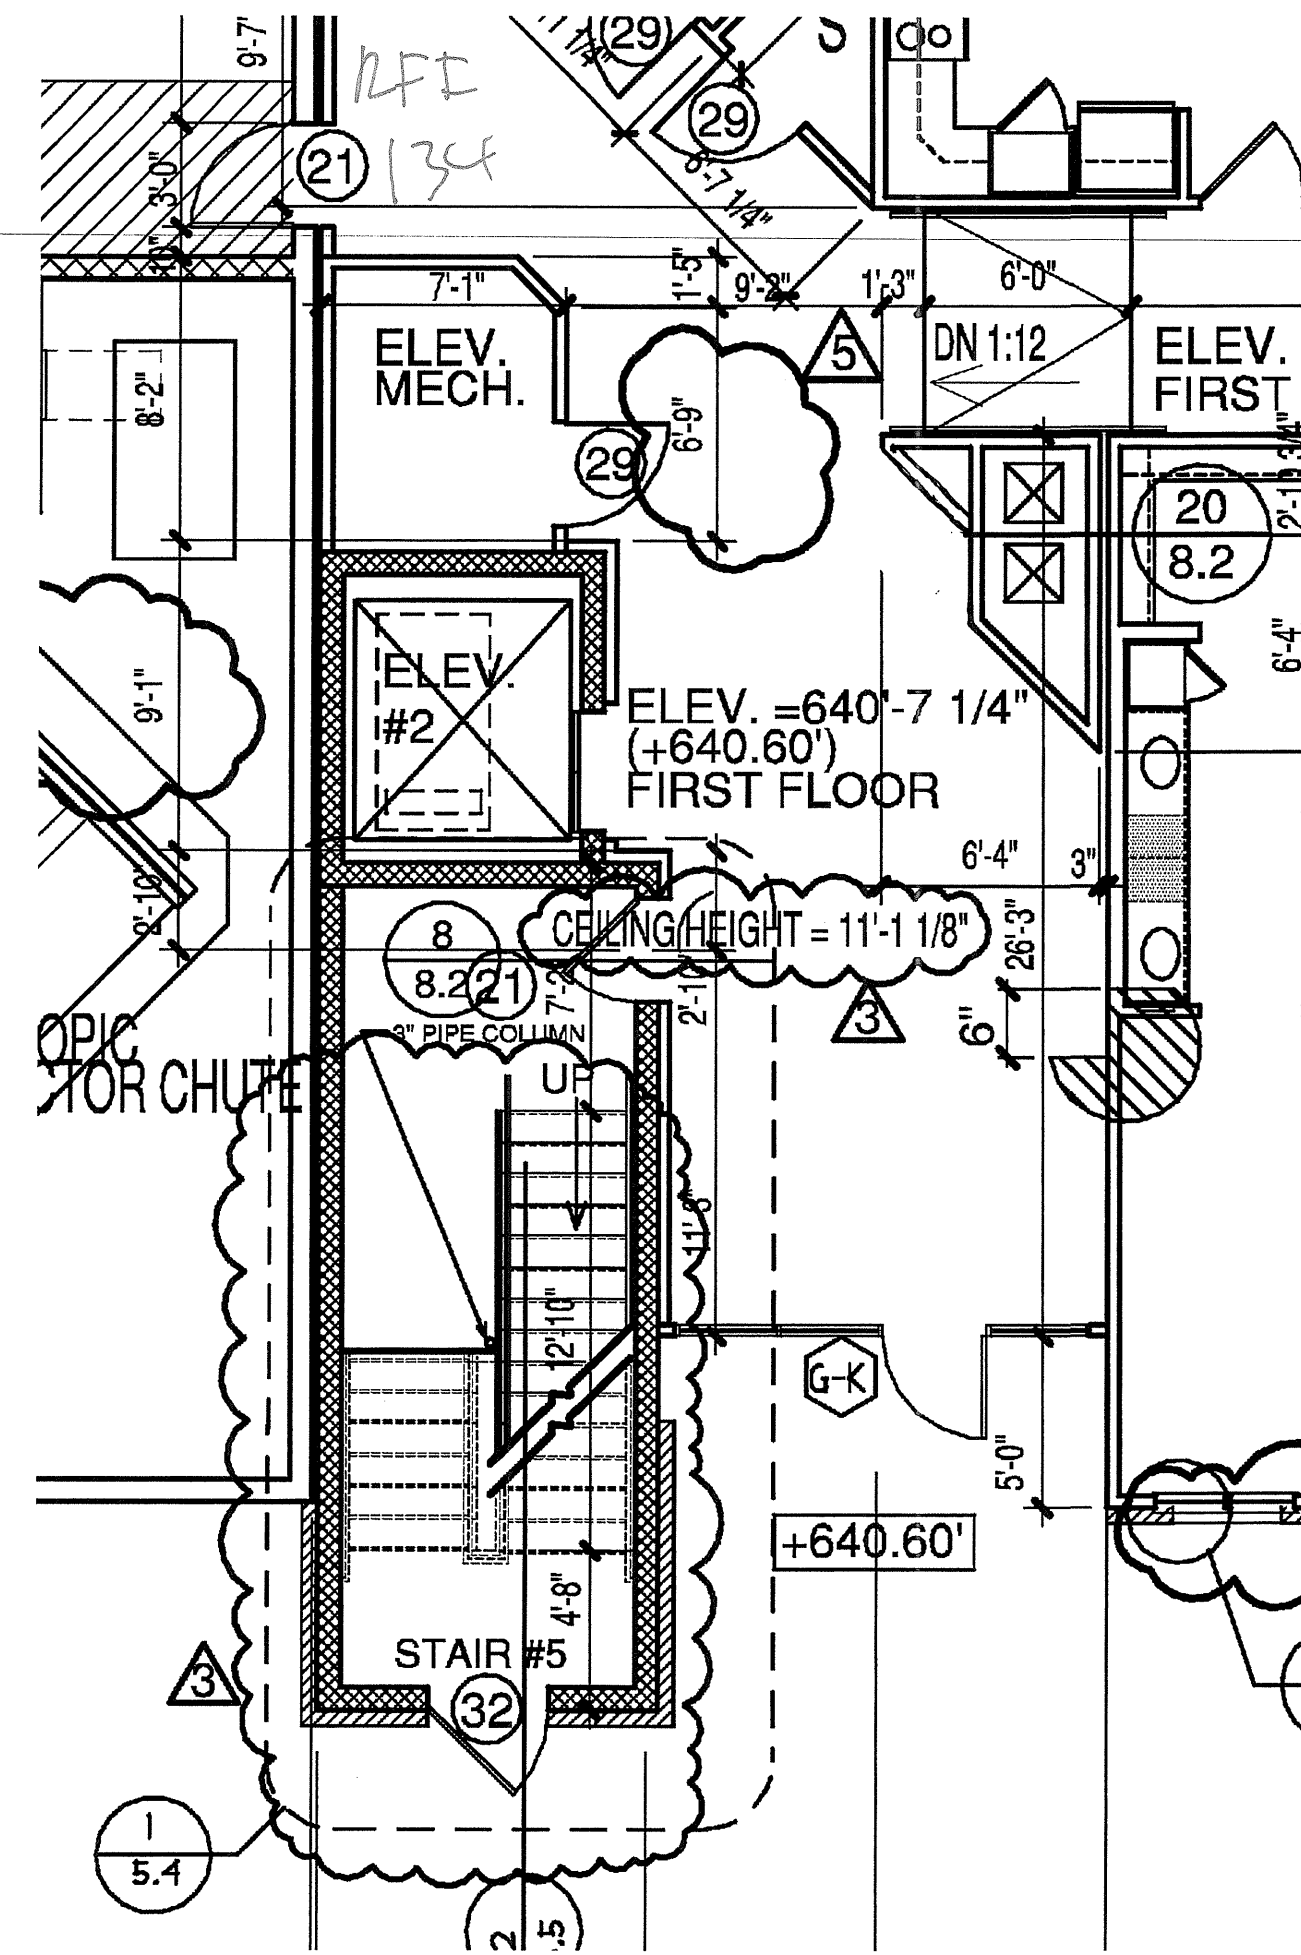
**Request:** Date Required: 6/7/2012  
 Due to the ramp at the mechanical shaft (near elevator #2), there is an added wall on the first floor that is not shown on the other floors. This additional wall will cause issues with the grill located in that area. Detail 7M4.2 shows the walls as they will be on floors 2, 3 and 4. Can the additional wall be modified to give the HVAC sub room for his grill? Please see attached sketch.  
**Requested by:** David Miller  
 Embrey Builders LLC

**Response:** This sketch looks to be what was proposed on RFI-128. GC to verify they are the same solution. I take no exception to this solution.  
 Ryan Faulds  
 BGO architects  
 June 28, 2012  
 Answered by: \_\_\_\_\_  
 Company: \_\_\_\_\_ Date: \_\_\_\_\_

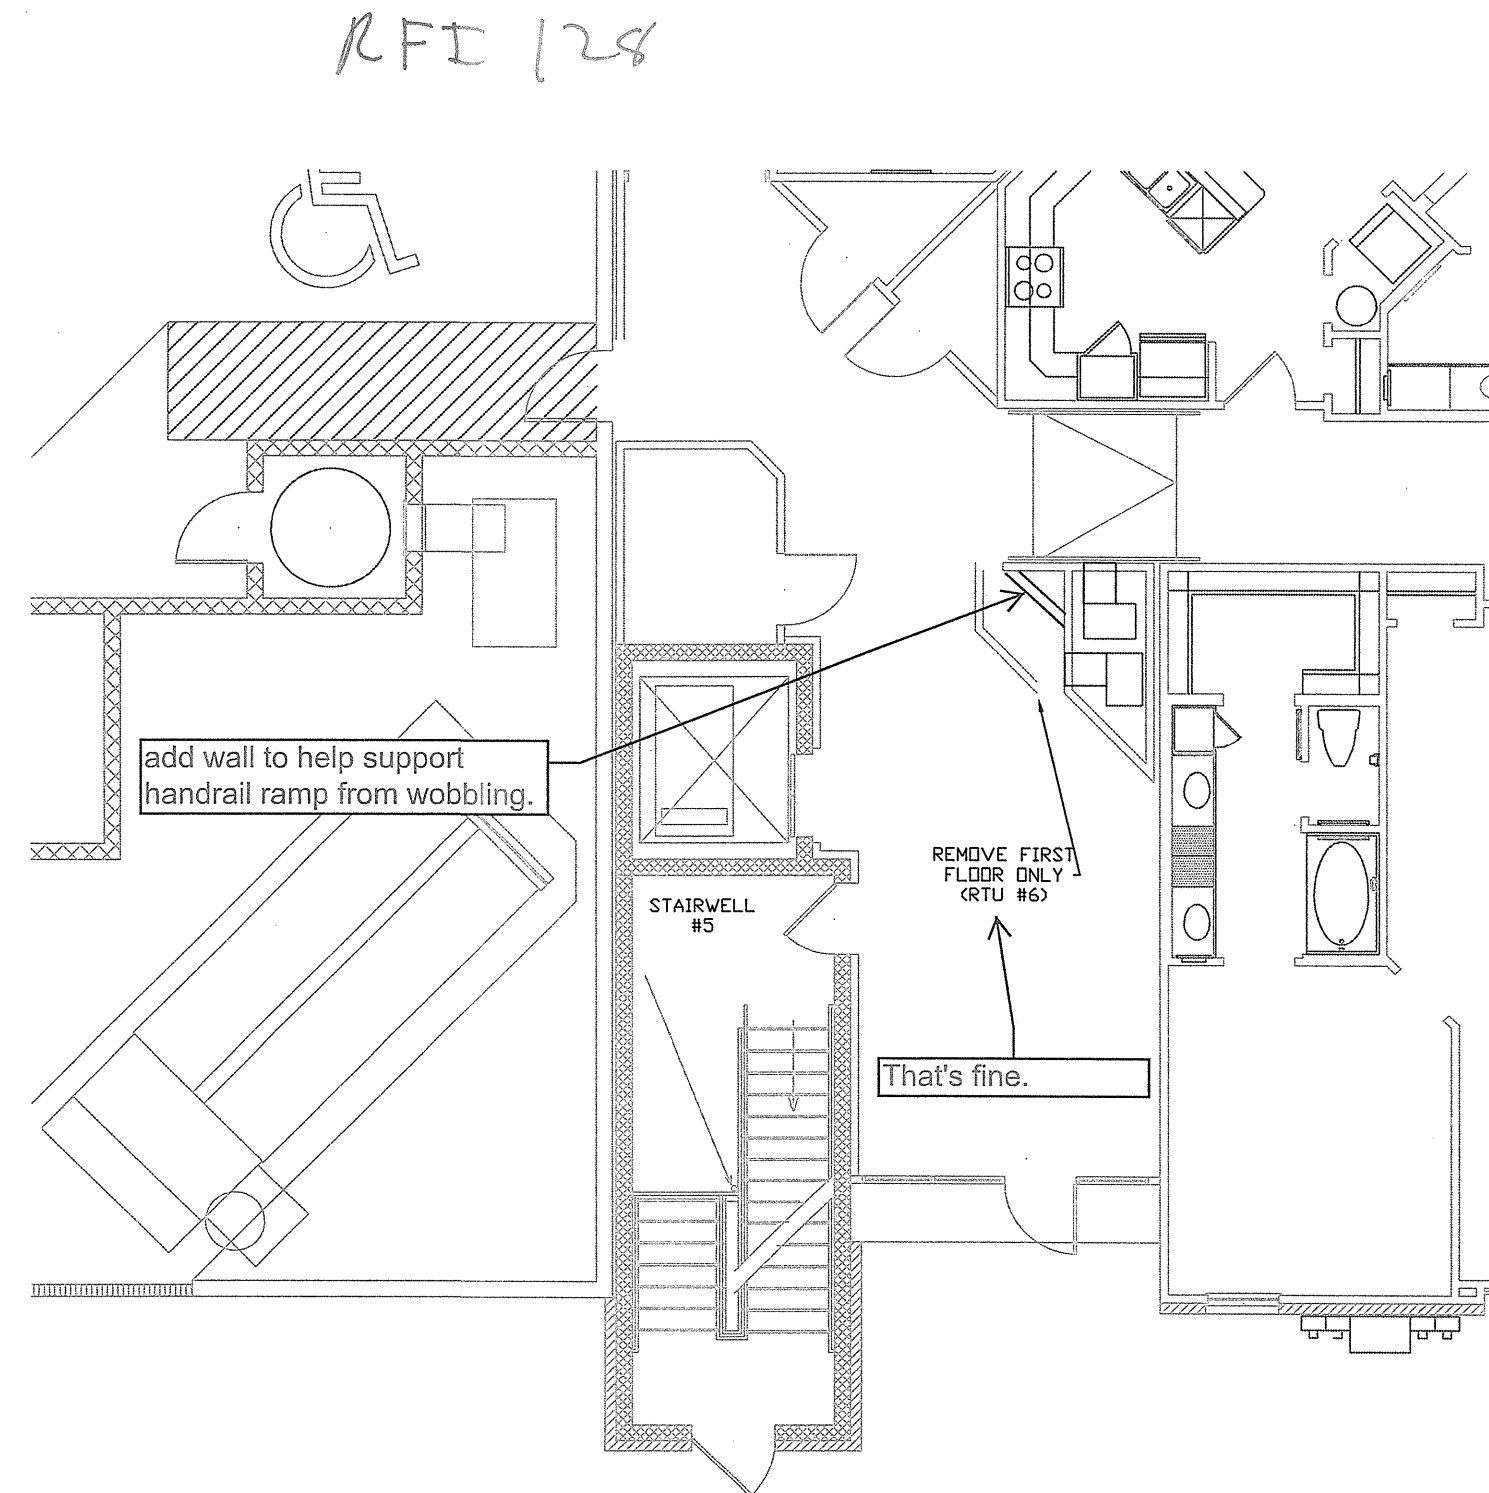
**Request:** Date Required: 6/5/2012  
 We are laying out the corridor duct that run through the shafts from the roof and have found some conditions that need addressing. The attached drawings and the following narrative should clarify these items:  
 1. The curved corridor wall at section C needs to be flat or have flat areas to mount the grilles.  
 2. The corridor wall at the shaft works well on floors 2-4 but changes on the first floor and creates a problem. Suggest using the upper floor configuration on the first floor.  
**Requested by:** Bryan Pickler  
 Embrey Partners, Ltd.

**Response:**  
 1- For air grills being installed in curved walls, I recommend popping the grill 2-3 inches off of the wall to allow for gypsum board to wrap around the grill where it protrudes from the wall.  
 2- The upper floors will not work due to the ramp and handrail. See next pages for possible solution.  
 Ryan Faulds  
 BGO architects  
 June 28, 2012  
 Answered by: \_\_\_\_\_  
 Company: \_\_\_\_\_ Date: \_\_\_\_\_
