Realignment Geotechnical Investigation - 1994

GEOTECHNICAL INVESTIGATION
ARAPAHO ROAD REALIGNMENT
DALLAS NORTH TOLLWAY TO ADDISON ROAD
ADDISON, TEXAS
TMI REPORT NO. DE94-040

September 29, 1994
Report No. DE94-040

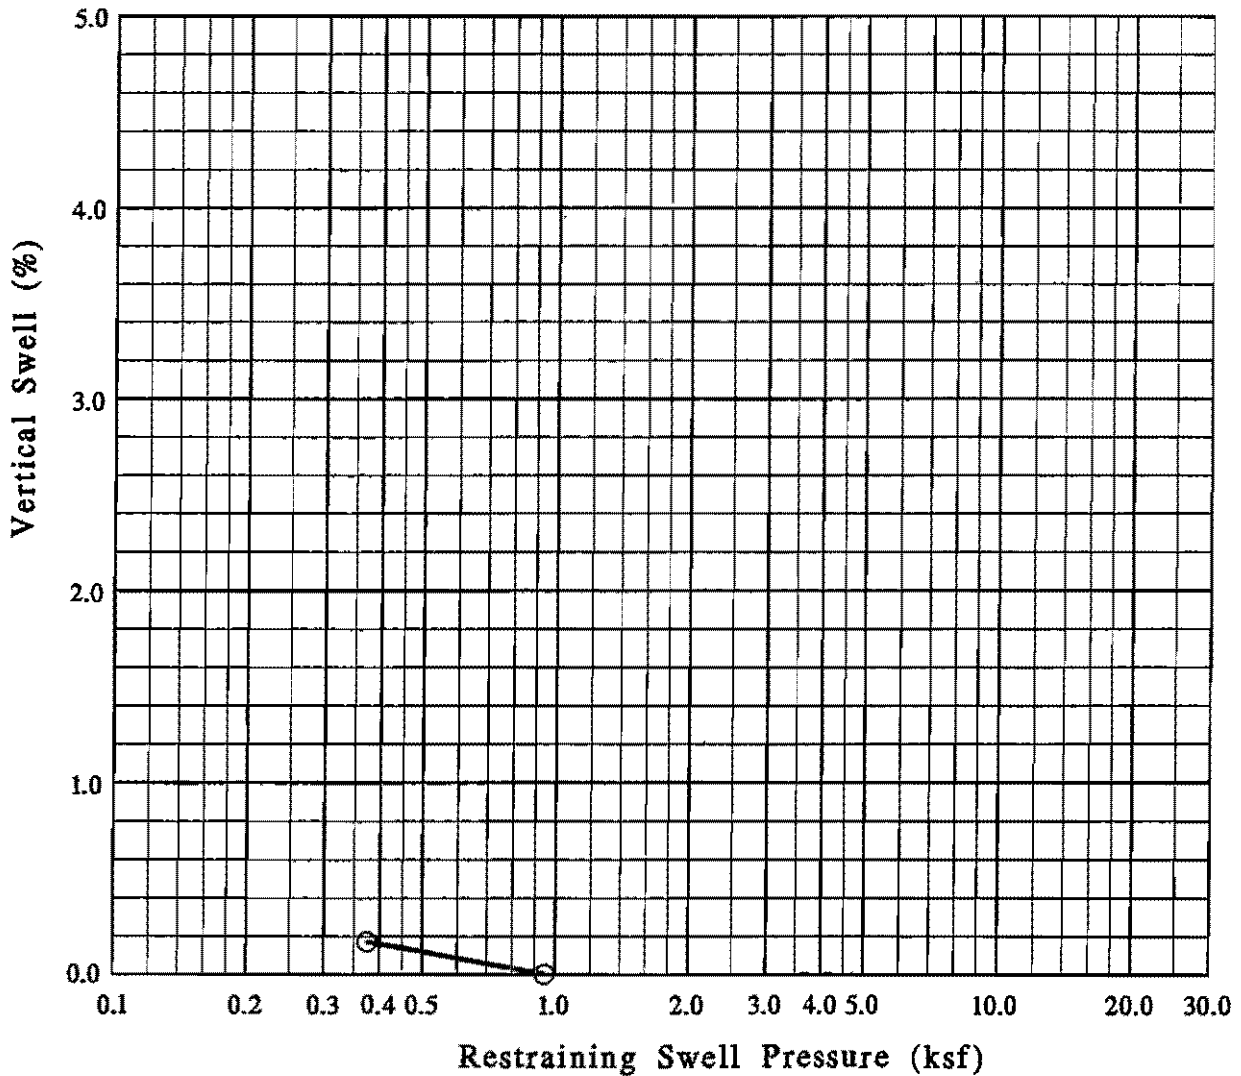
Absorption Pressure Swell Test

Boring No.	B-6
Depth (ft).	2-4
Soil Desc.	
Unit Dry Weight (pcf)	106.7
Initial Moisture Content (%).	18.9
Final Moisture Content (%)	20.7
Maximum Swell Pressure (ksf)	0.95
Vertical Swell (%).	0.17
Final Swell Pressure (Overburden)(ksf)	0.38
Liquid Limit (%).	36
Plasticity Index (PI).	17
Initial Penetrometer Reading (tsf)	4.5+
Final Penetrometer Reading (tsf)..	3.75

allowed to freely swell. These results are reported in the form of logarithmic pressure-swell graphs on Figures 16 through 21.

Sample borings were drilled along the new roadway alignment in both existing paved and unpaved areas to determine the differential PVR between the existing paved and unpaved areas. Based on the absorption pressure swell test results, shown on Figures 16 through 21, swell studies were performed to determine the magnitude of differential subgrade movement along the alignment. Our studies indicate that due to the anticipated shallow clay depths west of Quorum Drive, differential subgrade movements west of Quorum should be tolerable (less than one to two inches). However, deeper clay soils were encountered east of Quorum in the area of Borings B-11, B-12 and B-13. At the present time, the clay soils in the unpaved areas are moist and only slightly to moderately expansive. If construction begins prior to May, 1995, the subgrade moisture condition should not change significantly (and become drier) assuming normal winter and spring rainfall occurs. This could be confirmed by shallow soil borings at the time of construction. Under moist subgrade soil conditions, differential subgrade movements east of Quorum should also be tolerable (less than one to two inches). However, if construction occurs after a prolonged period of dry weather and the subgrade soils are dry and potentially expansive at the time of construction, differential subgrade movements east of Quorum could be excessive and on the order of four (4) to six (6) inches.

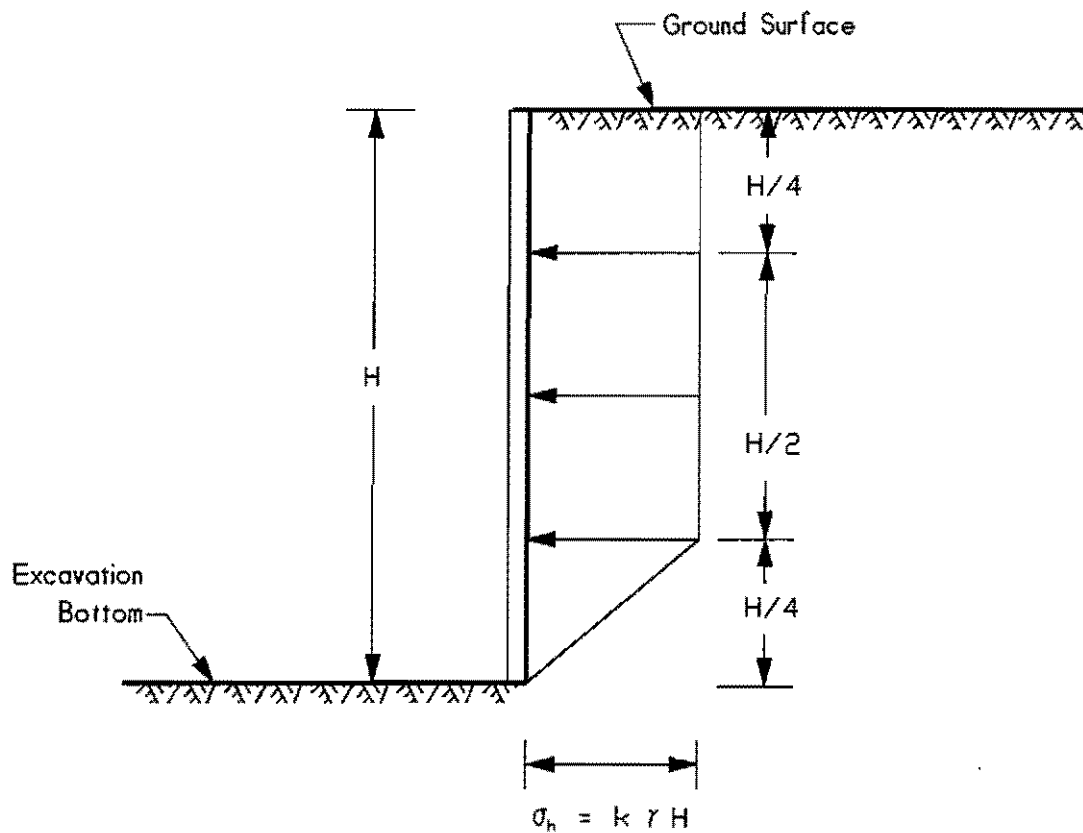
WHERE:

- σ_h = Lateral Earth Pressure, psf.
 γ = Saturated Unit Weight of Soil,
 Use 130 pcf for clay,
 Use 140 pcf for fractured
 or weathered rock.
 H = Height of Excavation (ft.)
 k = Earth Pressure Coefficient,
 Use 0.3 for clay,
 Use 0.2 for fractured
 or weathered rock.

Where site limitations require excavations to have vertical side walls, an internal bracing system will be necessary. Bracing may consist of timber or steel shoring or manufactured steel trench braces. The lateral pressure distribution to be used in the design of trench bracing may be determined as presented on Figures 24 and 25, depending on the type of soils penetrated. It should be noted that pressures are not included from surcharge loads or traffic live loads at trench sidewalls which, if present, must be included in bracing design. In lieu of a shoring system, a trench shield consisting of a prefabricated rigid steel unit, adequate to withstand anticipated lateral pressures, may be used.
