County: DALLAS
Bridge: 8042-18-003

Facility Over: HUTTON BRANCH
Feature Intersected: MIDWAY ROAD

Bridge Inspection Record

Description 3-BARREL RCB

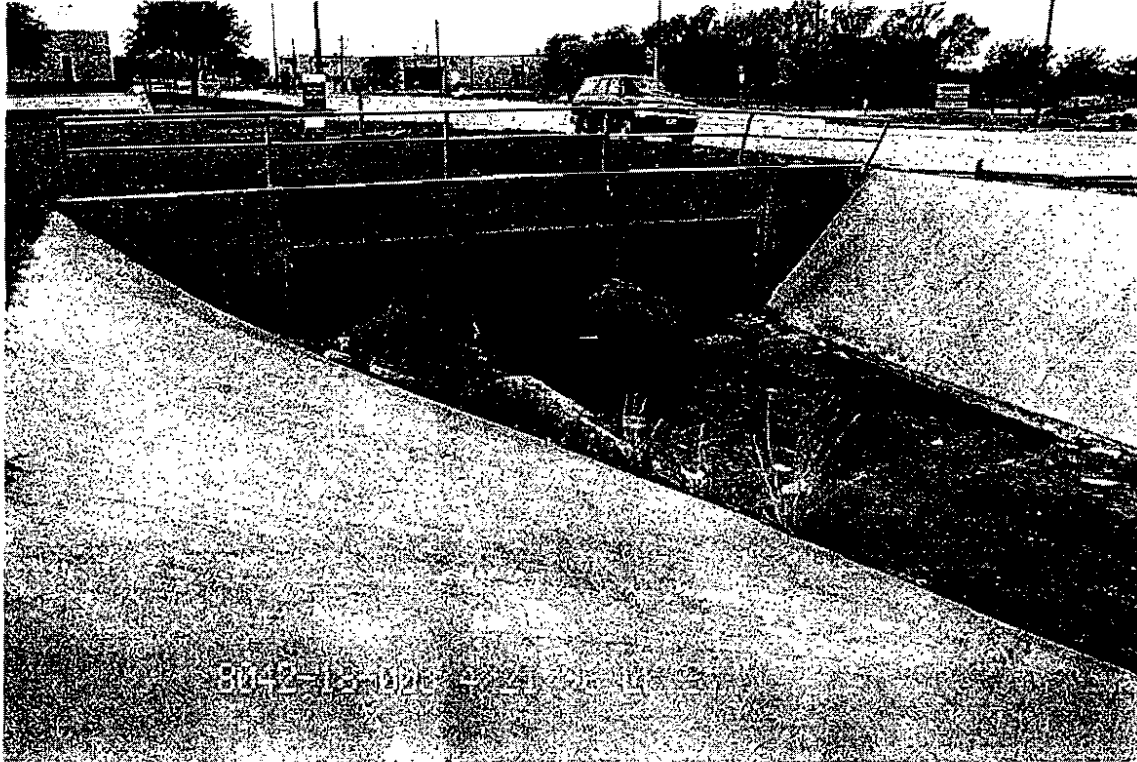
COUNTY : DALLAS FAU
BRIDGE NO.: 8042-18 003
LOCATION : MIDWAY ROAD OVER
HUTON BRANCH

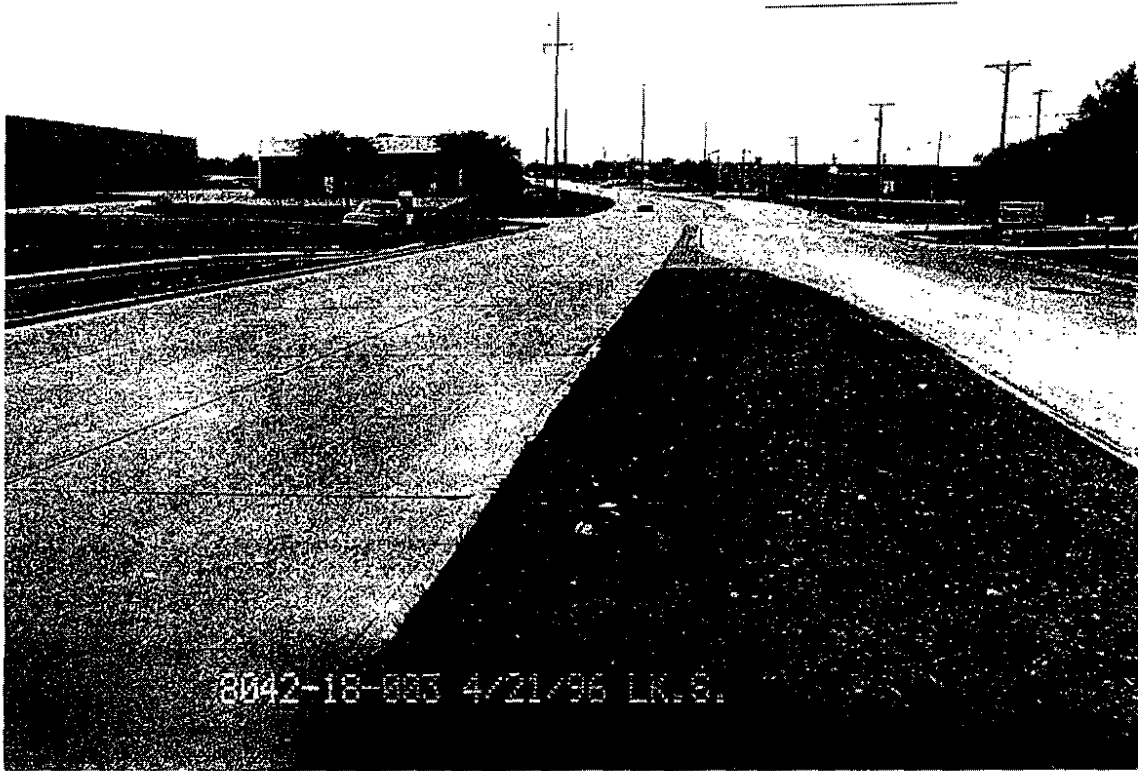
COUNTY : DALLAS FAU
BRIDGE NO.: 8042-18 003
LOCATION : MIDWAY ROAD OVER
HUTON BRANCH

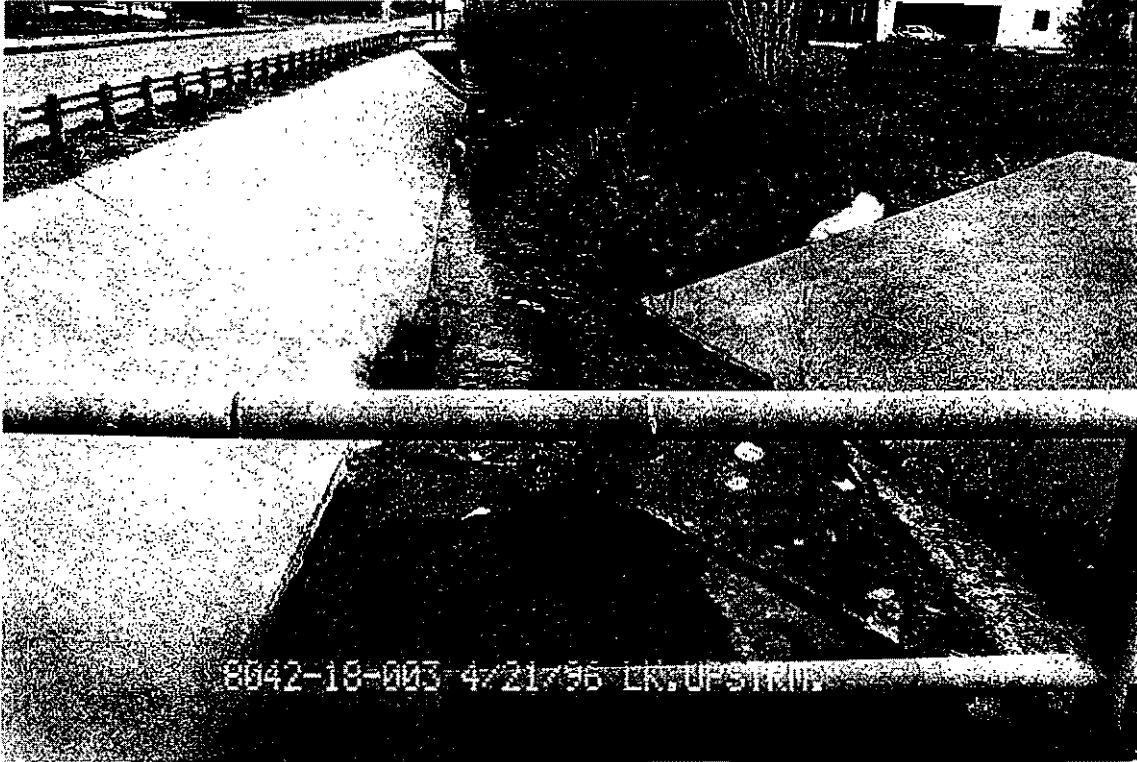
COUNTY : DALLAS FAU
BRIDGE NO.: 8042-18 003
LOCATION : MIDWAY ROAD OVER
HUTON BRANCH
