Bridge: 8050-026

Facility over: Belt Line Road

Feature Intersected: White Rock Creek

SUBJECT: DALLAS COUNTY FAU BRINSAP INSPECTION
BRIDGE NO. 8050-026, BELT LINE ROAD OVER
WHITE ROCK CREEK, CITY OF DALLAS

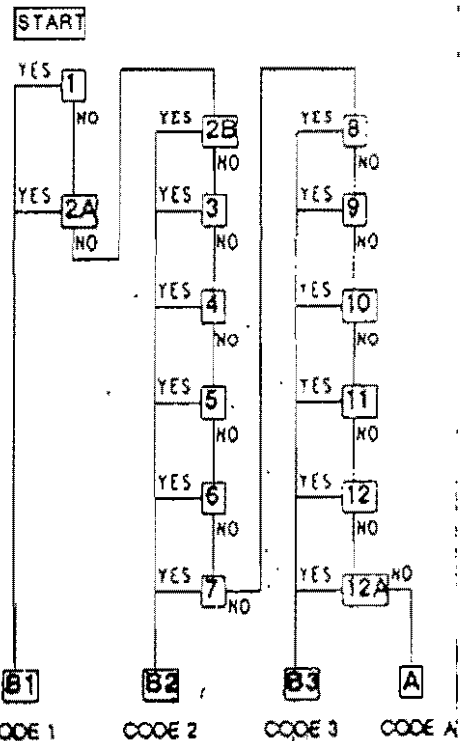
NUMBERS IN DECISION BOXES REFER TO YES/NO QUESTIONS ON THE SCOUR VULNERABILITY EXAMINATION

1 ANSWER ALL QUESTIONS BY CIRCLING YES OR NO
 2 THEN USE THE FLOW CHART TO RANK THE BRIDGE IN THE APPROPRIATE CATEGORY.
 3 CODE THE HIGHEST RANKING IN CARD 8 COLUMN 80 (BRINSAP CODING ITEM 113.1)
