PAVEMENT INVESTIGATION
MIDWAY ROAD
BELT LINE ROAD TO LINDBERGH DRIVE
ADDISON, TEXAS

**PAVEMENT INVESTIGATION
MIDWAY ROAD
BELT LINE ROAD TO LINDBERGH DRIVE
ADDISON, TEXAS**

Town of Addison, Texas

Shimek, Jacobs & Finklea, L.L.P.

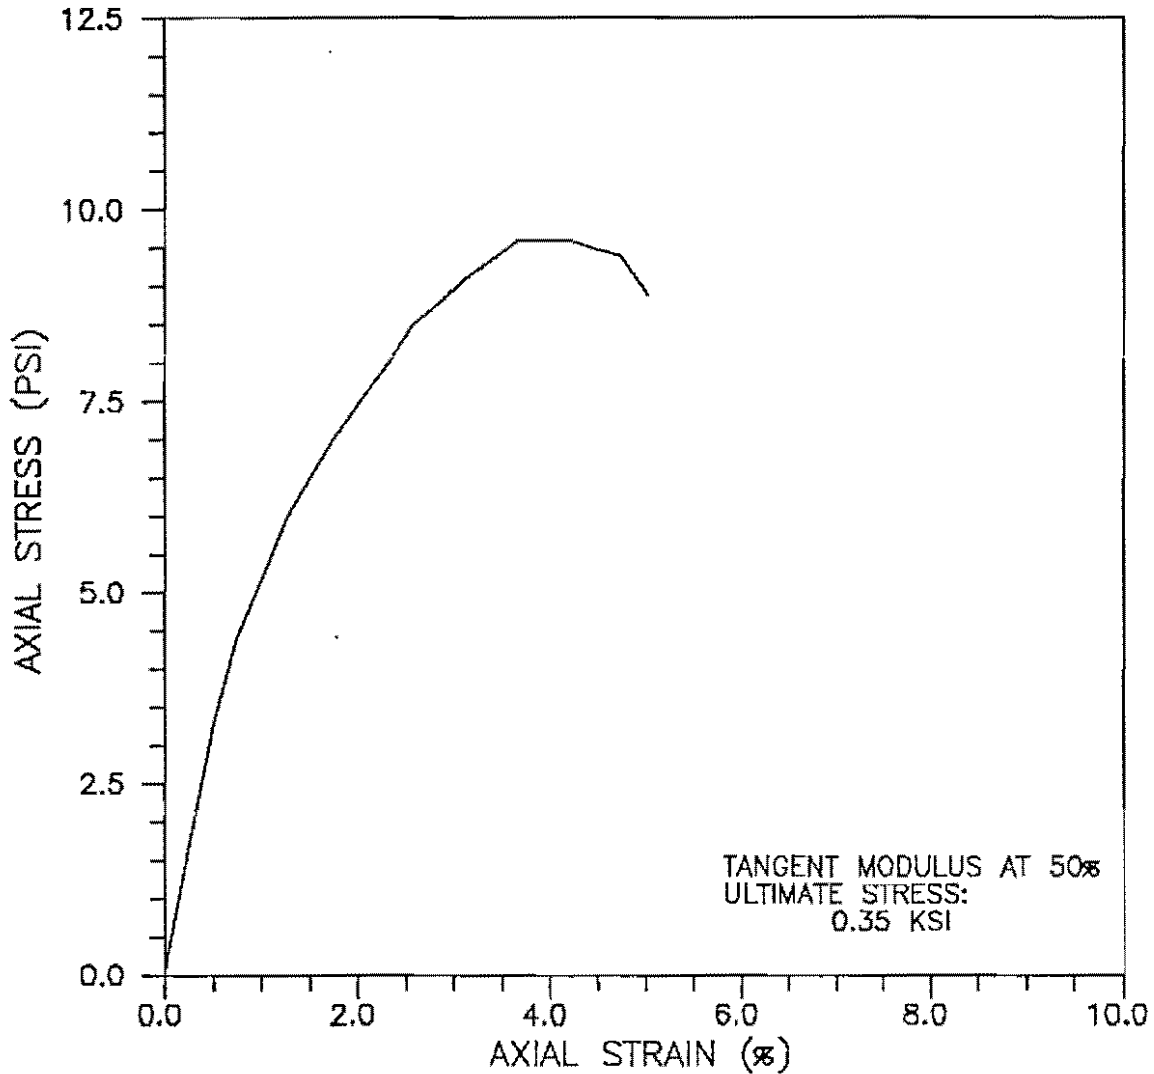
MIDWAY ROAD ADDISON, TEXAS	
UNCONFINED COMPRESSION TEST STRESS-STRAIN PLOT	
HENLEY-JOHNSTON & ASSOCIATES, INC. engineering geoscience consultants	
HJA NO.: 7025	PLATE 6
DATE TESTED: 05/26/99

BORING NO.: MW-2
 DEPTH (FT): 0.6-2.2
 CLAY, slightly silty,
 dark gray

TEST TYPE: UNCONFINED COMPRESSION TEST
 (ASTM D 2166)

MOISTURE CONTENT (%): 40.4
 DRY UNIT WEIGHT (PCF): 79.1

The strength of each cohesive sample was estimated using a hand penetrometer. The results of these estimates are tabulated on Plate 5. The strength properties of selected soil samples were investigated by Unconfined Compression tests. In this test, axial load is applied to a laterally unsupported cylindrical sample until failure occurs within the sample. This test is conducted fairly rapidly (failure within about 10 minutes) and generally conforms to ASTM D 2166. The Elastic Modulus values were interpreted from the stress-strain curves of the Unconfined Compression tests using a tangent modulus at 50 percent of peak strength. The soil strength test data are summarized on Plate 5. Stress-strain data for the Unconfined Compression tests are presented graphically on Plates 6 through 11.
