ADDISON RECREATION CENTER
3900 BELTWAY DRIVE
ADDISON, TEXAS

FOUNDATION and SLAB DETAILS SHEET 2

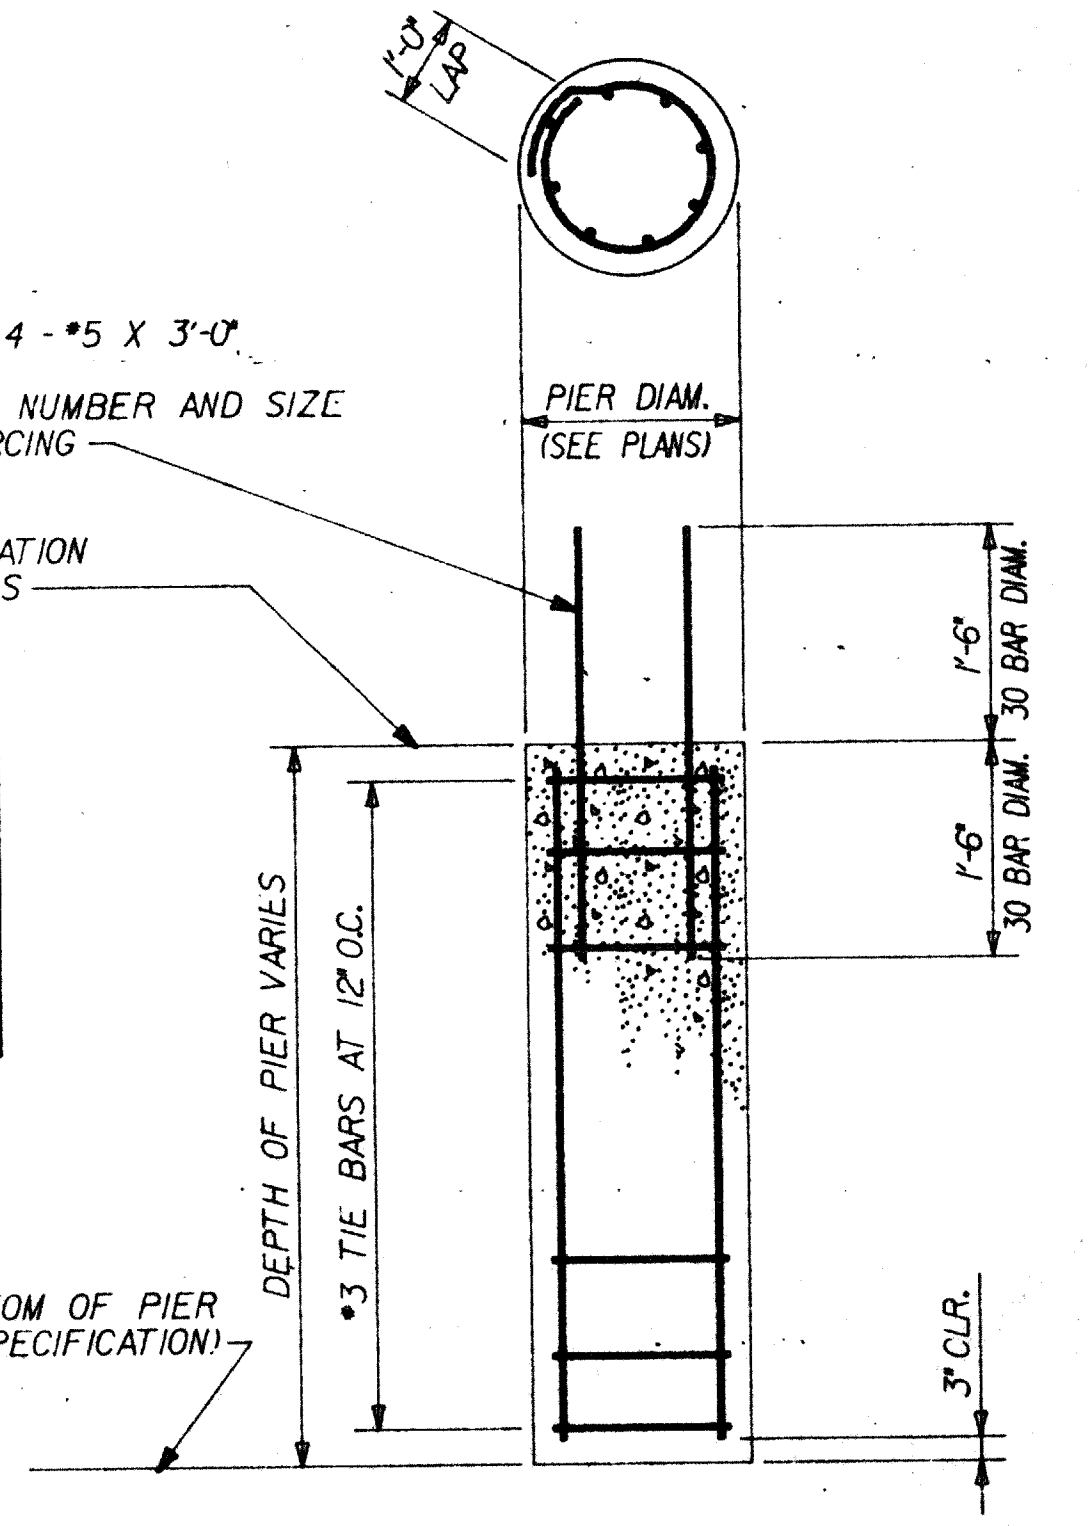
DRILLED PIER DETAIL
NO SCALE

DOWELS:
AT GRADE BEAMS - 4 - #5 X 3'-0"
AT COLUMNS - SAME NUMBER AND SIZE AS COLUMN REINFORCING

VERTICAL REINFORCING	
PIER DIAM.	REINF.
18"	5 - #5
24"	5 - #9
30"	7 - #9

APPROXIMATE BOTTOM OF PIER ELEVATION (SEE SPECIFICATION)
