**ADDISON AIRPORT
BUILDING REPORT**

Facility Information: **Facility Name:** 4540 Glenn Curtiss Drive
Facility Contact: Lisa Pyles **Contact Phone:** 972-450-2878

Accessology Inspector Information:
Inspector: Karen Jackson **Date:** April 17, 2017
Email: Kjackson@accessology.com

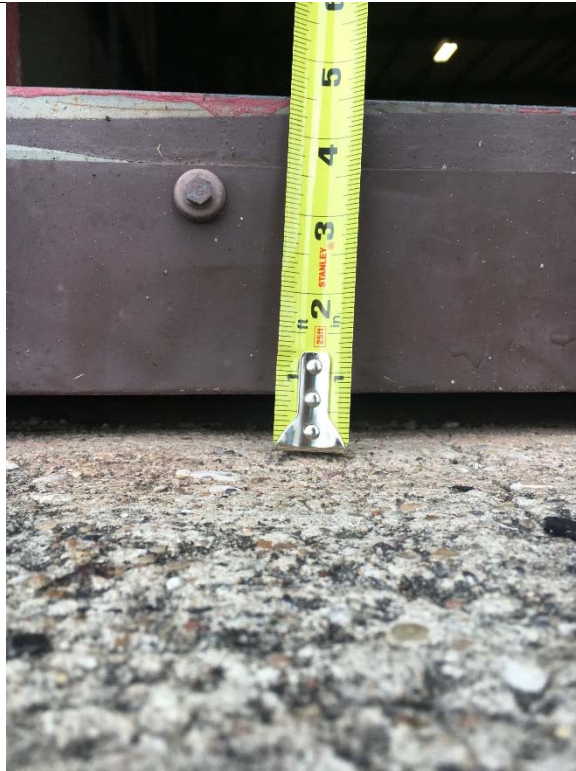
There is a 4-1/2" step at the entrance door.

2010 ADAAG 404.2.5 Thresholds.

Thresholds, if provided at doorways, shall be 1/2 inch high maximum. Raised thresholds and changes in level at doorways shall comply with 302 and 303.

Violation 1 - There is a 4-1/2" step at the entrance door.

Remove step and provide short ramp to entrance.

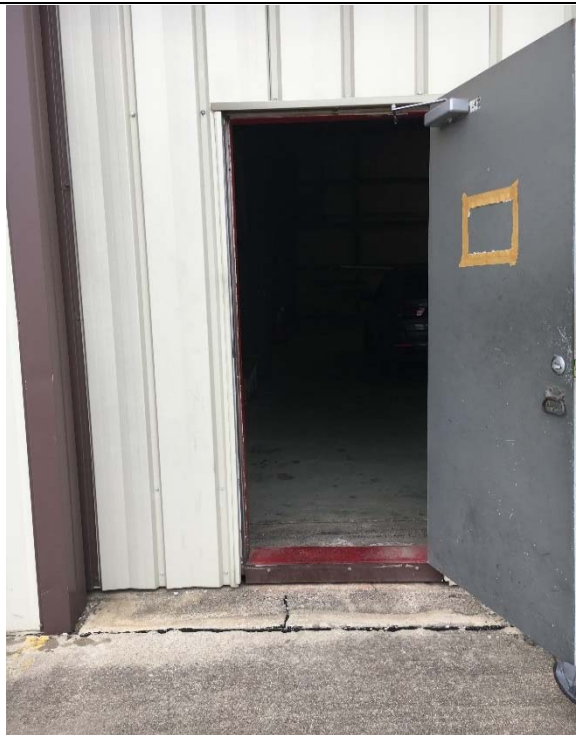
The door hardware/lock provided at the entrance requires grasping and twisting to operate.

2010 ADAAG 404.2.7 Door and Gate Hardware.

Handles, pulls, latches, locks, and other operable parts on doors and gates shall comply with 309.4.

Violation 2 - The door hardware/lock provided at the entrance requires grasping and twisting to operate.

Provide accessible door hardware.
