**ADDISON AIRPORT
BUILDING REPORT**

Facility Information: **Facility Name:** 4660 Jimmy Doolittle Drive
Facility Contact: Lisa Pyles **Contact Phone:** 972-450-2878

Accessology Inspector Information:
Inspector: Karen Jackson **Date:** April 17, 2017
Email: Kjackson@accessology.com

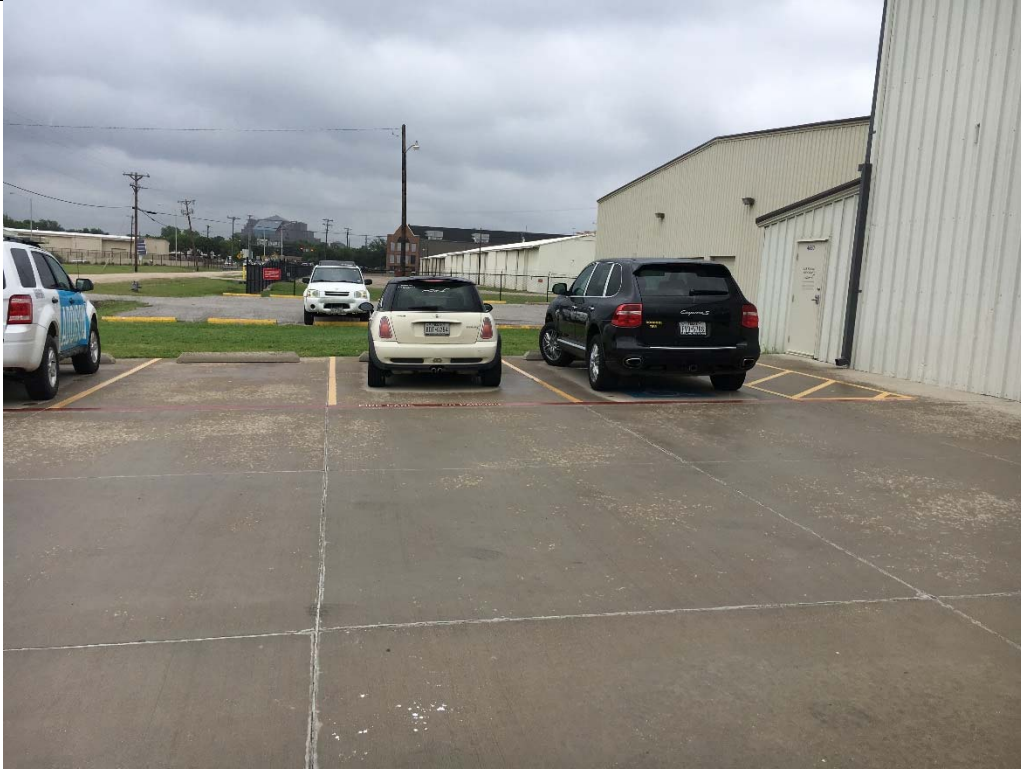
Violation #1: There is an accessible parking space, but no signage is provided.

Standard: **2010 ADAAG 502.6 Identification.**

Text: Signs identifying van parking spaces shall contain the designation "van accessible." Signs shall be 60 inches minimum above the finish floor or ground surface measured to the bottom of the sign.

Violation 1 - There is an accessible parking space, but no signage is provided.

Possible Solutions: Add a Van Accessible parking sign.

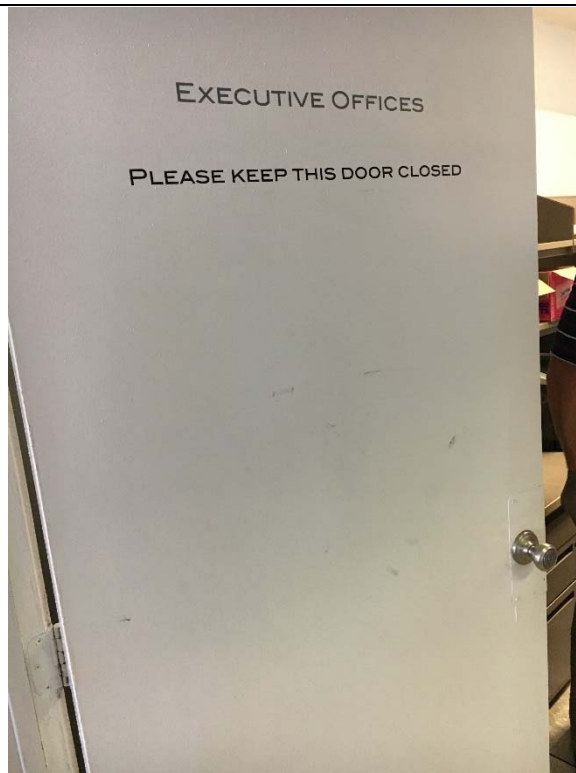
The door into the Executive Offices has knob style door hardware requiring grasping and twisting to operate.

Standard:**2010 ADAAG 404.2.7 Door and Gate Hardware.****Text:**

Handles, pulls, latches, locks, and other operable parts on doors and gates shall comply with 309.4.

Violation 2 - The door into the Executive Offices has knob style door hardware requiring grasping and twisting to operate.

Replace all knob hardware with lever hardware that doesn't require tight grasping or twisting to operate.

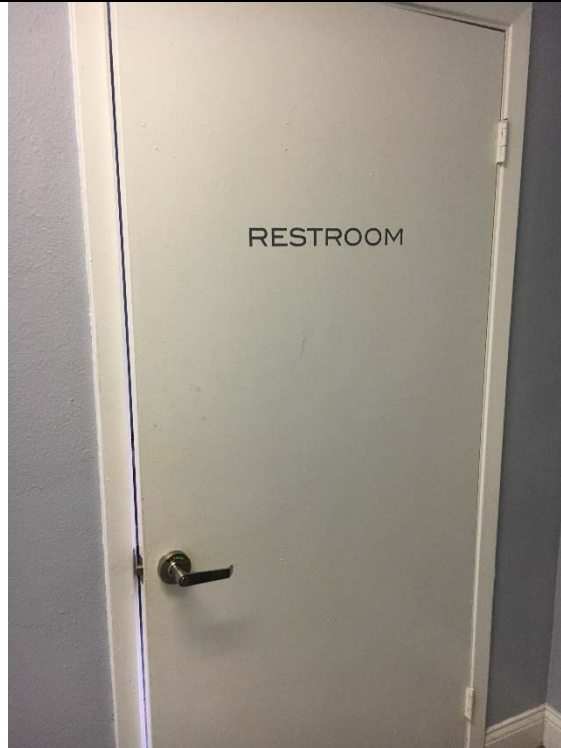
Violation #3: The restroom sign provided is mounted on the face of the door and the door swing outward. Additionally, the signage does not have Braille or tactile characters.

Standard: 2010 ADAAG 216.2 Designations.

Text: Interior and exterior signs identifying permanent rooms and spaces shall comply with 703.1, 703.2, and 703.5. Where pictograms are provided the pictograms shall comply with 703.6 and shall have text descriptors complying with 703.2 and 703.5.

Violation 3 - The restroom sign provided is mounted on the face of the door and the door swing outward. Additionally, the signage does not have Braille or tactile characters.

Possible Solutions: Provide new compliant signage amd install it on the latch side of the door.

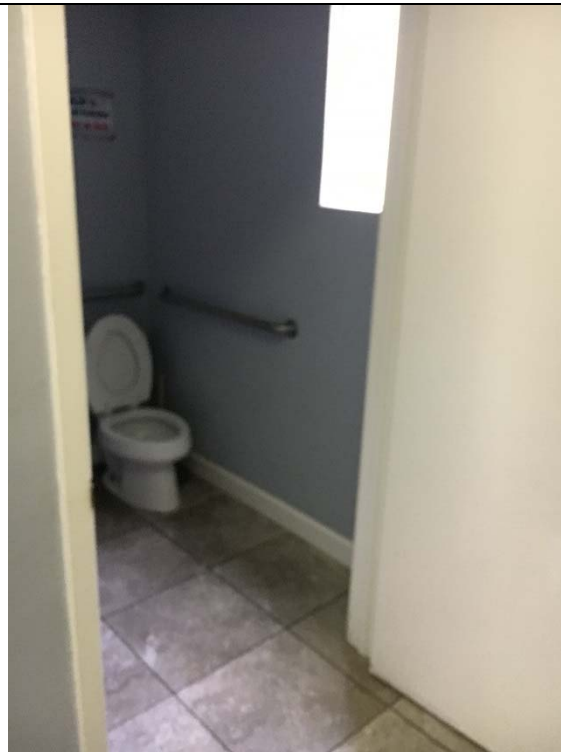
The restroom is not large enough to accommodate accessible fixtures and a wheelchair turning space.

2010 ADAAG 213.2 Toilet Rooms and Bathing Rooms.

Where toilet rooms are provided, each toilet room shall comply with 603. Where bathing rooms are provided, each bathing room shall comply with 603.

Violation 4 - The restroom is not large enough to accommodate accessible fixtures and a wheelchair turning space.

Enlarge restroom to accommodate accessible water closet, lavatory and wheelchair turning space.

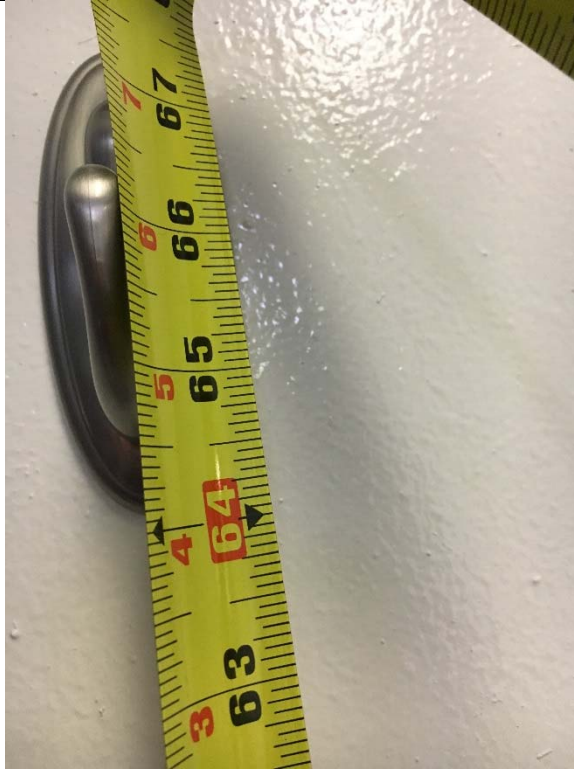
The coat hook is mounted at 66" where 48" is the maximum allowed.

2010 ADAAG 308.3.1 Unobstructed.

Where a clear floor or ground space allows a parallel approach to an element and the side reach is unobstructed, the high side reach shall be 48" max. and the low side reach shall be 15" min. above the finish floor.

Violation 5 - The coat hook is mounted at 66" where 48" is the maximum allowed.

Lower coat hook so its at 48" above finished floor.
