Summary Sheet for Cavanaugh Flight Museum - Hangar 2

Cavanaugh Flight Museum - Hangar 2

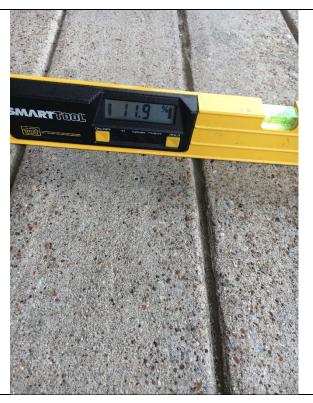
Violation 1 -The entrance into Hanger #2 has a 11.9% slope at the door.

ADDISON AIRPORT BUILDING REPORT			
Facility Information:		Facility Name: Cavanaugh Fli	ght Museum - Hangar 2
Facility Contact: L	isa Pyles	Contact Phone: 972-450-2878	
Accessology Inspector In	formation:		
Inspector: K Email: K	aren Jackson jackson@accessology.com	Da	ate: April 17, 2017
Latitude: 32	2.972295	Longitude: -96.834397	
Address: 4	572 Clair Chenault Street	City: Addison	County: Dallas
General Entrance Notes:	:		
Т	he entrance into the facility ha	as non-compliant slopes.	
of the nearest accessible Violation #1: T Standard:	r that is accessible? le door have signage indicati door? the entrance into Hanger #2 ha 2010 ADAAG 404.2.4.4	as a 11.9% slope at the door. 4 Floor or Ground Surface. within required maneuvering cleara	
comply with 302. Changes in level are not permitted. EXCEPTIONS: Slopes not steeper than 1:48 shall be permitted. Remove and replace pavement in front of the door to achieve a 2% slope in all directions.

#	VIOLATION SUMMARY	PRIORITY LEVEL	COST
1	Remove and replace pavement in front of the door to achieve a 2% slope in all directions.	Level 3	\$2,625.00
2	Replace hardware with lever hardware.	Level 2	\$525.00

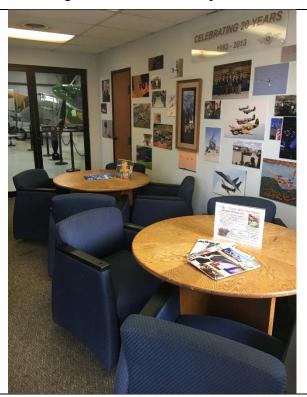
Violation 2 - There is a storage room in the office portion of the facility that has knob hardware.
