**TOWN OF ADDISON
Spruill Park**

Facility Information: **Facility Name:** Spruill Park
Facility Contact: Lisa Pyles **Contact Phone:** 972-450-2878

Accessology Inspector Information:
Inspector: Karen Jackson **Date:** April 4, 2017
Email: kjackson@accessology.com

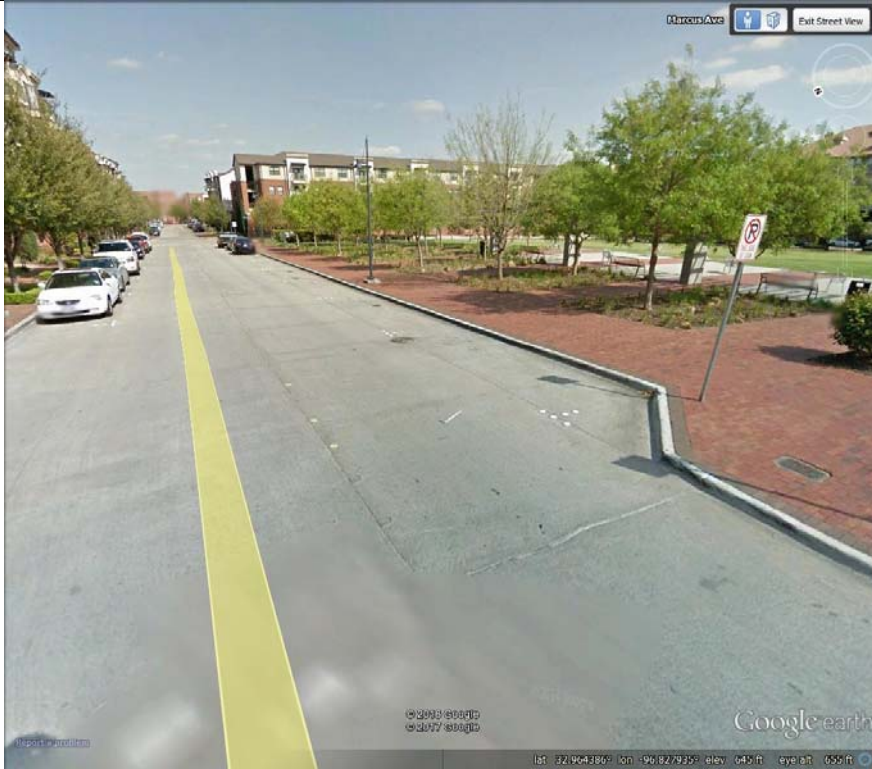
Violation #1: There are no marked accessible parking spaces or access aisles serving the park.

Violation 1 - There are no marked accessible parking spaces or access aisles serving the park.

Add one van accessible parking space with an access aisle and compliant signage. Ensure it is located where an accessible route is provided to the park.

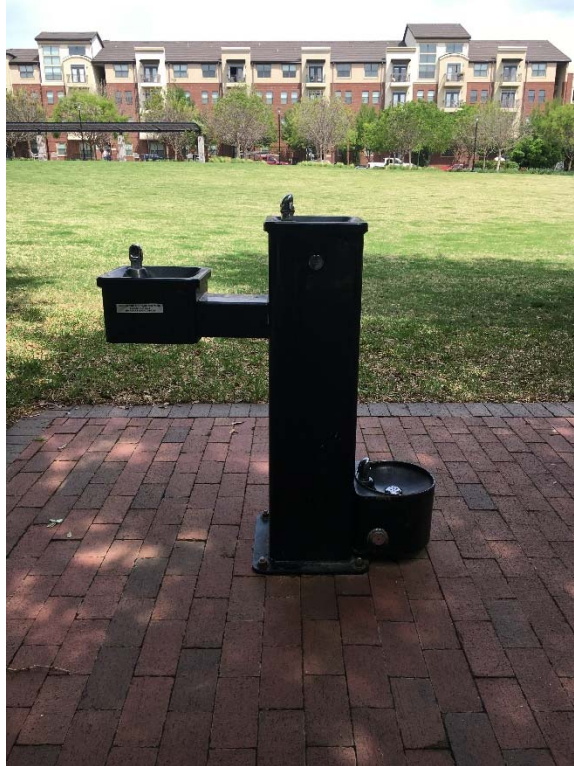
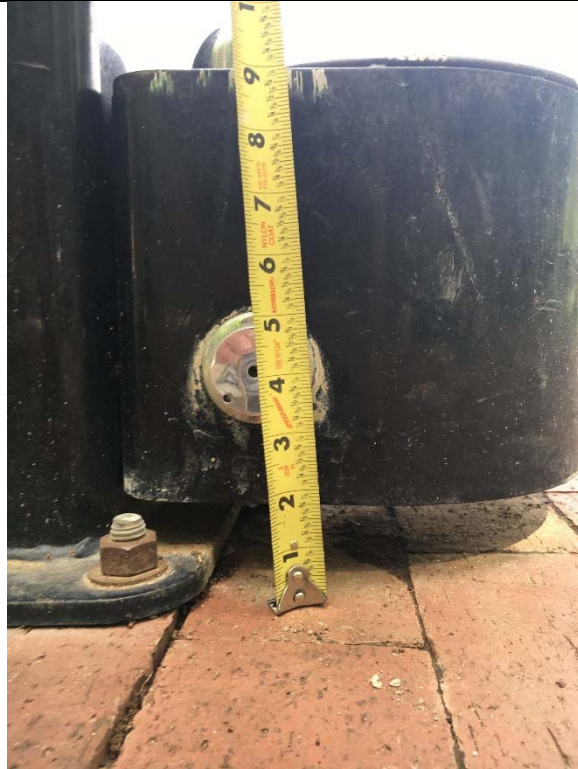
The operating mechanism for the dog bowl fountain is mounted too low at 4" high.

Violation 2 - The operating mechanism for the dog bowl provided on the drinking fountain is mounted too low at 4" above finished floor.

Relocate or add an additional operator for the dog bowl at a minimum of 15" high.
