Client: Town of Addison Date: 1/2/18
 Program: ADA Self-Evaluation and Transition Plan Prepared By: CMP
 KHA No.: 063543021 Checked By: EPE

Corridor : Airport Pkwy GPS ID: 124
 Project Name: Intersection of Airport Pkwy and driveway (Lat. 32.9660; Long. -96.8278)
 Town: Addison

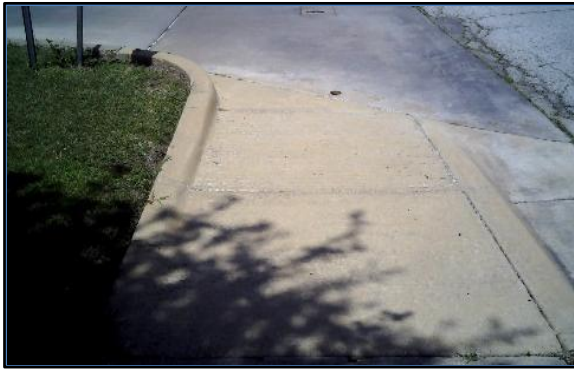
Ramp 3A

Curb Ramp Issues	Curb Ramp ID ('2' or '1' in ramp label indicates no existing ramp)		Possible Solutions
	3A	4A	
Curb ramp does not exist and is needed			Remove and replace curb ramp
Curb ramp does not land in crosswalk			
No 4' x 4' clear space at base of curb ramp			
Curbed side is not 90° or has traversable adjacent surface			
Flare cross slope is greater than 10%			
Curb ramp running slope is greater than 8.3%			
Blended transition running slope is greater than 5%			
Cut-thru ramp running slope is greater than 5%			
Curb ramp cross slope is greater than 2%	X	X	
Cut-thru ramp cross slope is greater than 2%			
Curb ramp width is less than 48"			For intersection, commercial driveway, and park ramps, install color truncated domes
Cut-thru ramp width is less than 60"			
Permanent obstruction (>0.25") in curb ramp/landing/flares			
Temporary obstruction (>0.25") in curb ramp/landing/flares			
No textured surface at base of curb ramp	X	X

No color contrast at base of curb ramp	X	X	
Landing area does not exist and is needed			
Landing area is less than 5' x 5' or slopes greater than 2%	X	X	
Curb ramp transition onto roadway is greater than 0.25'			
Counter slope of the gutter or street at the foot of the curb ramp is greater than 5%			
Ponding occurs at base of curb ramp			Remove and replace landing area

Item No.	Item Description	Quantity	Unit	Unit Price	Item Cost
TxDOT 110-6001	EXCAVATION (ROADWAY)	0	CY	\$ 10.00	\$ -
TxDOT 529-6002	CONC CURB (TY II)	0	LF	\$ 15.00	\$ -
TxDOT 531-6001	CONC SIDEWALKS (4")	0	SY	\$ 45.00	\$ -
TxDOT 531	CURB RAMPS	2	EA	\$ 1,500.00	\$ 3,000.00
TxDOT 5003-6002	RETROFIT DET WARN SURF (CAST IN PLACE)	0	SF	\$ 50.00	\$ -
TxDOT 104-6015	REMOVING CONC (SIDEWALKS)	21	SY	\$ 9.00	\$ 189.00
TxDOT 677	ELIM EXT PAVE MRK & MRKS	0	LF	\$ 2.80	\$ -
TxDOT 666/678	REFL PAV MRK PREP TY I & TY II (W) 24" (SLD)	0	LF	\$ 8.50	\$ -
---	REPAVE ROADWAY	0	LS	\$ 5,000.00	\$ -
---	FIX PONDING	0	LS	\$ 2,000.00	\$ -
---	FIX CURB RAMP TRANSITION	0	LS	\$ 2,000.00	\$ -
---	MEDIAN NOSE MODIFICATION	0	LS	\$ 5,000.00	\$ -
---	REMOVE TEMPORARY OBSTRUCTION	0	LS	\$ 500.00	\$ -
---	FIX CURB RAMP COUNTER SLOPE	0	LS	\$ 2,000.00	\$ -
