Project Location

Field Observations

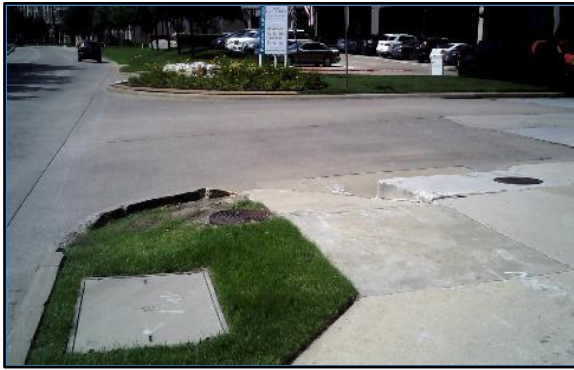
Ramp 1A

Curb Ramp Issues	Curb Ramp ID ('z' or 'l' in ramp label indicates no existing ramp)				Possible Solutions
	1A	2z	3z	4z	
Curb ramp does not exist and is needed				X	Install curb ramp; if median improvement, see shapefile
Curb ramp does not land in crosswalk					
No 4' x 4' clear space at base of curb ramp					Remove and replace curb ramp
Curbed side is not 90° or has traversable adjacent surface					
Flare cross slope is greater than 10%					
Curb ramp running slope is greater than 8.3%	X				
Blended transition running slope is greater than 5%					
Cut-thru ramp running slope is greater than 5%					
Curb ramp cross slope is greater than 2%					
Cut-thru ramp cross slope is greater than 2%					
Curb ramp width is less than 48"					
Cut-thru ramp width is less than 60"					
Permanent obstruction (>0.25") in curb ramp/landing/flares	X				For intersection, commercial driveway, and park ramps, install color truncated domes

Temporary obstruction (>0.25") in curb ramp/landing/flares					
No textured surface at base of curb ramp	X				Remove and replace landing area
No color contrast at base of curb ramp	X				
Landing area does not exist and is needed					Fix curb ramp transition
Landing area is less than 5' x 5' or slopes greater than 2%	X				
Curb ramp transition onto roadway is greater than 0.25'	X				
Counter slope of the gutter or street at the foot of the curb ramp is greater than 5%					
Ponding occurs at base of curb ramp
