Client: Town of Addison Date: 1/2/18  
 Program: ADA Self-Evaluation and Transition Plan Prepared By: CMP  
 KHA No.: 063543021 Checked By: EPE

Corridor : Addison Cir GPS ID: 135  
 Project Name: Intersection of Addison Rd and Addison Cir  
 Town: Addison

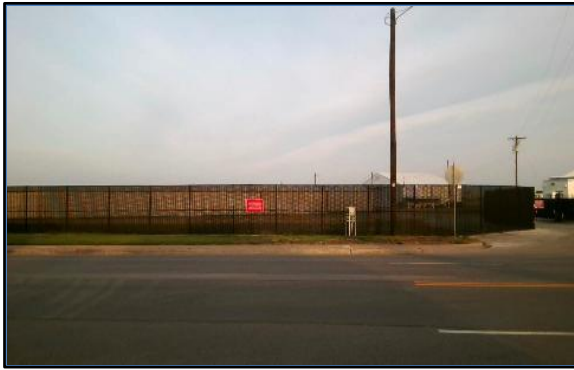
Corner 1 No Ramp (1z)

| Curb Ramp Issues | Curb Ramp ID ('z' or 'l' in ramp label indicates no existing ramp) | | | | Possible Solutions |
|---|--|---|---|---|--|
| Curb ramp does not exist and is needed | | | | X | Install curb ramp; if median improvement, see shapefile |

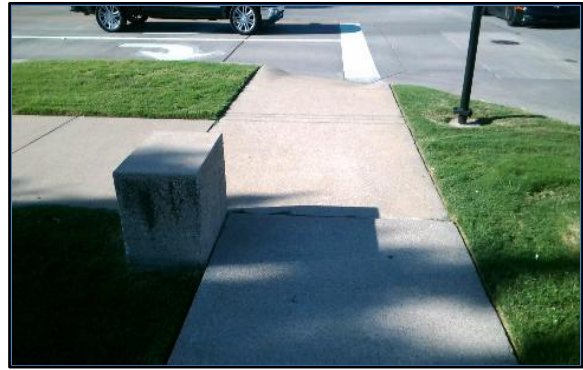
Ramp 2A

| Curb Ramp Issues | Curb Ramp ID ('z' or 'l' in ramp label indicates no existing ramp) | | | | Possible Solutions |
|---|--|---|---|---|--|
| Flare cross slope is greater than 10% | | X | | | |
| Curb ramp running slope is greater than 8.3% | | X | | | |
| Curb ramp cross slope is greater than 2% | | X | | | |
| No textured surface at base of curb ramp | | X | X | | Remove and replace landing area |
| No color contrast at base of curb ramp | | X | | | |
| Curb ramp transition onto roadway is greater than 0.25' | | X | | | |

| Item No. | Item Description | Quantity | Unit | Unit Price | Item Cost |
|---|--|---|---|---|---|
| --- | FIX CURB RAMP TRANSITION | 1 | LS | \$ 2,000.00 | \$ 2,000.00 |

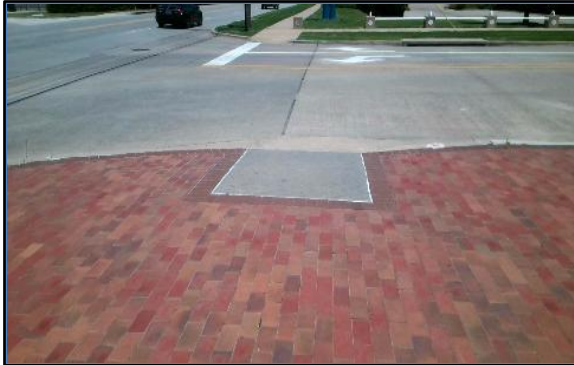
Ramp 3A

| Curb Ramp Issues | Curb Ramp ID ('z' or 'l' in ramp label indicates no existing ramp) | | | | Possible Solutions |
|---|--|---|---|---|--|
| Permanent obstruction (>0.25") in curb ramp/landing/flares | | | X | | For intersection, commercial driveway, and park ramps, install color truncated domes |
| Landing area is less than 5' x 5' or slopes greater than 2% | | | X | | |
