Client: Town of Addison Date: 1/2/18
 Program: ADA Self-Evaluation and Transition Plan Prepared By: CMP
 KHA No.: 063543021 Checked By: EPE

Corridor : Addison Rd GPS ID: 165
 Project Name: Intersection of Addison Rd and driveway (Lat. 32.9549; Long. -96.8298)
 Town: Addison

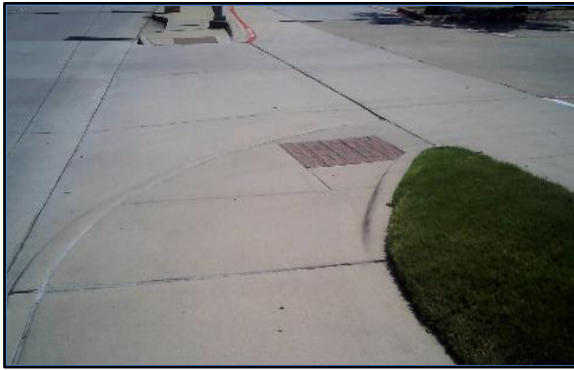
Ramp 1A

Landing area does not exist and is needed			
Landing area is less than 5' x 5' or slopes greater than 2%	X	X	
Curb ramp transition onto roadway is greater than 0.25'			
Counter slope of the gutter or street at the foot of the curb ramp is greater than 5%			
Ponding occurs at base of curb ramp
