Client: Town of Addison Date: 1/2/18
 Program: ADA Self-Evaluation and Transition Plan Prepared By: CMP
 KHA No.: 063543021 Checked By: EPE

Corridor: Belt Line Rd GPS ID: 172
 Project Name: Intersection of Belt Line Rd and driveway (Lat. 32.9543; Long. -96.8380)
 Town: Addison

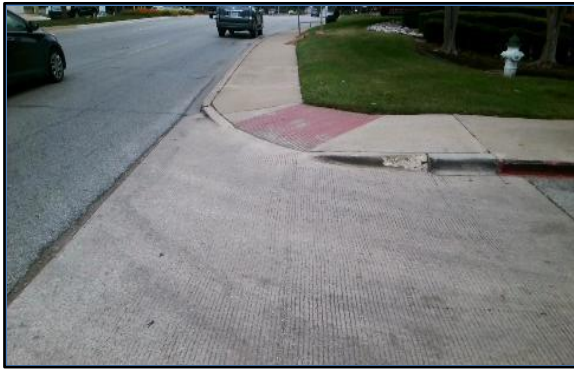
Ramp 3A

Curb Ramp Issues	Curb Ramp ID ('z' or 'l' in ramp label indicates no existing ramp)		Possible Solutions
	3A	4A	
Curb ramp does not exist and is needed			Remove and replace curb ramp
Curb ramp does not land in crosswalk			
No 4' x 4' clear space at base of curb ramp			
Curbed side is not 90° or has traversable adjacent surface			
Flare cross slope is greater than 10%	X	X	
Curb ramp running slope is greater than 8.3%	X		
Blended transition running slope is greater than 5%			
Cut-thru ramp running slope is greater than 5%			
Curb ramp cross slope is greater than 2%		X	
Cut-thru ramp cross slope is greater than 2%			
Curb ramp width is less than 48"			For intersection, commercial driveway, and park ramps, install color truncated domes
Cut-thru ramp width is less than 60"			
Permanent obstruction (>0.25") in curb ramp/landing/flares			
Temporary obstruction (>0.25") in curb ramp/landing/flares			
No textured surface at base of curb ramp	X	X

No color contrast at base of curb ramp		X	
Landing area does not exist and is needed			
Landing area is less than 5' x 5' or slopes greater than 2%	X	X	
Curb ramp transition onto roadway is greater than 0.25"	X	X	
Counter slope of the gutter or street at the foot of the curb ramp is greater than 5%			
Ponding occurs at base of curb ramp
