Client: Town of Addison Date: 1/2/18
 Program: ADA Self-Evaluation and Transition Plan Prepared By: CMP
 KHA No.: 063543021 Checked By: EPE

Corridor : Beltway Dr GPS ID: 241
 Project Name: Intersection of Beltway Dr and driveway (Lat. 32.9517; Long. -96.8409)
 Town: Addison

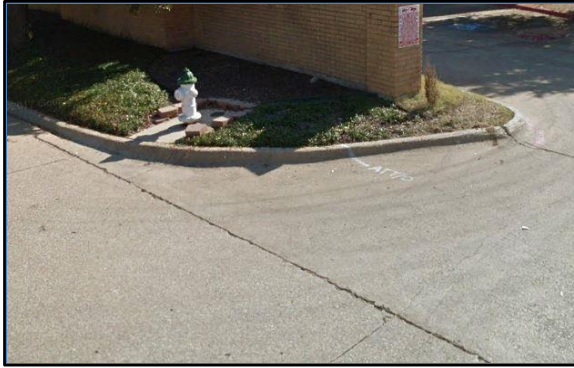
Curb Ramp Issues	Curb Ramp ID ('z' or 'i' in ramp label indicates no existing ramp)		Possible Solutions
	3z	4z	
Curb ramp does not exist and is needed	X	X	Install curb ramp; if median improvement, see shapefile
Curb ramp does not land in crosswalk			
No 4' x 4' clear space at base of curb ramp			
Curbed side is not 90° or has traversable adjacent surface			
Flare cross slope is greater than 10%			
Curb ramp running slope is greater than 8.3%			
Blended transition running slope is greater than 5%			
Cut-thru ramp running slope is greater than 5%			
Curb ramp cross slope is greater than 2%			
Cut-thru ramp cross slope is greater than 2%			
Curb ramp width is less than 48"			
Cut-thru ramp width is less than 60"			
Permanent obstruction (>0.25") in curb ramp/landing/flares			
Temporary obstruction (>0.25") in curb ramp/landing/flares			
No textured surface at base of curb ramp			
No color contrast at base of curb ramp

Corner 3 No Ramp (3z)

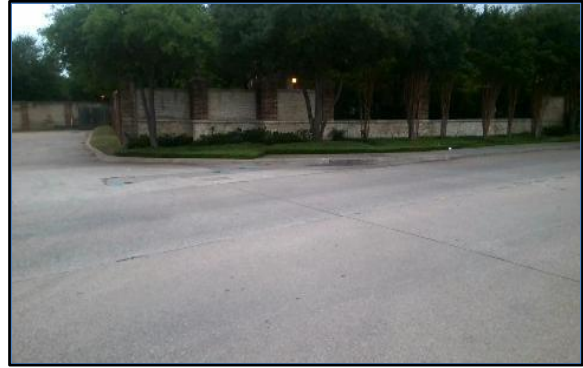
Corner 4 No Ramp (4z)
