Client: Town of Addison Date: 1/2/18
 Program: ADA Self-Evaluation and Transition Plan Prepared By: CMP
 KHA No.: 063543021 Checked By: EPE

Corridor : Proton Rd GPS ID: 257
 Project Name: Intersection of Proton Dr and driveway (Lat. 32.9459; Long. -96.8410)
 Town: Addison

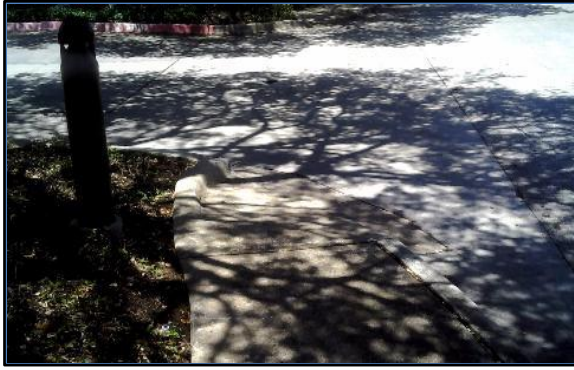
Ramp 3A

Curb Ramp Issues	Curb Ramp ID ('2' or '1' in ramp label indicates no existing ramp)		Possible Solutions
	3A	4A	
Curb ramp does not exist and is needed			Remove and replace curb ramp
Curb ramp does not land in crosswalk			
No 4' x 4' clear space at base of curb ramp			
Curbed side is not 90° or has traversable adjacent surface			
Flare cross slope is greater than 10%			
Curb ramp running slope is greater than 8.3%	X	X	
Blended transition running slope is greater than 5%			
Cut-thru ramp running slope is greater than 5%			
Curb ramp cross slope is greater than 2%	X	X	
Cut-thru ramp cross slope is greater than 2%			
Curb ramp width is less than 48"	X	X	For intersection, commercial driveway, and park ramps, install color truncated domes
Cut-thru ramp width is less than 60"			
Permanent obstruction (>0.25") in curb ramp/landing/flares			
Temporary obstruction (>0.25") in curb ramp/landing/flares			
No textured surface at base of curb ramp	X	X

No color contrast at base of curb ramp	X	X	
Landing area does not exist and is needed			
Landing area is less than 5' x 5' or slopes greater than 2%	X	X	
Curb ramp transition onto roadway is greater than 0.25"		X	
Counter slope of the gutter or street at the foot of the curb ramp is greater than 5%			
Ponding occurs at base of curb ramp

Item No.	Item Description	Quantity	Unit	Unit Price	Item Cost
TxDOT 110-6001	EXCAVATION (ROADWAY)	0	CY	\$ 10.00	\$ -
TxDOT 529-6002	CONC CURB (TY II)	0	LF	\$ 15.00	\$ -
TxDOT 531-6001	CONC SIDEWALKS (4")	0	SY	\$ 45.00	\$ -
TxDOT 531	CURB RAMPS	2	EA	\$ 1,500.00	\$ 3,000.00
TxDOT 5003-6002	RETROFIT DET WARN SURF (CAST IN PLACE)	0	SF	\$ 50.00	\$ -
TxDOT 104-6015	REMOVING CONC (SIDEWALKS)	20	SY	\$ 9.00	\$ 180.00
TxDOT 677	ELIM EXT PAVE MRK & MRKS	0	LF	\$ 2.80	\$ -
TxDOT 666/678	REFL PAV MRK PREP TY I & TY II (W) 24" (SLD)	0	LF	\$ 8.50	\$ -
---	REPAVE ROADWAY	0	LS	\$ 5,000.00	\$ -
---	FIX PONDING	0	LS	\$ 2,000.00	\$ -
---	FIX CURB RAMP TRANSITION	1	LS	\$ 2,000.00	\$ 2,000.00
---	MEDIAN NOSE MODIFICATION	0	LS	\$ 5,000.00	\$ -
---	REMOVE TEMPORARY OBSTRUCTION	0	LS	\$ 500.00	\$ -
---	FIX CURB RAMP COUNTER SLOPE	0	LS	\$ 2,000.00	\$ -
