Client: Town of Addison Date: 1/2/18
 Program: ADA Self-Evaluation and Transition Plan Prepared By: CMP
 KHA No.: 063543021 Checked By: EPE

Corridor: Spring Valley Rd GPS ID: 306
 Project Name: Intersection of Spring Valley Rd and driveway (Lat. 32.9398; Long. -96.8494)
 Town: Addison

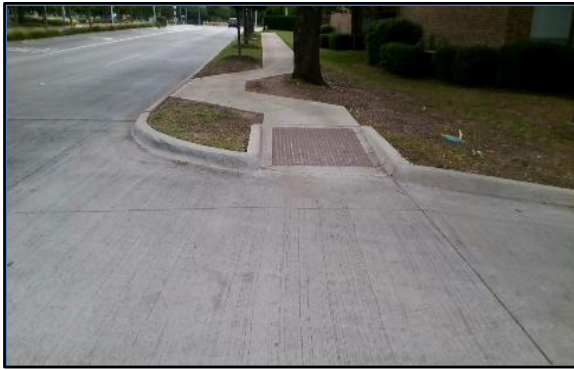
Ramp 3A

Curb Ramp Issues	Curb Ramp ID ('2' or '1' in ramp label indicates no existing ramp)		Possible Solutions
	3A	4A	
Curb ramp does not exist and is needed			
Curb ramp does not land in crosswalk			
No 4' x 4' clear space at base of curb ramp			
Curbed side is not 90° or has traversable adjacent surface			
Flare cross slope is greater than 10%			
Curb ramp running slope is greater than 8.3%			
Blended transition running slope is greater than 5%			
Cut-thru ramp running slope is greater than 5%			
Curb ramp cross slope is greater than 2%			
Cut-thru ramp cross slope is greater than 2%			
Curb ramp width is less than 48"			
Cut-thru ramp width is less than 60"			
Permanent obstruction (>0.25") in curb ramp/landing/flares			
Temporary obstruction (>0.25") in curb ramp/landing/flares			
No textured surface at base of curb ramp			
No color contrast at base of curb ramp			
Landing area does not exist and is needed

Landing area is less than 5' x 5' or slopes greater than 2%		X	
Curb ramp transition onto roadway is greater than 0.25"	X		
Counter slope of the gutter or street at the foot of the curb ramp is greater than 5%			
Ponding occurs at base of curb ramp
