Client: Town of Addison Date: 1/2/18
 Program: ADA Self-Evaluation and Transition Plan Prepared By: CMP
 KHA No.: 063543021 Checked By: EPE

Corridor: Morris Ave GPS ID: 90078
 Project Name: Intersection of Morris Ave and driveway (Lat. 32.9627; Long. -96.8289)
 Town: Addison

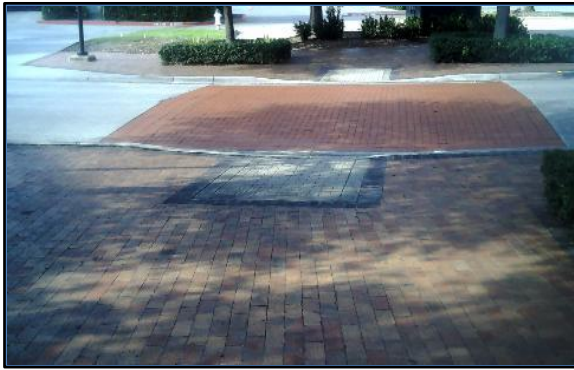
Ramp 1A

| Curb Ramp Issues | Curb Ramp ID ('2' or '1' in ramp label indicates no existing ramp) | | Possible Solutions |
|---|---|---|---|
| Landing area is less than 5' x 5' or slopes greater than 2% | X | X | Remove and replace landing area |
| Curb ramp transition onto roadway is greater than 0.25' | X | | Fix curb ramp transition |

| Item No. | Item Description | Quantity | Unit | Unit Price | Item Cost |
|---|---|---|---|---|---|
| --- | FIX CURB RAMP TRANSITION | 1 | LS | \$ 2,000.00 | \$ 2,000.00 |

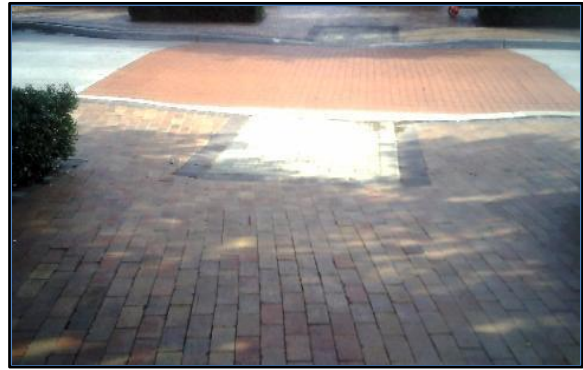
Ramp 4A

| Curb Ramp Issues | Curb Ramp ID ('2' or '1' in ramp label indicates no existing ramp) | | Possible Solutions |
|---|---|---|---|
| Ponding occurs at base of curb ramp | | X | Fix ponding |

| Item No. | Item Description | Quantity | Unit | Unit Price | Item Cost |
|---|---|---|---|---|---|
| --- | FIX PONDING | 1 | LS | \$ 2,000.00 | \$ 2,000.00 |
