Client: Town of Addison Date: 1/2/18
 Program: ADA Self-Evaluation and Transition Plan Prepared By: CMP
 KHA No.: 063543021 Checked By: EPE

Corridor : Oaks N Dr GPS ID: 90094
 Project Name: Intersection of Oaks N Dr and driveway (Lat. 32.9501; Long. -96.8154)
 Town: Addison

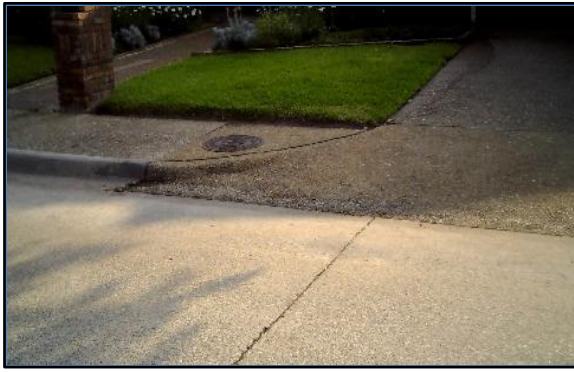
Corner 2 No Ramp (2z)

Curb Ramp Issues	Curb Ramp ID ('z' or 'r' in ramp label indicates no existing ramp)		Possible Solutions
	2z	3z	
Curb ramp does not exist and is needed	X	X	Install curb ramp; if median improvement, see shapefile
Curb ramp does not land in crosswalk			
No 4' x 4' clear space at base of curb ramp			
Curbed side is not 90° or has traversable adjacent surface			
Flare cross slope is greater than 10%			
Curb ramp running slope is greater than 8.3%			
Blended transition running slope is greater than 5%			
Cut-thru ramp running slope is greater than 5%			
Curb ramp cross slope is greater than 2%			
Cut-thru ramp cross slope is greater than 2%			
Curb ramp width is less than 48"			
Cut-thru ramp width is less than 60"			
Permanent obstruction (>0.25") in curb ramp/landing/flares			
Temporary obstruction (>0.25") in curb ramp/landing/flares			
No textured surface at base of curb ramp			
No color contrast at base of curb ramp
