Client: Town of Addison Date: 1/2/18
 Program: ADA Self-Evaluation and Transition Plan Prepared By: CMP
 KHA No.: 063543021 Checked By: EPE

Corridor : Oaks N Dr GPS ID: 90096
 Project Name: Intersection of Oaks N Dr and driveway (Lat. 32.9506; Long. -96.8157)
 Town: Addison

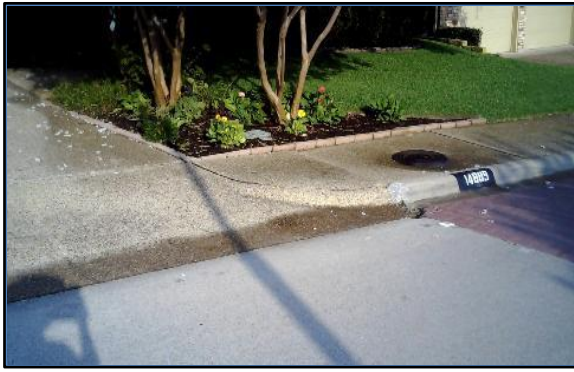
Curb Ramp Issues	Curb Ramp ID ('z' or 'i' in ramp label indicates no existing ramp)		Possible Solutions
	1z	4z	
Curb ramp does not exist and is needed	X	X	Install curb ramp; if median improvement, see shapefile
Curb ramp does not land in crosswalk			
No 4' x 4' clear space at base of curb ramp			
Curbed side is not 90° or has traversable adjacent surface			
Flare cross slope is greater than 10%			
Curb ramp running slope is greater than 8.3%			
Blended transition running slope is greater than 5%			
Cut-thru ramp running slope is greater than 5%			
Curb ramp cross slope is greater than 2%			
Cut-thru ramp cross slope is greater than 2%			
Curb ramp width is less than 48"			
Cut-thru ramp width is less than 60"			
Permanent obstruction (>0.25") in curb ramp/landing/flares			
Temporary obstruction (>0.25") in curb ramp/landing/flares			
No textured surface at base of curb ramp			
No color contrast at base of curb ramp

Corner 1 No Ramp (1z)

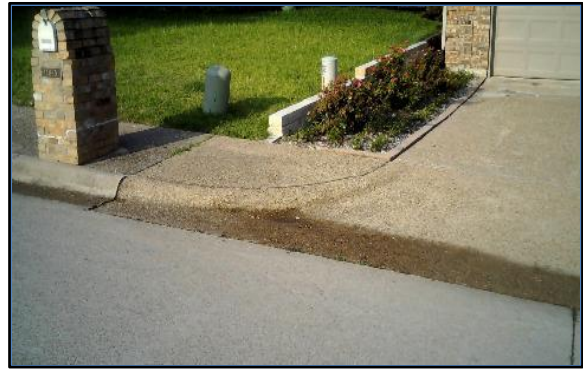
Corner 4 No Ramp (4z)
