Client: Town of Addison Date: 1/2/18
 Program: ADA Self-Evaluation and Transition Plan Prepared By: CMP
 KHA No.: 063543021 Checked By: EPE

Corridor : Oaks N Dr GPS ID: 90100
 Project Name: Intersection of Oaks N Dr and driveway (Lat. 32.9510; Long. -96.8160)
 Town: Addison

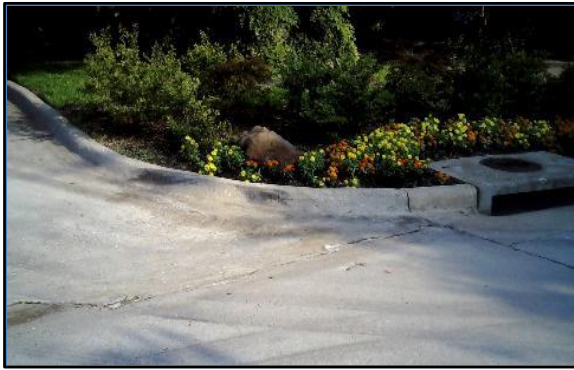
Curb Ramp Issues	Curb Ramp ID ('z' or 'l' in ramp label indicates no existing ramp)		Possible Solutions
	1z	4z	
Curb ramp does not exist and is needed	X	X	Install curb ramp; if median improvement, see shapefile
Curb ramp does not land in crosswalk			
No 4' x 4' clear space at base of curb ramp			
Curbed side is not 90° or has traversable adjacent surface			
Flare cross slope is greater than 10%			
Curb ramp running slope is greater than 8.3%			
Blended transition running slope is greater than 5%			
Cut-thru ramp running slope is greater than 5%			
Curb ramp cross slope is greater than 2%			
Cut-thru ramp cross slope is greater than 2%			
Curb ramp width is less than 48"			
Cut-thru ramp width is less than 60"			
Permanent obstruction (>0.25") in curb ramp/landing/flares			
Temporary obstruction (>0.25") in curb ramp/landing/flares			
No textured surface at base of curb ramp			
No color contrast at base of curb ramp

Corner 1 No Ramp (1z)

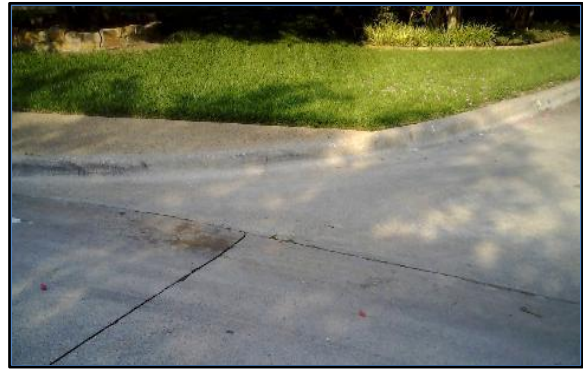
Corner 4 No Ramp (4z)
