Client: Town of Addison Date: 1/2/18
 Program: ADA Self-Evaluation and Transition Plan Prepared By: CMP
 KHA No.: 063543021 Checked By: EPE

Corridor : Oaks N Dr GPS ID: 90101
 Project Name: Intersection of Oaks N Dr and driveway (Lat. 32.9512; Long. -96.8158)
 Town: Addison

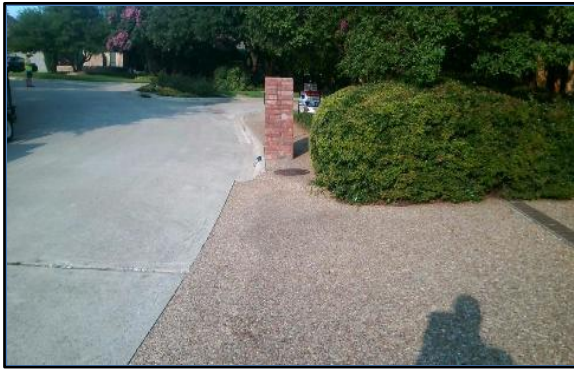
Curb Ramp Issues	Curb Ramp ID ('z' or 'i' in ramp label indicates no existing ramp)		Possible Solutions
	1z	2z	
Curb ramp does not exist and is needed	X	X	Install curb ramp; if median improvement, see shapefile
Curb ramp does not land in crosswalk			
No 4' x 4' clear space at base of curb ramp			
Curbed side is not 90° or has traversable adjacent surface			
Flare cross slope is greater than 10%			
Curb ramp running slope is greater than 8.3%			
Blended transition running slope is greater than 5%			
Cut-thru ramp running slope is greater than 5%			
Curb ramp cross slope is greater than 2%			
Cut-thru ramp cross slope is greater than 2%			
Curb ramp width is less than 48"			
Cut-thru ramp width is less than 60"			
Permanent obstruction (>0.25") in curb ramp/landing/flares			
Temporary obstruction (>0.25") in curb ramp/landing/flares			
No textured surface at base of curb ramp			
No color contrast at base of curb ramp

Corner 1 No Ramp (1z)

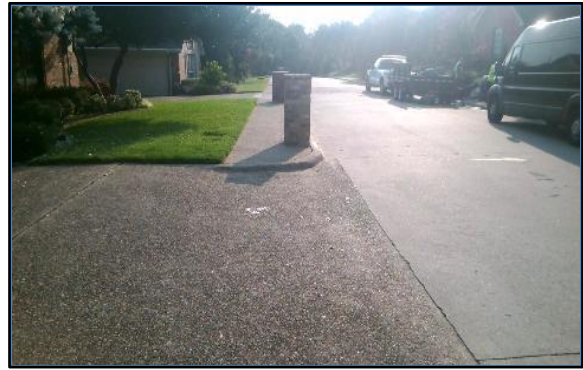
Corner 2 No Ramp (2z)
