Client: Town of Addison Date: 1/2/18
 Program: ADA Self-Evaluation and Transition Plan Prepared By: CMP
 KHA No.: 063543021 Checked By: EPE

Corridor : Oaks N Dr GPS ID: 90105
 Project Name: Intersection of Oaks N Dr and driveway (Lat. 32.9516; Long. -96.8151)
 Town: Addison

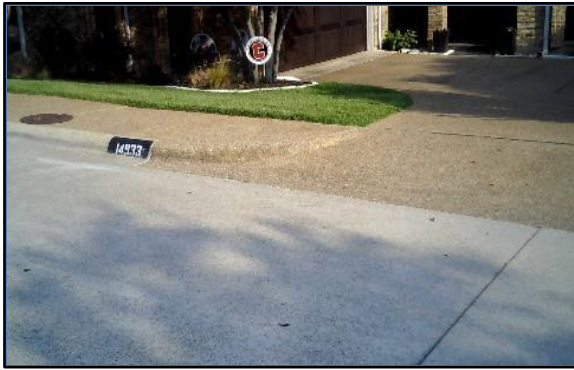
Curb Ramp Issues	Curb Ramp ID ('z' or 'l' in ramp label indicates no existing ramp)		Possible Solutions
	1z	2z	
Curb ramp does not exist and is needed	X	X	Install curb ramp; if median improvement, see shapefile
Curb ramp does not land in crosswalk			
No 4' x 4' clear space at base of curb ramp			
Curbed side is not 90° or has traversable adjacent surface			
Flare cross slope is greater than 10%			
Curb ramp running slope is greater than 8.3%			
Blended transition running slope is greater than 5%			
Cut-thru ramp running slope is greater than 5%			
Curb ramp cross slope is greater than 2%			
Cut-thru ramp cross slope is greater than 2%			
Curb ramp width is less than 48"			
Cut-thru ramp width is less than 60"			
Permanent obstruction (>0.25") in curb ramp/landing/flares			
Temporary obstruction (>0.25") in curb ramp/landing/flares			
No textured surface at base of curb ramp			
No color contrast at base of curb ramp

Corner 1 No Ramp (1z)

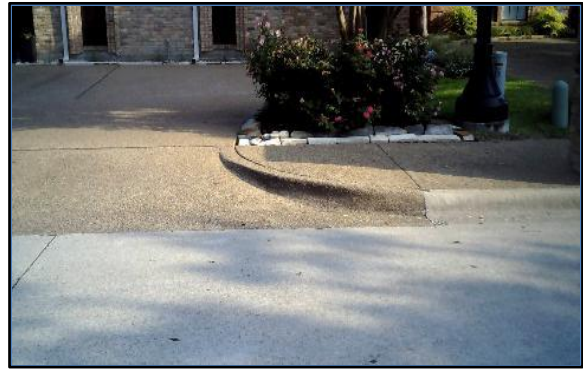
Corner 2 No Ramp (2z)
